COMPLETION OF LASER-GUIDED LANE STRIPING SYSTEM (PHASE II)

AHMCT Final Report UCD-ARR-97-8-31-01

August 31, 1997

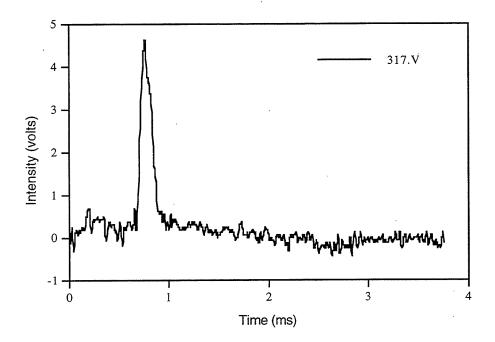
Figures 1 to 4 are sample data collected from roadways. Data in Figure 1 were collected from a white stripe in good condition at Norman Road off-ramp along Highway 5. Figure 2 was from a worn-out old stripe on an unused road near UC Davis Campus by Hutchson Road. It can be seen that although signals from stripes with good condition are OK, the signals from worn-out old stripes are too weak to be separated from noise. Data in Figure 4 were collected from a fairly good double yellow line on the same unused road near Campus.

Figure 1- Sample scanning data from a white paint stripe in fairly good condition

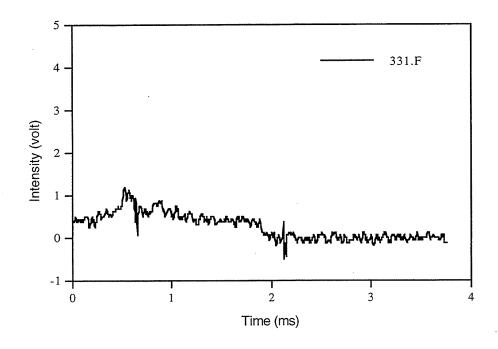
Figure 2- Sample data from a worn-out old paint stripe.

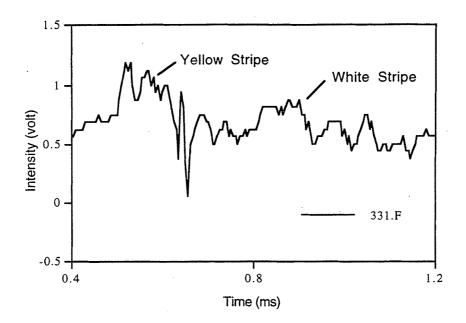
Figure 3- Rescaling of Figure 2

Figures 5 and 6 are the data collected by ARTI from worn-out old stripes, of which the reflectivity was estimated to be 50% degraded. Figure 3 is a re-scaled curve of Figure 2 to show its similarity to the data by ARTI. It can be seen that both of the data sets have very low signal-to-noise ratio. The horizontal coordinate of Figures 5 and 6 is the number of data points and, the horizontal coordinate of data collected by us is time in millisecond. Both number of data points and time can be converted to the lateral distance of a stripe. The data by ARTI were included in their monthly report in March, 1991 to justify the improved algorithm. explained in the report that with the original algorithm the center of an old stripe was determined at 48.01 at threshold level of 400. While with the improved algorithm, a correct center position of 31.777 was predicted at threshold level of 350. Here a few fundamental signal problems are obvious. First, the center value of the stripe is very sensitive to threshold level, a significant difference in stripe position prediction (about 2.6 inches, assuming the data were from a 5 ft beam) resulted when threshold level was reduced from 400 to 350. Secondly, the signal-to-noise ratio was so low that a threshold level suitable for one case would not work on other cases. For example, a threshold level of 350 may be considered to be a desired value for the case in Figure 5 but it certainly would not work for the case in Figure 6 for it falls into its noise region. On the other hand, a threshold level between 600 to 680 may work well for the case in Figure 6 but it is beyond the signal level for the case in Figure 5. It would be impractical to continuously adjust the threshold level according to the changing signals during an actual operation, not to mention that it is very difficult to determine a good level even only for a single case. The fundamental concept of using the laser scanner furnished by ARTI is inadequate to produce a signal quality at a high signal-to-noise ratio for the expected paint stripe conditions the equipment is to be used for. While it is possible with more sophisticated computer signal processing algorithms to improve the signal-to -noise ratio, it may be better to consider systems which overcome this inherent deficiency.

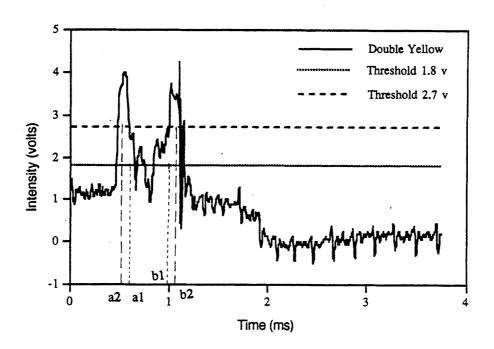
Figure 4- Sample data from a double yellow stripe

(a1 and b1 are the center values of the stripes at threshold level of 2.7v, a2 and b2 are the center values at threshold level of 1.8v)

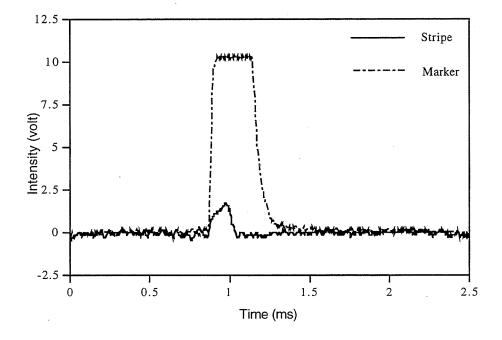
Figures 7 shows the signals of a new stripe and a reflective marker which has the same width as the stripe (4 "). It can be seen that the signal of the marker is not only much higher in magnitude but also much wider than that of the stripe. Although the reflective marker can be recognized by software algorithm, this extreme indicates the significant effect of paint reflectivity on the scanned signals. Figures 8 compares signals of a new paint stripe obtained at two different scanner height, 20" and 34". It is obvious that the difference is tremendous. Although the signal obtained at scanner height of 20" is ideal, the one from actual mounting height on the MB machine (34") is relatively very weak. The construction of the MB paint striping machine hinders the scanner from being mounted at a height of 20 inches. Further more, it is not desirable to mount such a fragile unit with rotating mirror and prisms at such low height for highway operation. While a stronger laser or a better optical system design may solve this problem, the current laser unit was found to be not capable of providing a good signal at a practical mounting height.

Figure 7- Comparison of data from a paint stripe and a reflective marker.

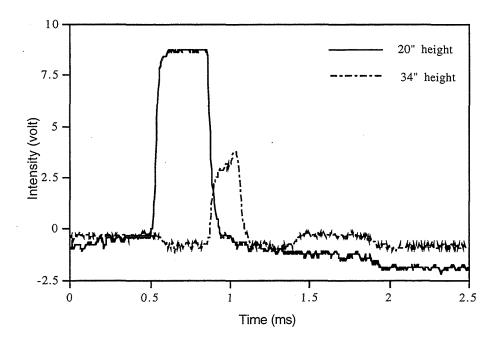
Figure 8 - Comparison of data of the same stripe at two different scanner heights.

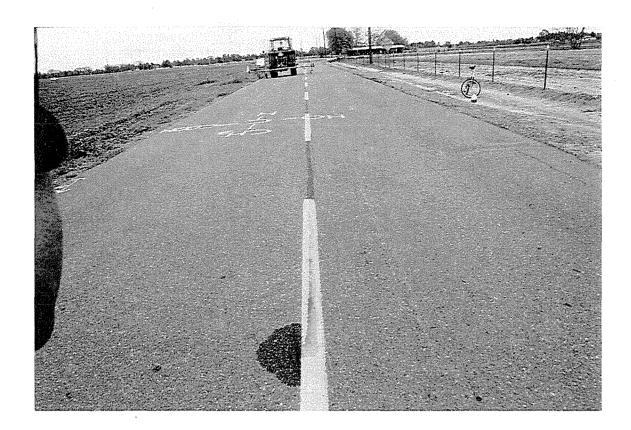
Color video images of paint stripes with various conditions were collected using a Sony 710 video camera and analyzed in the lab using the existing software to see if the stripes could be recognized. The results showed that the pattern of the worst worn-out stripes could be recognized without any problems. Thus a field try-out test was conducted using the vision-guided cultivator to trace the paint stripes along an unused road on Campus by Hutchson road and Campbell Dr. nearby. A small water container was mounted behind the camera and red-colored water was drained during test runs to trace the paint stripes. The results were very satisfactory (see photo in Figure 9) even on the worn-out old paint stripes which could not be detected by the Laser scanner (shown in Figure 2 and 3).

Figure 9- Field tests of a vision-based guidance system

Results of our investigation show that the current Laser-scan guidance system is inadequately designed and it has many inherent problems. The probability of success for developing such a system to an operable unit is therefore low. On the other hand, our preliminary tests indicate that a machine-vision system using a video-camera guidance system can work well and has many advantages over the laser-scan system. It would be more logical to concentrate our effort on the development of the superior machine-vision system based on the technology available at UC Davis. This approach, in our estimates, has a much higher probability of success. This vision system is based on currently available electronic hardware which is much lower in cost and easier to implement than older concepts of vision system that required much more sophisticated and expensive electronics.
