## **Field Testing of the Snowplow Driver Assistance System**

Report Number: CA17-2990

AHMCT Research Report: UCD-ARR-16-11-23-01

## CHAPTER 2: MAINTENANCE AND REPAIR ISSUES ENCOUNTERED DURING DAS FIELD TESTING

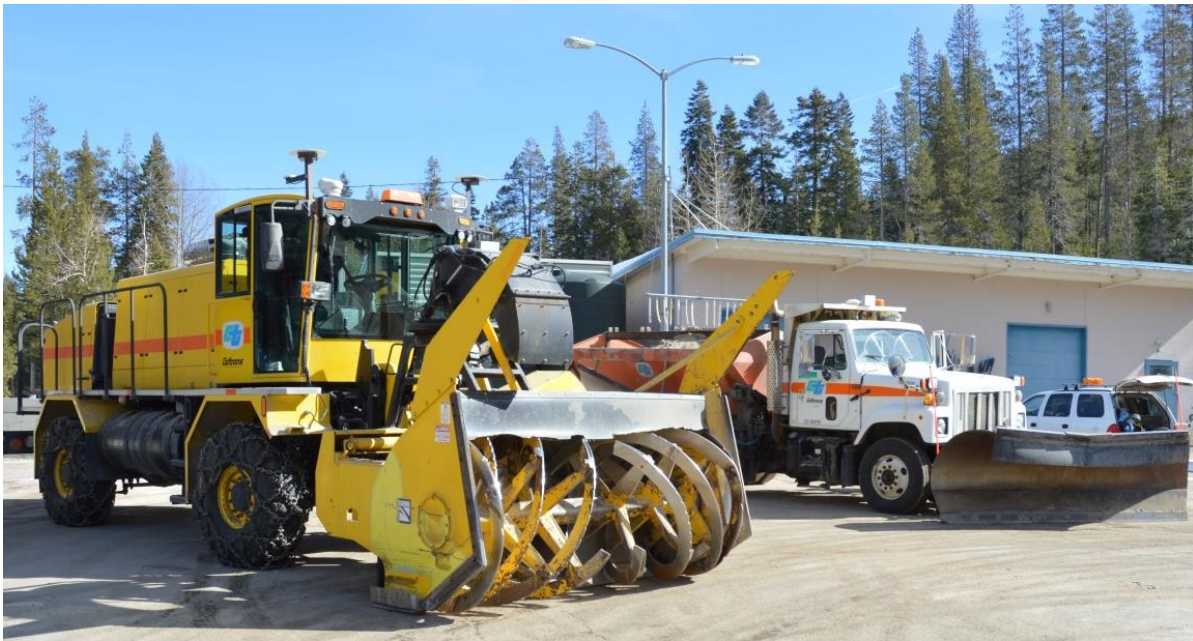
**Figure 1.1: Snowplow Driver Assistance System installed on Caltrans snow blower (yellow) and snowplow (white)**

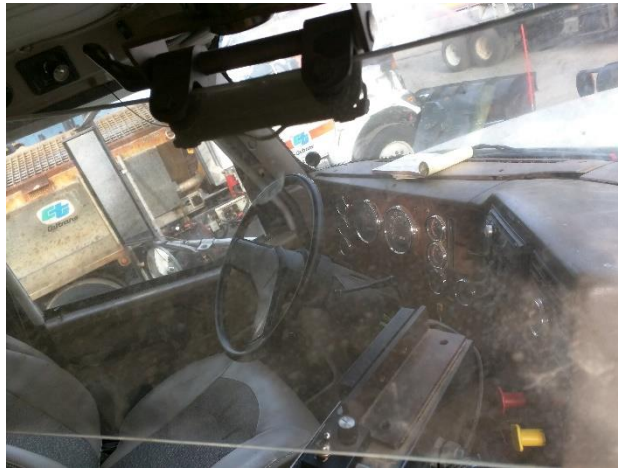
- The combiner of the snow blower and the 0506 and 0024 snowplows were cleaned carefully to avoid scratching the semi-reflective surface before the winter session began (10/15/2015). Since the 0024 snowplow was used to haul sand and dirt when there were no storms, the 0024 combiner was quite dirty compared to the combiner in the 0506 snowplow.

**Figure 2.1: The 0024 snowplow combiner before cleaning**

- DRISI expressed concern about the combiner sensitivity to dirt and dust, and the difficulty of cleaning. They asked about possibilities for putting a protective film on during the summer and perhaps the winter. The suggestion was to switch the film between seasons or remove it before winter if the film impacts the optics. They suggested something with static, non-adhesive application. AHMCT researchers were concerned that the plastic film might interact with the delicate semi-reflective coating. Pursuit of this idea by MTS would be best since the film would be an add-on to their commercial system.

- AHMCT recommends taking the combiners off during the summer, keeping them in safe storage, and reinstalling them before winter. They should not be exposed to the harsh and dirty conditions of Caltrans summer operations.

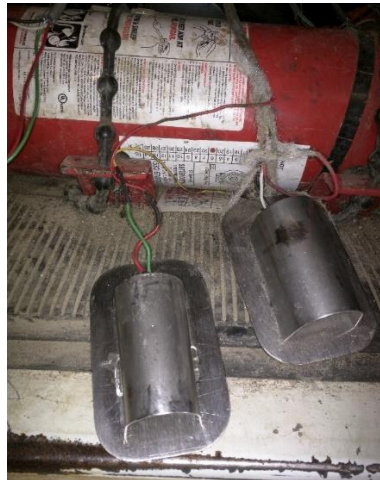
2. A new system power switch was installed on the 0024 snowplow to replace a broken snowplow DAS power switch.
3. The DAS seat vibration motors were left on the floor of the 0506 snowplow (see Figure 2.2) on 04/05/2016 when the driver seat was replaced. The seat vibration motors need to be reinstalled into the new seat. However, the 0506 snowplow may be retired soon, possibly during summer 2017. The seat vibration motor installation procedure documentation was requested and received from MTS. Some wiring work would be required to add connectors to aid future driver seat maintenance. The vibration motors are currently secured next to the center console of the 0506 snowplow.
4. The modified heated radar enclosures and wipers were reinstalled 04/05/2016 on snowplows 0506 and 0024. See Chapter 3 for details.

**Figure 2.2: The 0506 seat vibration motors**

3. DAS installation improvement needed:
  - a. Currently, the DAS computer and the GNSS receiver are installed under the passenger seat, and the vibration motor on the driver seat is directly wired to the DAS electronics located under the passenger seat. When performing repairs on the snowplow engine and transmission, the driver and passenger seats must be removed in order to access the drivetrain components. Connectors should be added to allow breaking the electrical connection to the vibration motors so that the driver seat can be removed and reinstalled easily. In addition, bulkhead connectors should also be added to the DAS electronics installed under the passenger seat so that the electrical connections can be disconnected and connected easily during the removal and installation of the passenger seat. MTS has already incorporated most, if not all, of these features into their new generation DAS.

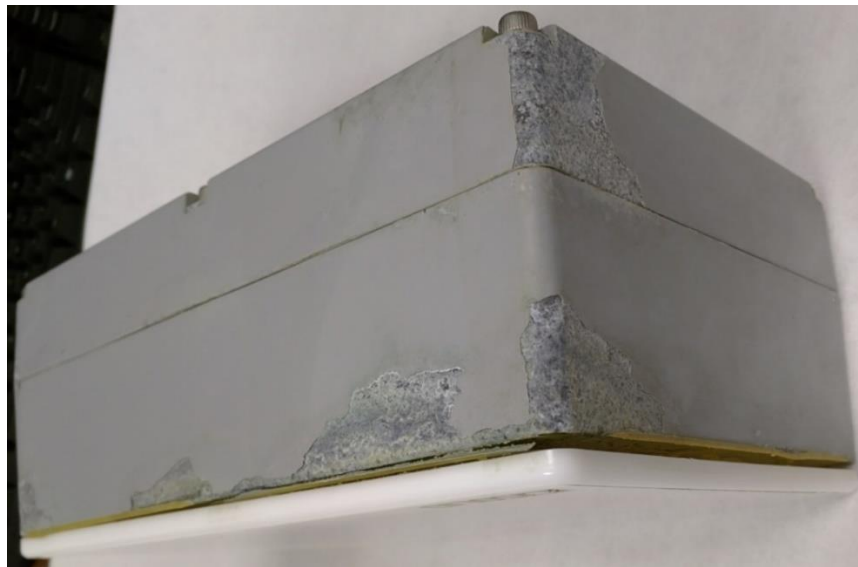
**Figure 3.1: Heated enclosure ver. 1.1. Adhesive failure causing delamination between the aluminum enclosure and the Delrin fascia**

A teleconference was held to solicit AutonomouStuff’s support for the development of the next generation of their heated enclosure for the ESR. However, AutonomouStuff, the sole distributor of the Delphi ESR radar and the original maker of the heated enclosure ver. 1.0, had decided to discontinue the heated enclosure ver. 1.0 and any future development of radar heated enclosures for the DAS. AutonomouStuff sent AHMCT the remaining spare parts of the heated enclosure ver. 1.0 in their inventory for free in March 2016 in order for AHMCT to repair the system quickly and continue the DAS evaluation and testing. Consequently, once all the spare parts of the heated enclosure ver. 1.0 have been consumed by corrosion or other failures, there will be no replacements. As shown in Figure 3.2, AHMCT added mechanical fasteners to prevent the

delamination of the front fascia of the heated enclosure ver. 1.0 from interfering with the heated wiper operation. The radar enclosure icing mitigation system ver. 1.5 was installed on both the 0024 and 0506 snowplows on 04/05/2016. Previous test results show that the heated enclosure ver. 1.2 will eventually fail due to delamination since the design did not change from that of the previous enclosure which did delaminate. Any new radar enclosure icing mitigation system should be designed so that it does not have any epoxy joints or metal that can corrode. The solution to this problem is to design away from any adhesive joint and non-anodized aluminum. AutonomouStuff currently provides sealed (non-heated) enclosures for ESRs used in the mining industry. Their new sealed enclosures for the mining industry use rubber gasket and mechanical fasteners to secure the front fascia onto the aluminum housing. The snowplow DAS does not require the factory-sealed ESR to be housed inside any sealed enclosure since the ESR is already sealed. The AutonomouStuff heated enclosure happens to be sealed.

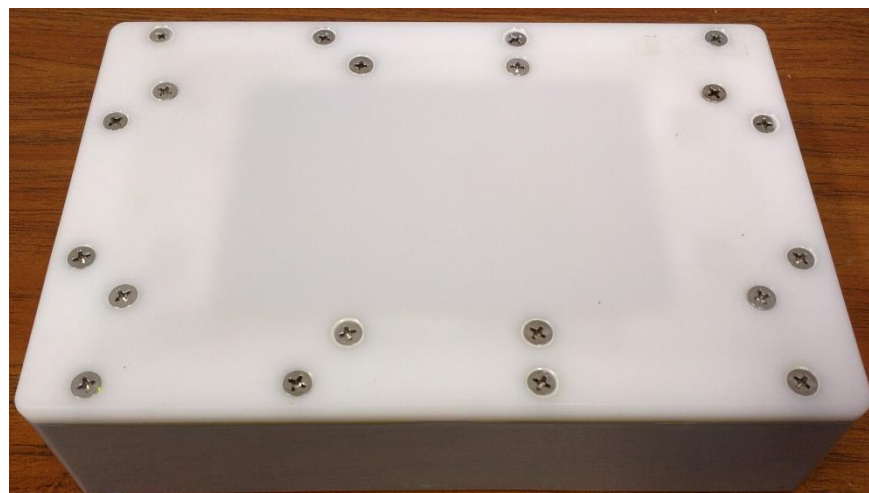
Heated enclosure ver. 1.2	<ul style="list-style-type: none"> <li>• Heated enclosure ver. 1.1 with added fasteners to Delrin front fascia to prevent delamination. (see Figure 3.2)</li> <li>• Water drain hole added at the bottom of the enclosure.</li> </ul>	April 2016 (this research)	<ul style="list-style-type: none"> <li>• Able to prevent icing when vehicle is not moving.</li> <li>• Failed to prevent icing on its own when vehicle is moving.</li> </ul>

**Figure 3.2: Heated enclosure ver. 1.2. AHMCT added mechanical fasteners to prevent delamination in the event of adhesive failure between the aluminum enclosure and the Delrin fascia**

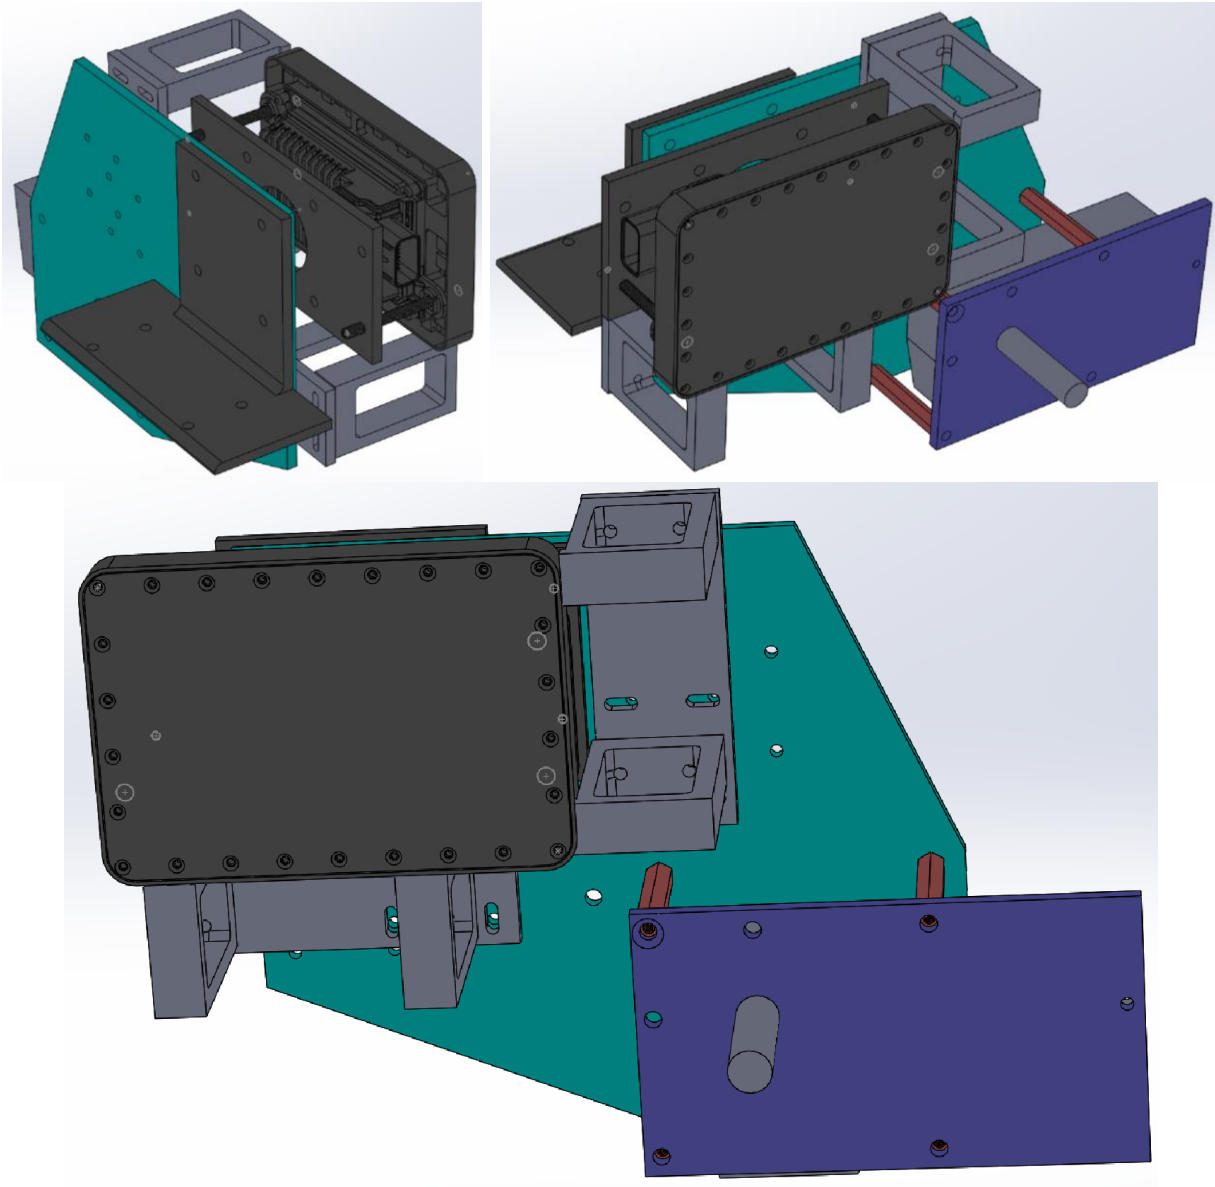
The radar enclosure icing mitigation system ver. 2.0 was designed in this research. This design features a heated wiper blade and marine grade wiper motor (the same motor used in radar enclosure icing mitigation system ver. 1.5) with a different heated front Delrin fascia design. The design uses higher heater power output for increased snow and ice melting. It also features reduced frontal area, to reduce heat power requirements. Finally, the ESR is not enclosed to avoid overheating by the Delrin front fascia heater. This system has not been tested. The design model is shown in Figure 3.4.

**Figure 3.4: SolidWorks model of radar enclosure icing mitigation system ver. 2.0 with heated fascia**

- The current heater power is limited by wire size and vehicle alternator power output. An alternator upgrade is needed.
- A higher-power heater may overheat the ESR if the ESR is housed inside a sealed enclosure. The radar enclosure icing mitigation system ver. 2.0 has an open heated front fascia design to keep the ESR from overheating.
- Teflon has better hydrophobic property than Delrin. Thus, Teflon should be used for the front fascia material in the radar enclosure icing mitigation system ver. 2.0 design.
- Reducing the frontal area of the fascia would reduce the heater power requirement.

- Plastic or stainless fasteners should be used to eliminate the corrosion problem.
- A new heater temperature controller should be incorporated to enable a higher front fascia temperature.
- 3D printing of plastic parts would reduce the manufacturing cost.
- A new wiper controller is needed to control the wiper cycle frequency based on vehicle speed using GPS as a speed sensor. This would reduce wiper blade wear.
- Experiments should be performed for embedding heating wires in the front fascia.
- Extensive field testing is needed to ensure the reliability of the new design.
