CORROSION MITIGATION - LESSONS FROM UTAH AND OTHER STATE DOTs

CORROSION PROTECTION TECHNOLOGY(CPT) FOR WINTER MAINTENANCE CONFERENCE

UTAH DOT PROJECT - OVERVIEW

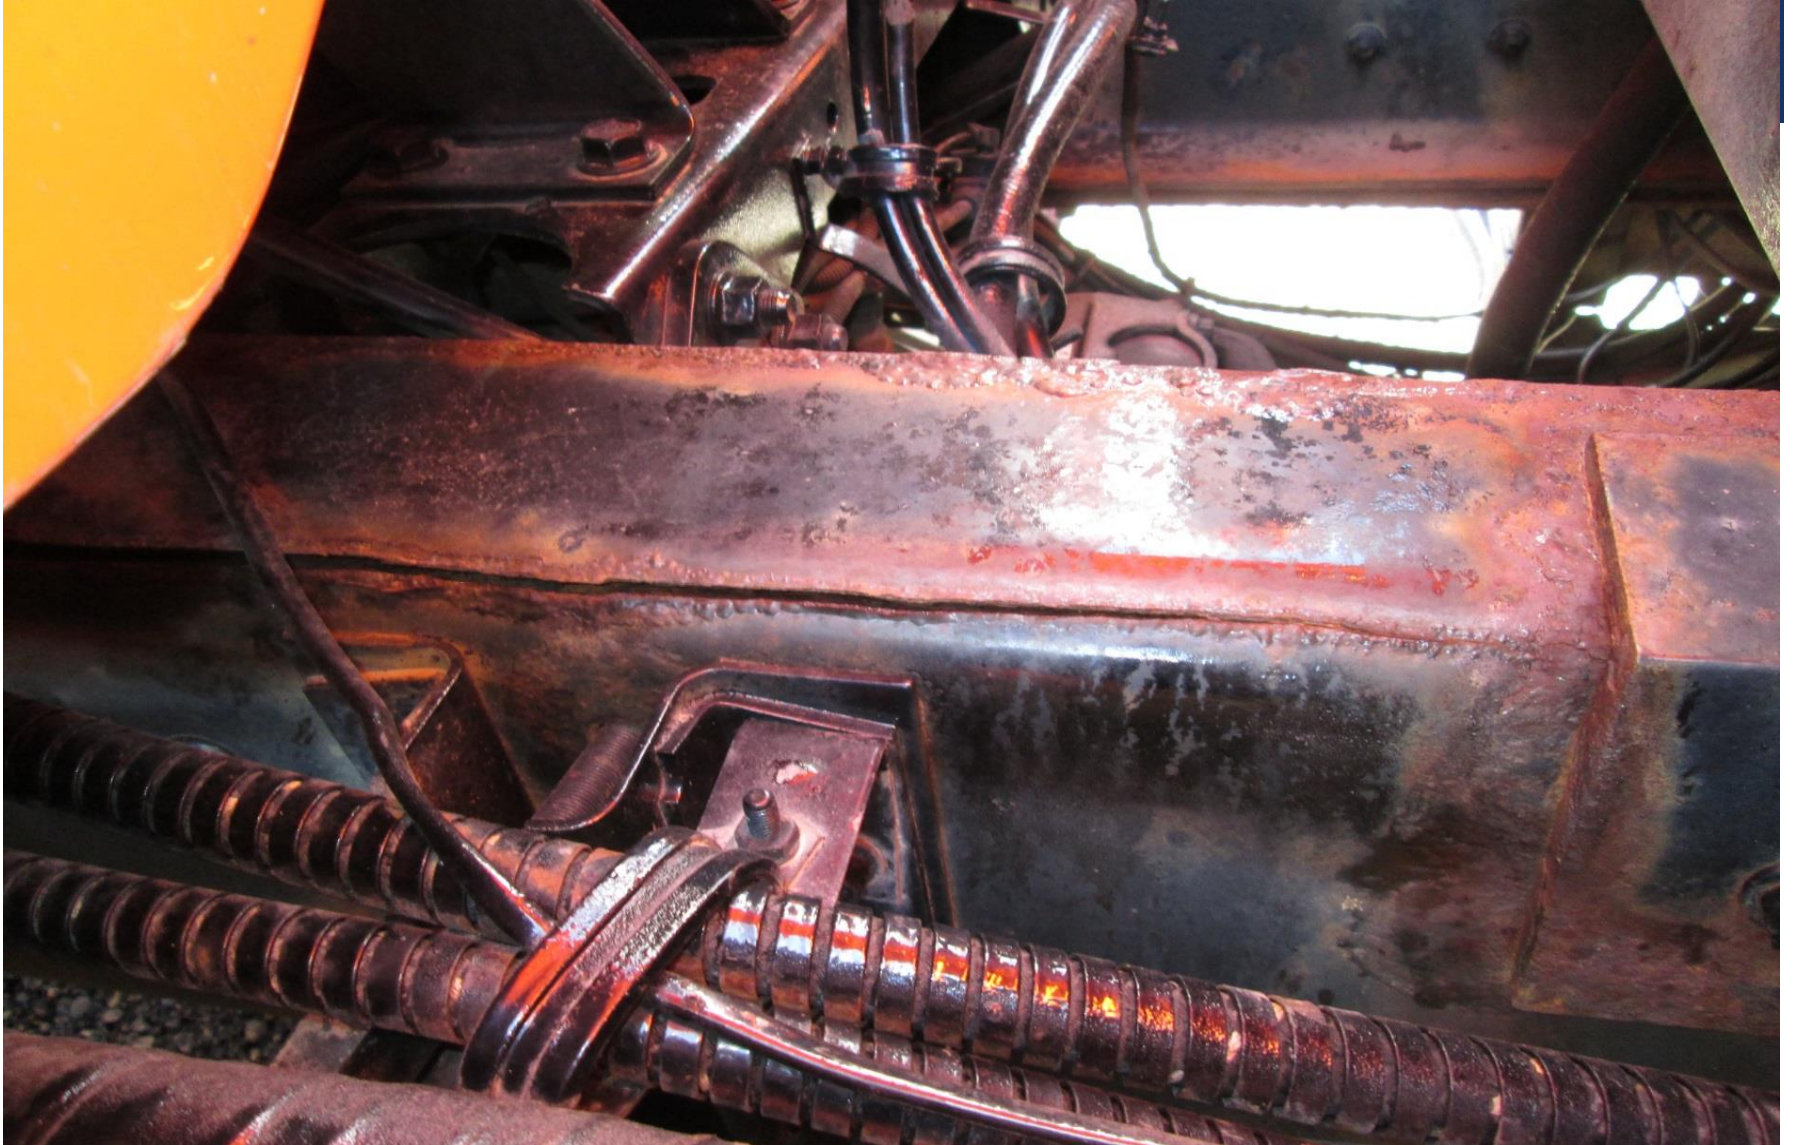
FRAME CRACKING*

- UDOT was experiencing corrosion-related frame cracking
 - Attributed to double “C”-channel frame design
 - 197 total units with this design
 - 59 units had experienced significant frame cracking
- Other corrosion issues also being experienced plow trucks
 - Oil pans, differential cases and covers, brake shoes and lines, cab floors, firewall and doors, windshield frames, etc.
 - Electrical connections, steel hydraulic connectors, battery cases, dump body, etc.

- Frame corrosion linked to gaps in double “C” frames
 - Prioritized the replacing vehicles with nested frame design
 - Shift to single rail design mostly addressed frame cracking
- Changed specs of oil pans and differential covers to non-rusting / rust-resistant materials
- Improved electrical connector specs and junction box location
- Implemented corrosion assessment program and include the calculated score as part of the replacement prioritization
