1. REPORT NUMBER CA12-1954	2. GOVERNMENT ASSOCIATION NUMBER	3. RECIPIENT'S CATALOG NUMBER
4. TITLE AND SUBTITLE Evaluation of New Technology in Culvert Cleaning		5. REPORT DATE June 30, 2012

6. PERFORMING ORGANIZATION CODE AHMCT Research Center, UC Davis
7. AUTHOR Allyson E. Clark, Ben C. Creed, Wilderich A. White, & Steven A. Velinsky		8. PERFORMING ORGANIZATION REPORT NO. UCD-ARR-12-06-30-09

Advanced Highway Maintenance and Construction Technology Research Center

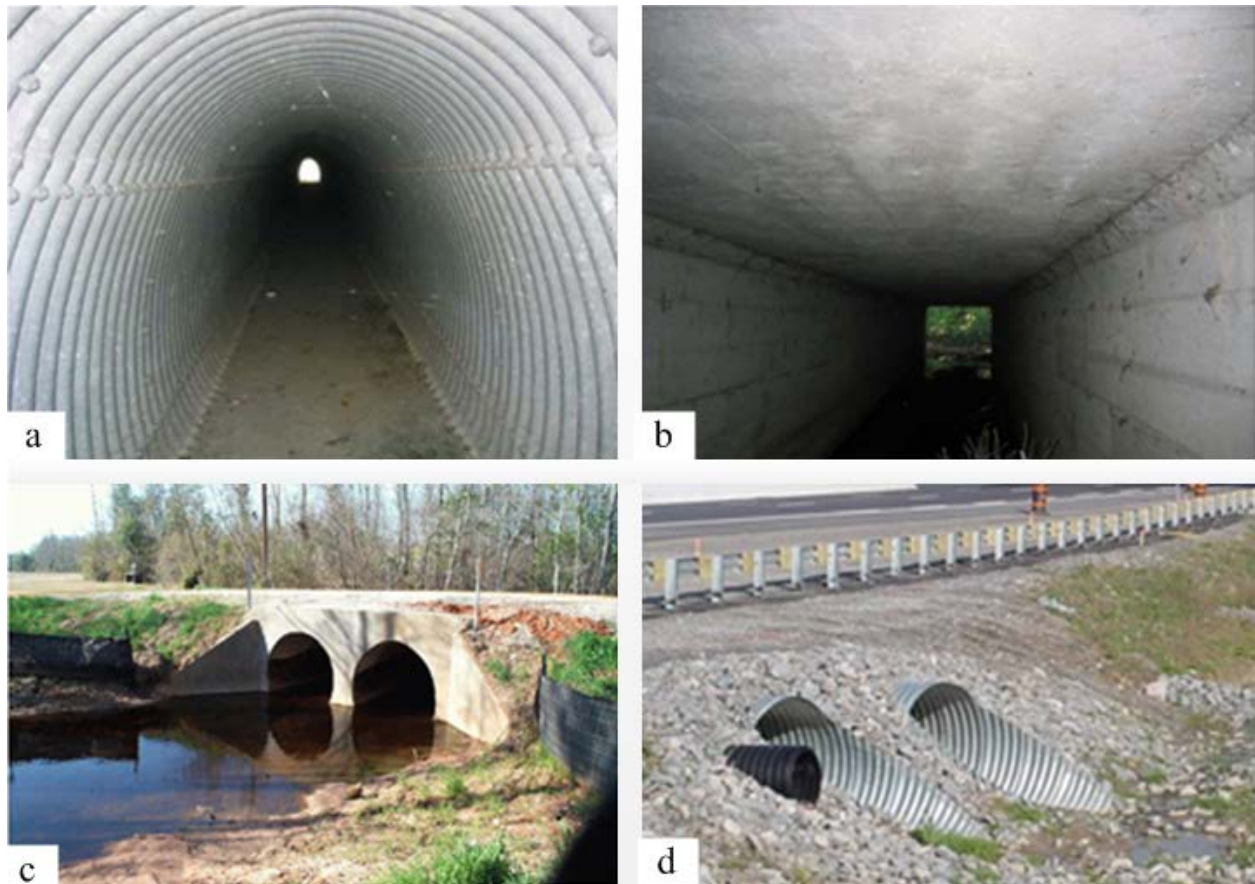
**Figure 2.1: (a) Corrugated steel pipe [3] (b) Concrete box culvert [3]
(c) Concrete culvert for stream crossing [2] (d) Corrugated steel pipe culvert [4]**

Both functional types come in many sizes, shapes, and materials. Both consist of a mix of these particular components: span barrel, headwall, endwall, and wingwalls. The span barrel is the tunnel structure that traverses the width of the highway. These can range in shape from round to rectangular and anything in between. Culvert span barrels can be made from concrete or more flexible materials such as plastic, steel, or aluminum. Examples of different shapes and materials can be seen in Figures 2.1a to d.

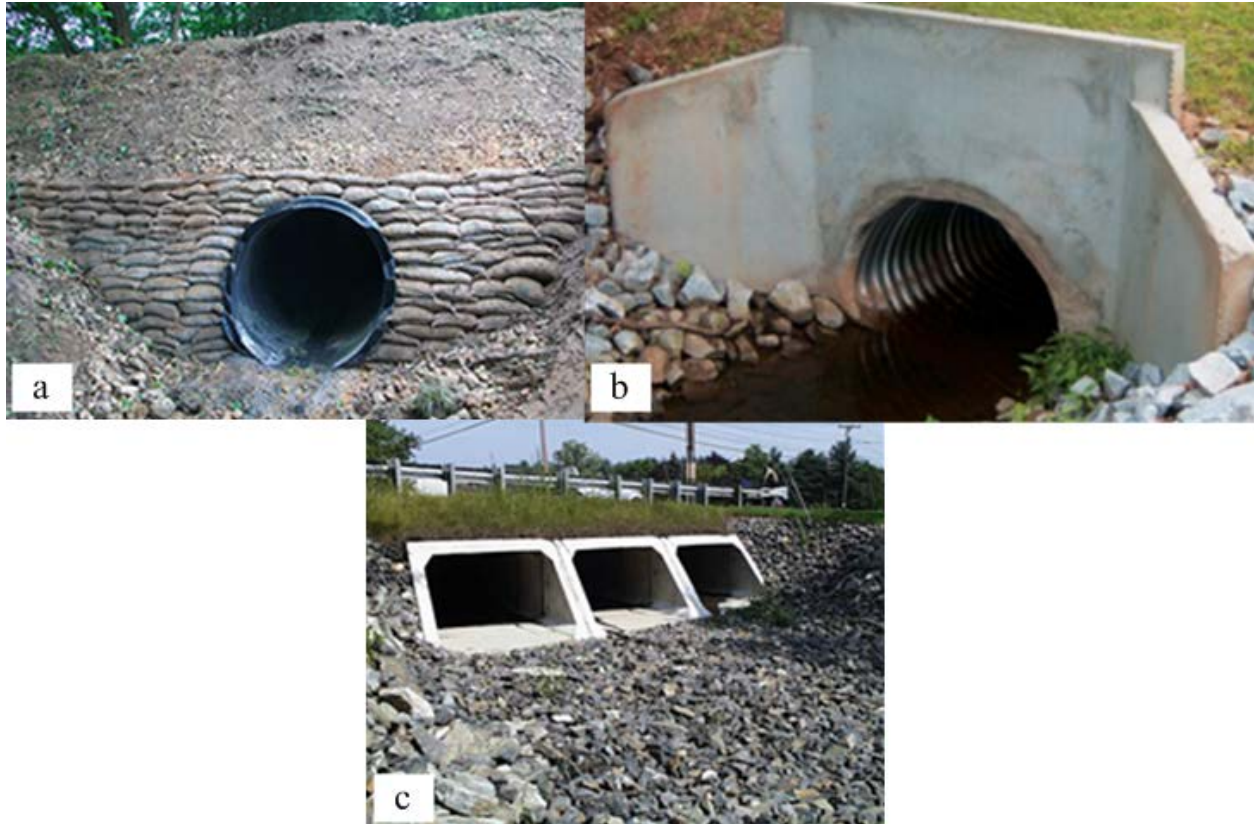
**Figure 2.2: (a) Headwall constructed with hessian sacks filled with semi-dry C20 concrete mix [6]
(b) Concrete headwall with two wingwalls [7] (c) Triple concrete box culvert [8]**

The headwall and endwall are responsible for controlling the erosion around the culvert span barrel entrance and exit respectively. These walls also help to prevent debris from sloughing off the containing embankment into the culvert opening as well as prevent the movement of the culvert due to hydraulic pressures [5]. Examples of headwalls can be seen in Figures 2.2 a, b, and c.

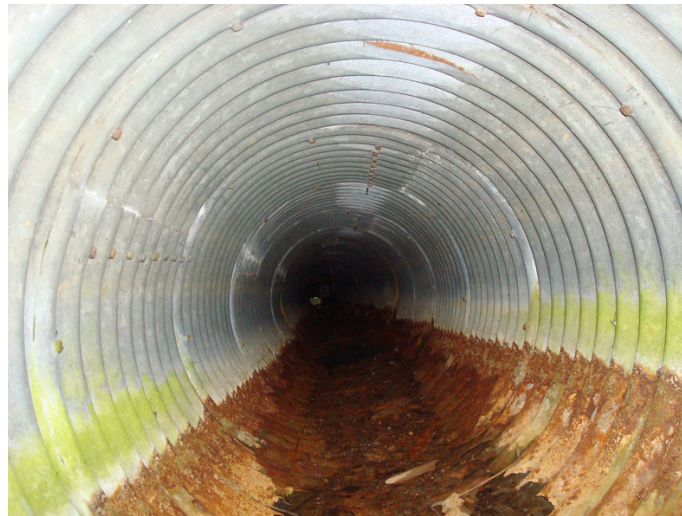
Figure 2.3: Rusty corrugated culvert [9]

Figure 2.3 shows an example of a culvert with rust damage. Rust not only compromises the integrity of the barrel, but also pollutes the water travelling through it.

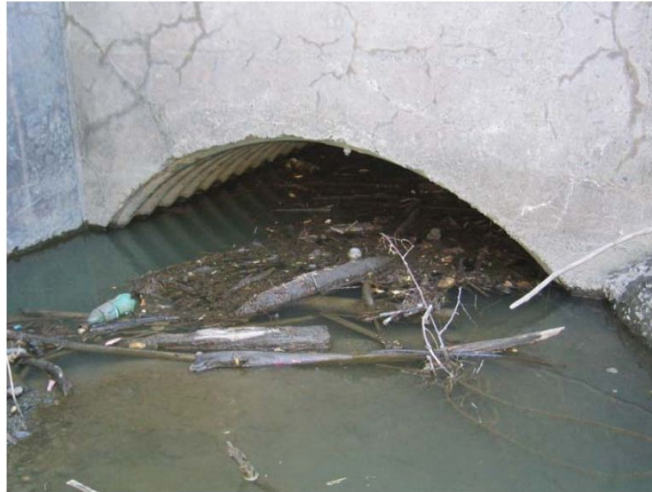
Figure 2.4: Blocked culvert [3]

Culverts can also fill with debris thus limiting their ability to transport water. This can lead to flooding on the roadway or in the inlet areas. A blocked culvert can be seen in Figure 2.4.

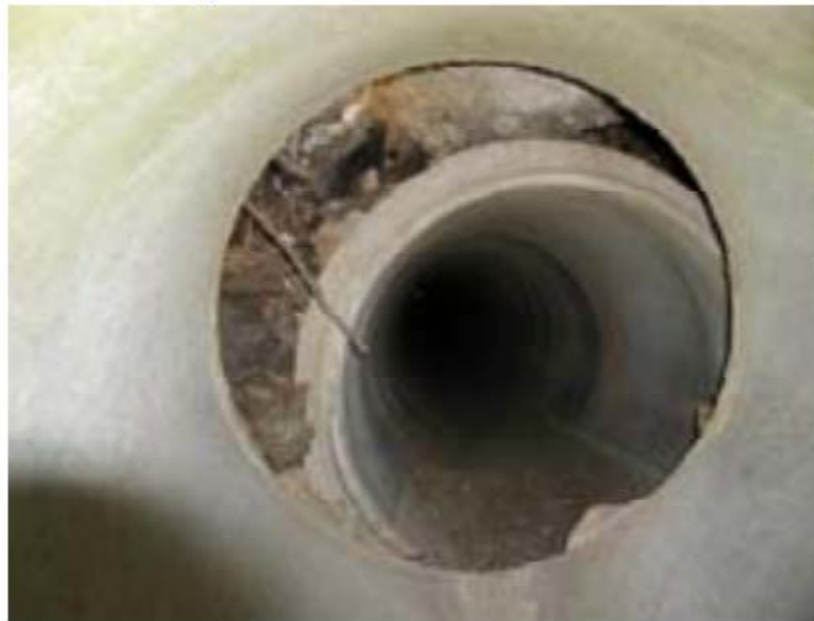
Figure 2.5: Joint failure in a round concrete culvert [10]

If not maintained or repaired on a regular basis, culvert sections can experience joint failures as show in Figure 2.5. A joint failure as bad as this can cause severe water leakage into the surrounding soil.

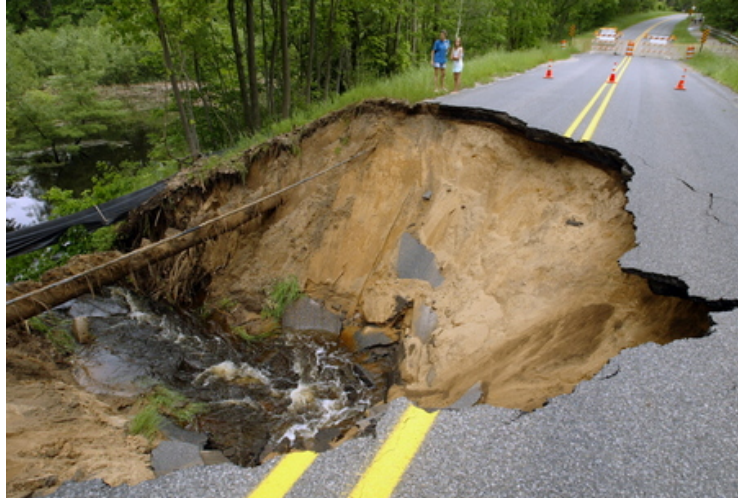
Figure 2.6: Highway washout due to culvert failure [11]

If a culvert is not properly maintained and the soil supporting the highway becomes too saturated with moisture, this could lead to the sudden washout of a highway or other safety hazard as shown in Figure 2.6.

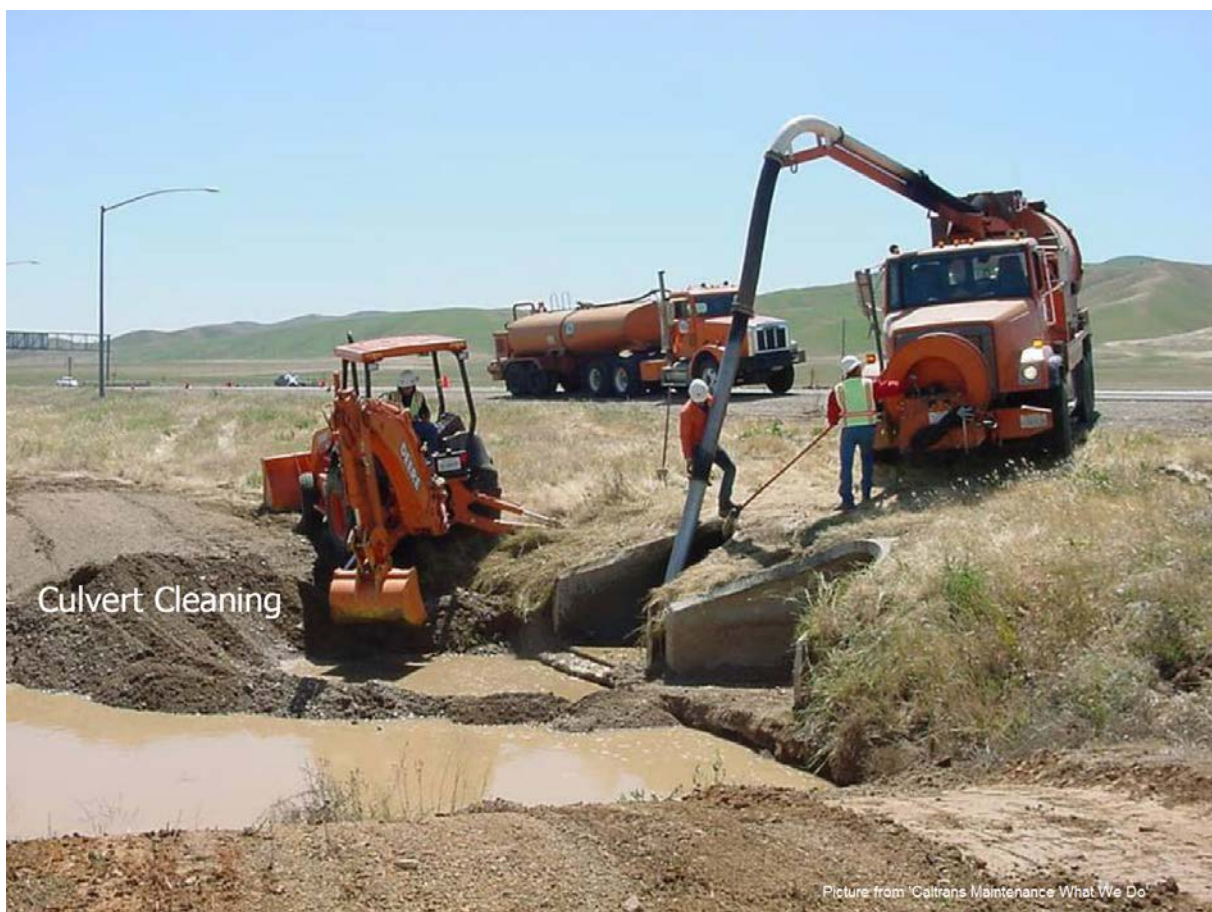
Figure 2.7: Vacuum truck culvert clearing operation (From Caltrans Maintenance What We Do)

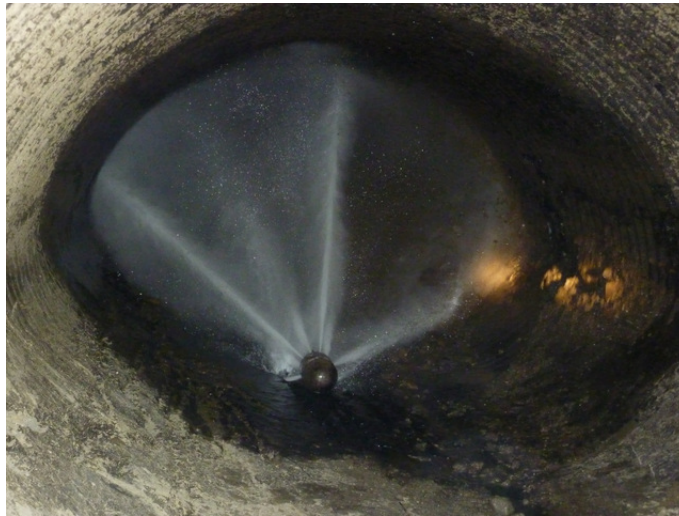
Figure 2.8: Sewer jet flushing debris in a culvert

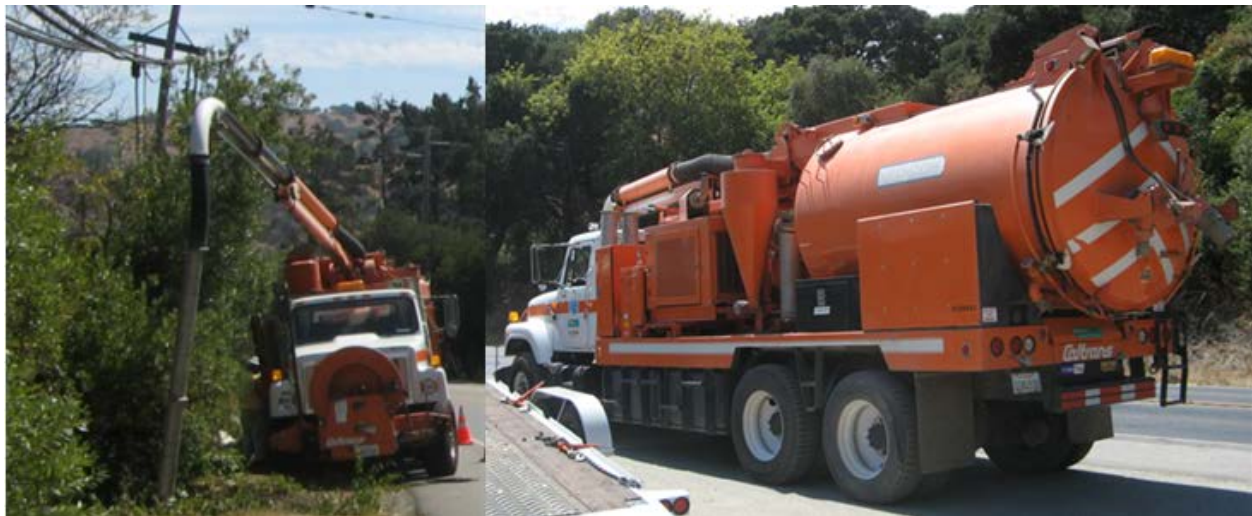
Figure 2.9: Tank system on vacuum truck with jetter system

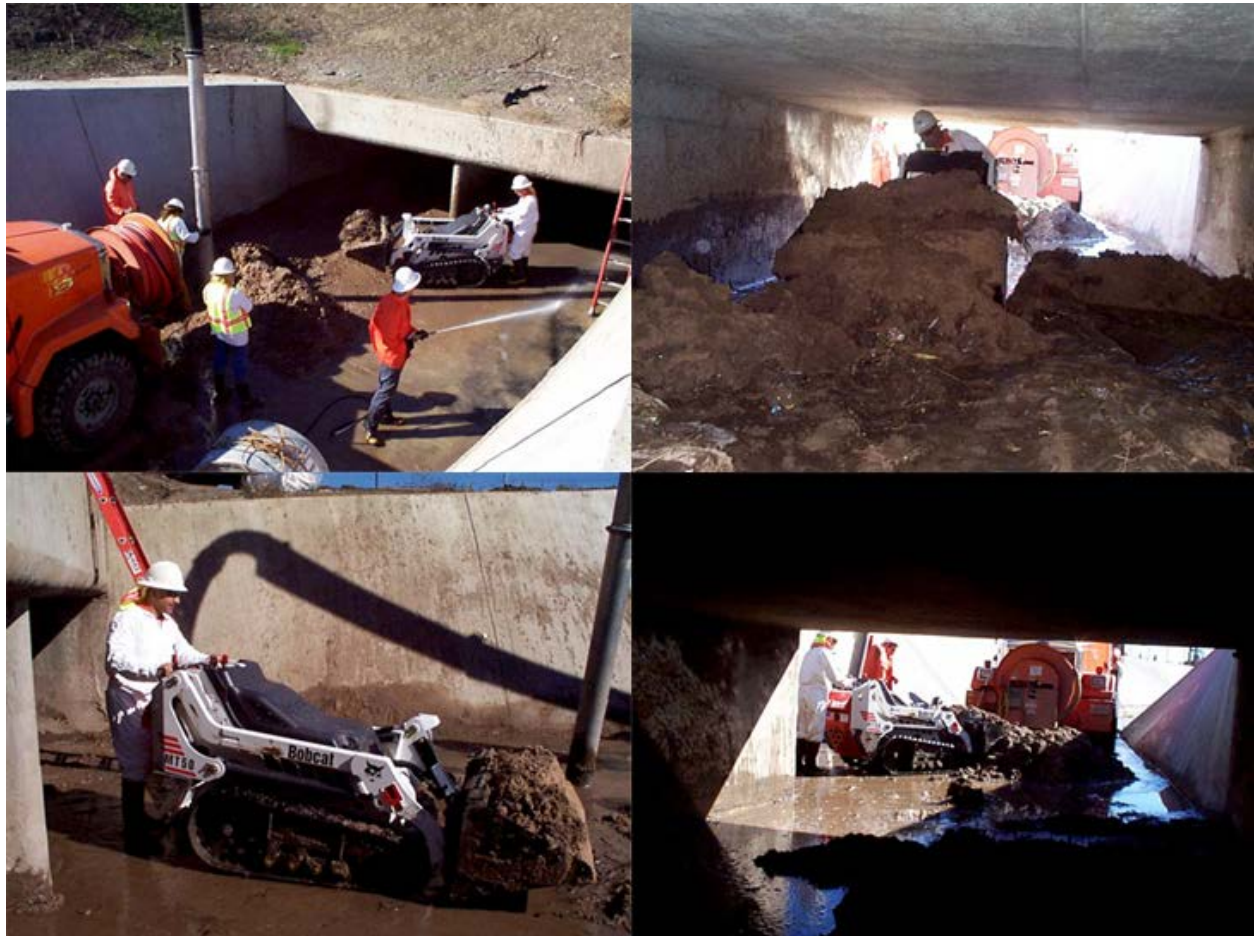
Figure 2.10: Using a walk-behind loader to clean the culvert

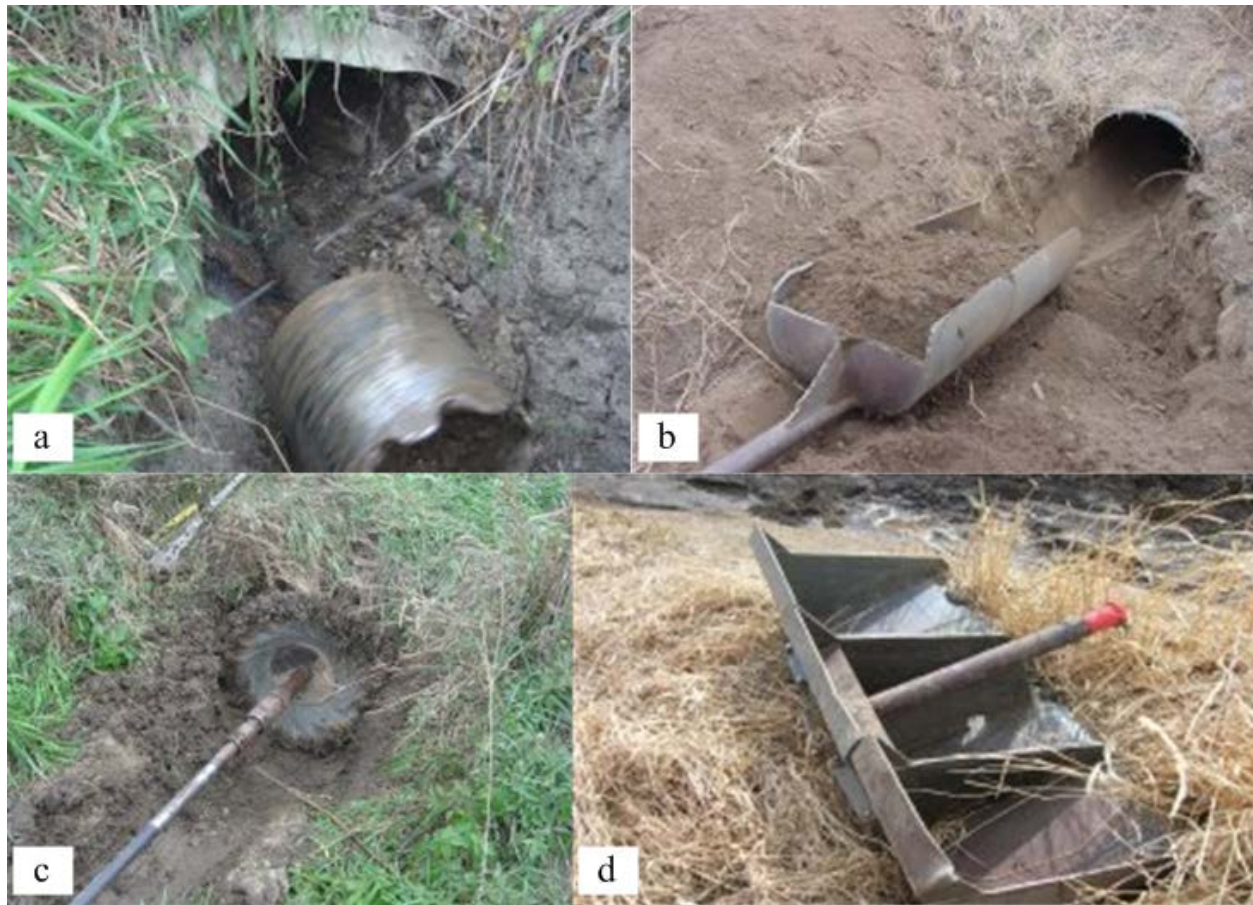
Figure 2.12: Drill attachments (a) Barrel reamer (b) Push bucket (c) Brush (d) Box tool [14]

Another solution for cleaning culverts is to use a horizontal directional drill. Hurk Underground Technologies produces a horizontal directional drill for the purpose of cleaning culverts. It has multiple attachments that allow it to clean culverts with a variety of shapes and sizes. A few attachments are shown in Figure 2.12 (a-d). This system appears to be developed by the company for use in its culvert servicing work and is not generally available.

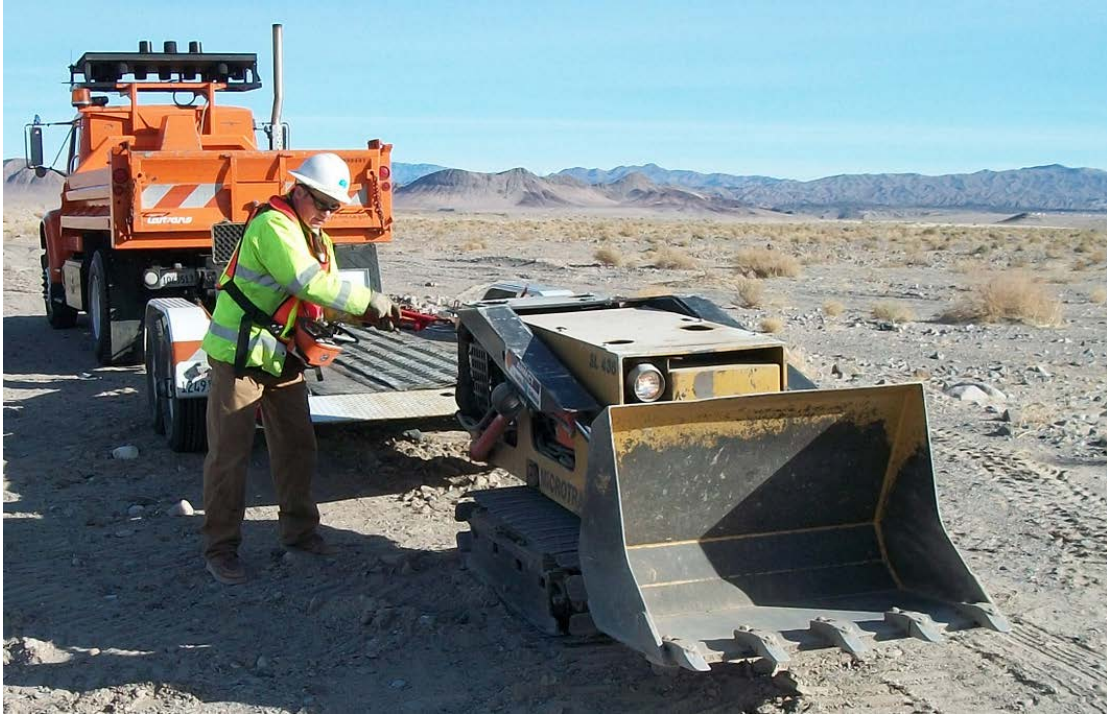
Figure 2.13: Deploying the tunnel mucker

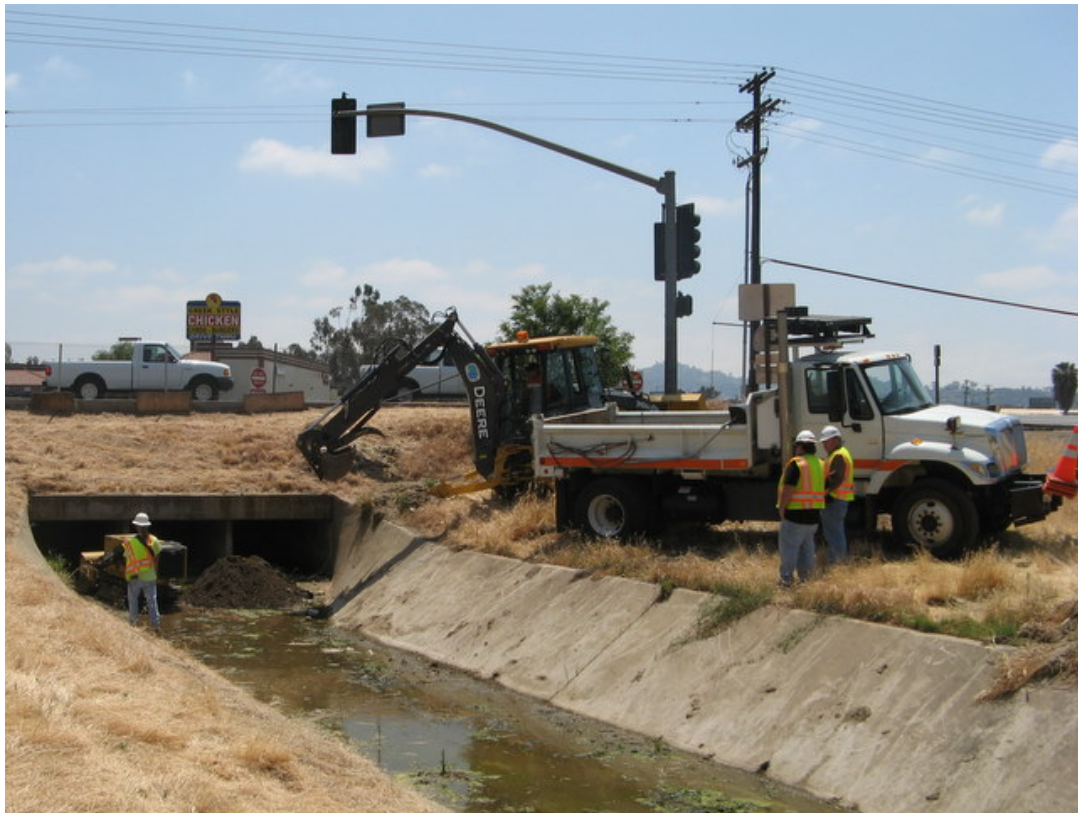
Figure 2.14: Microtraxx tunnel mucker and support equipment

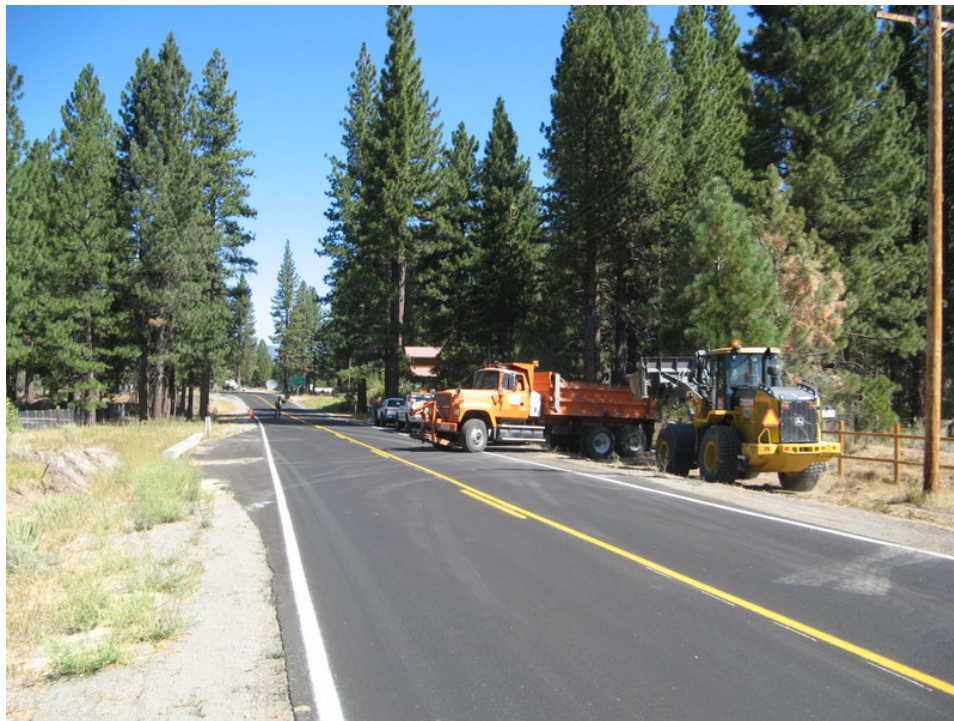
The site was located on California Hwy 89 at Fletcher Creek, a few miles north of Sierraville. The crew operating the mucker was trained the previous day in Sacramento and had then transported it to the Sierraville yard. Figure 3.1 shows the staging area the day of the mucker operation.

Figure 3.1: Staging of the culvert cleaning operation at Sierraville CA

On days prior to use of the mucker, crews had cleared the waterway both upstream and downstream. The area was heavily overgrown and a large amount of material was moved. Usually the mucker will easily work concurrently with any other stream bed work since it only requires access to the culvert and a small flat staging area at the entrance of the culvert to start work. This staging area serves as a transfer point where the debris removed from the culvert is then collected by a full sized loader or back hoe for transfer to a dump truck or other point of collection. The transfer loader will easily operate at other tasks while periodically returning to collect the debris removed by the mucker. On the day of this test, the mucker was supported by a loader and dump truck. Technically a bridge, this culvert system consisted of three 8 ft by 5 ft box sections approximately 45 ft long.

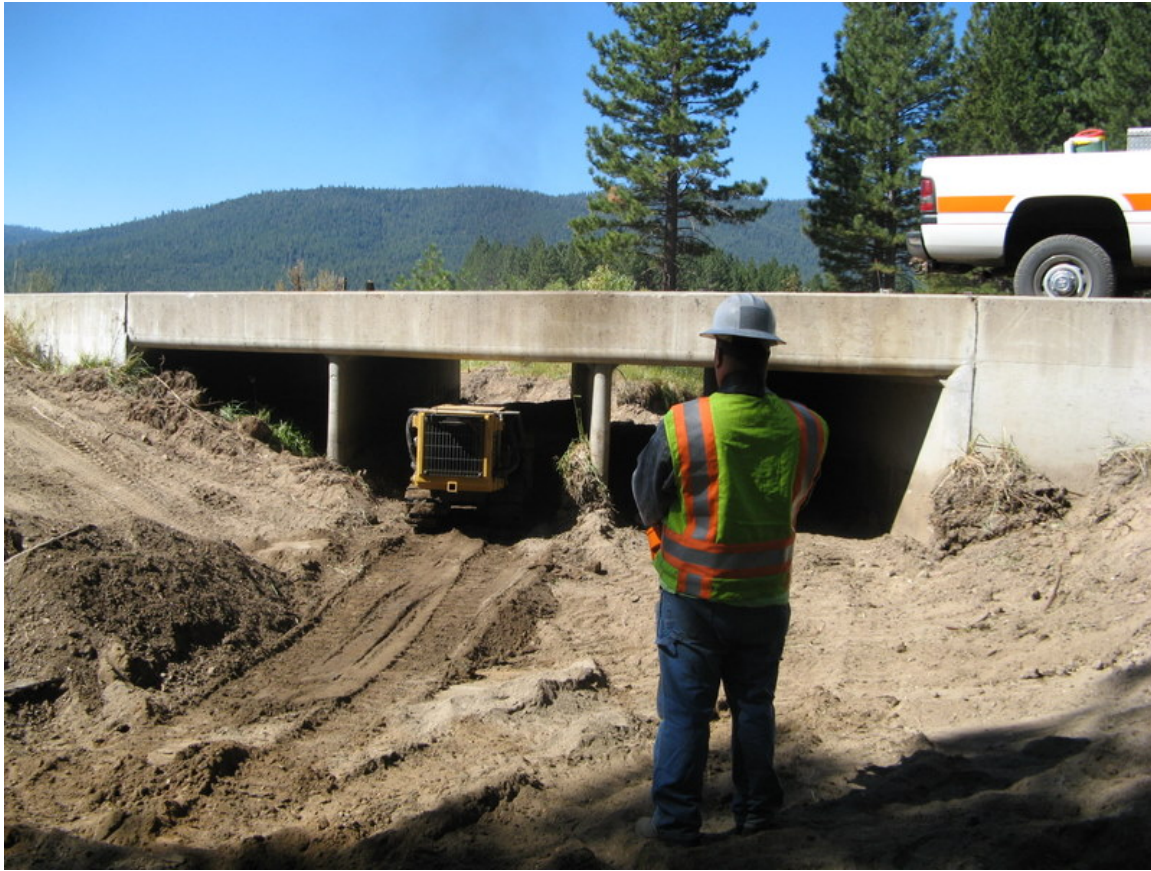
Figure 3.2: Mucker enters to collect a bucket full

In Figure 3.2 the operator is shown controlling it from a location where he is not breathing the exhaust fumes and is removed from the work area. Because the culvert was relatively short, the operator had good visibility while standing back.

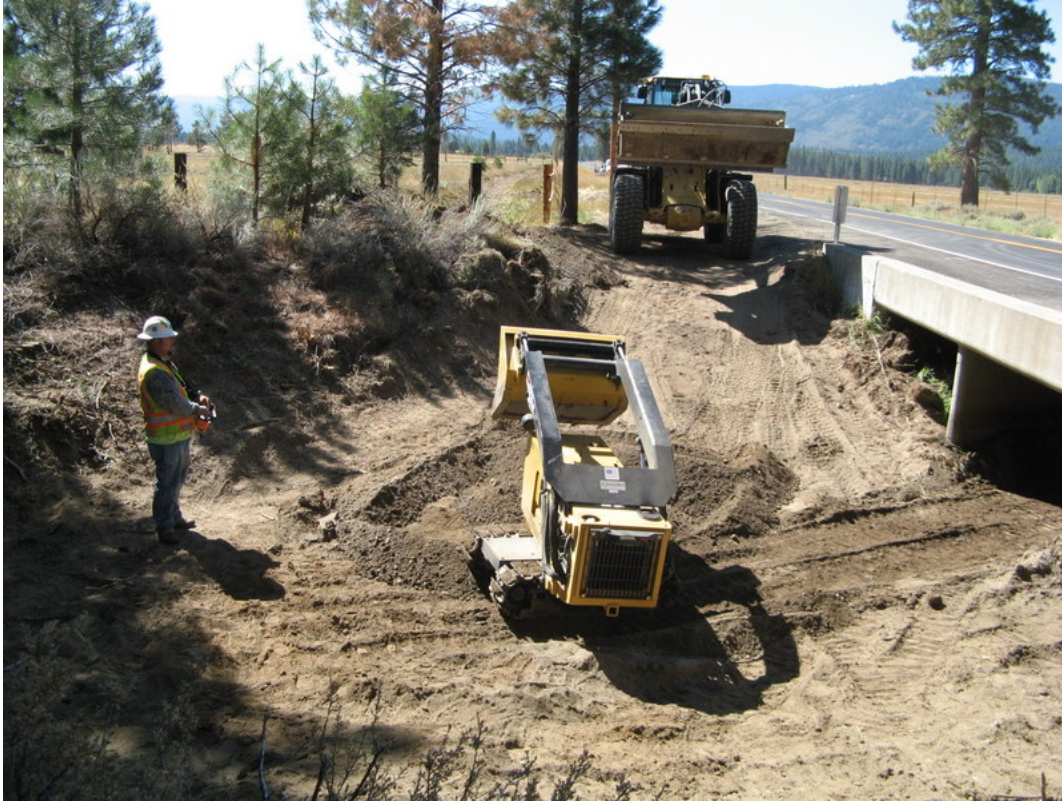
Figure 3.3: Slews to dumps material at the base of ramp

The ability of the bucket to slew (rotate) about the tracked base is an important feature. The lateral action of steering the track assembly causes the machine to churn the ground and dig itself into a depression that then has to be smoothed over periodically. This slows the operation and causes additional stream bed erosion.

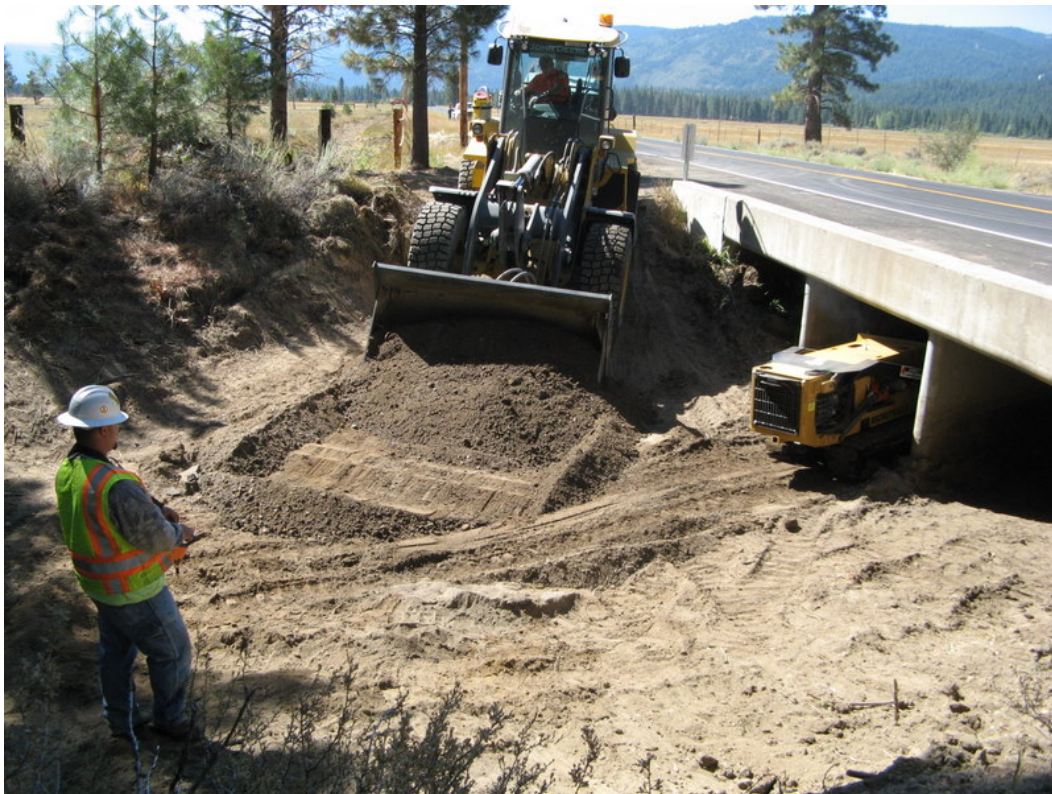
Figure 3.4: Loader moves debris from mucker staging area to dump truck

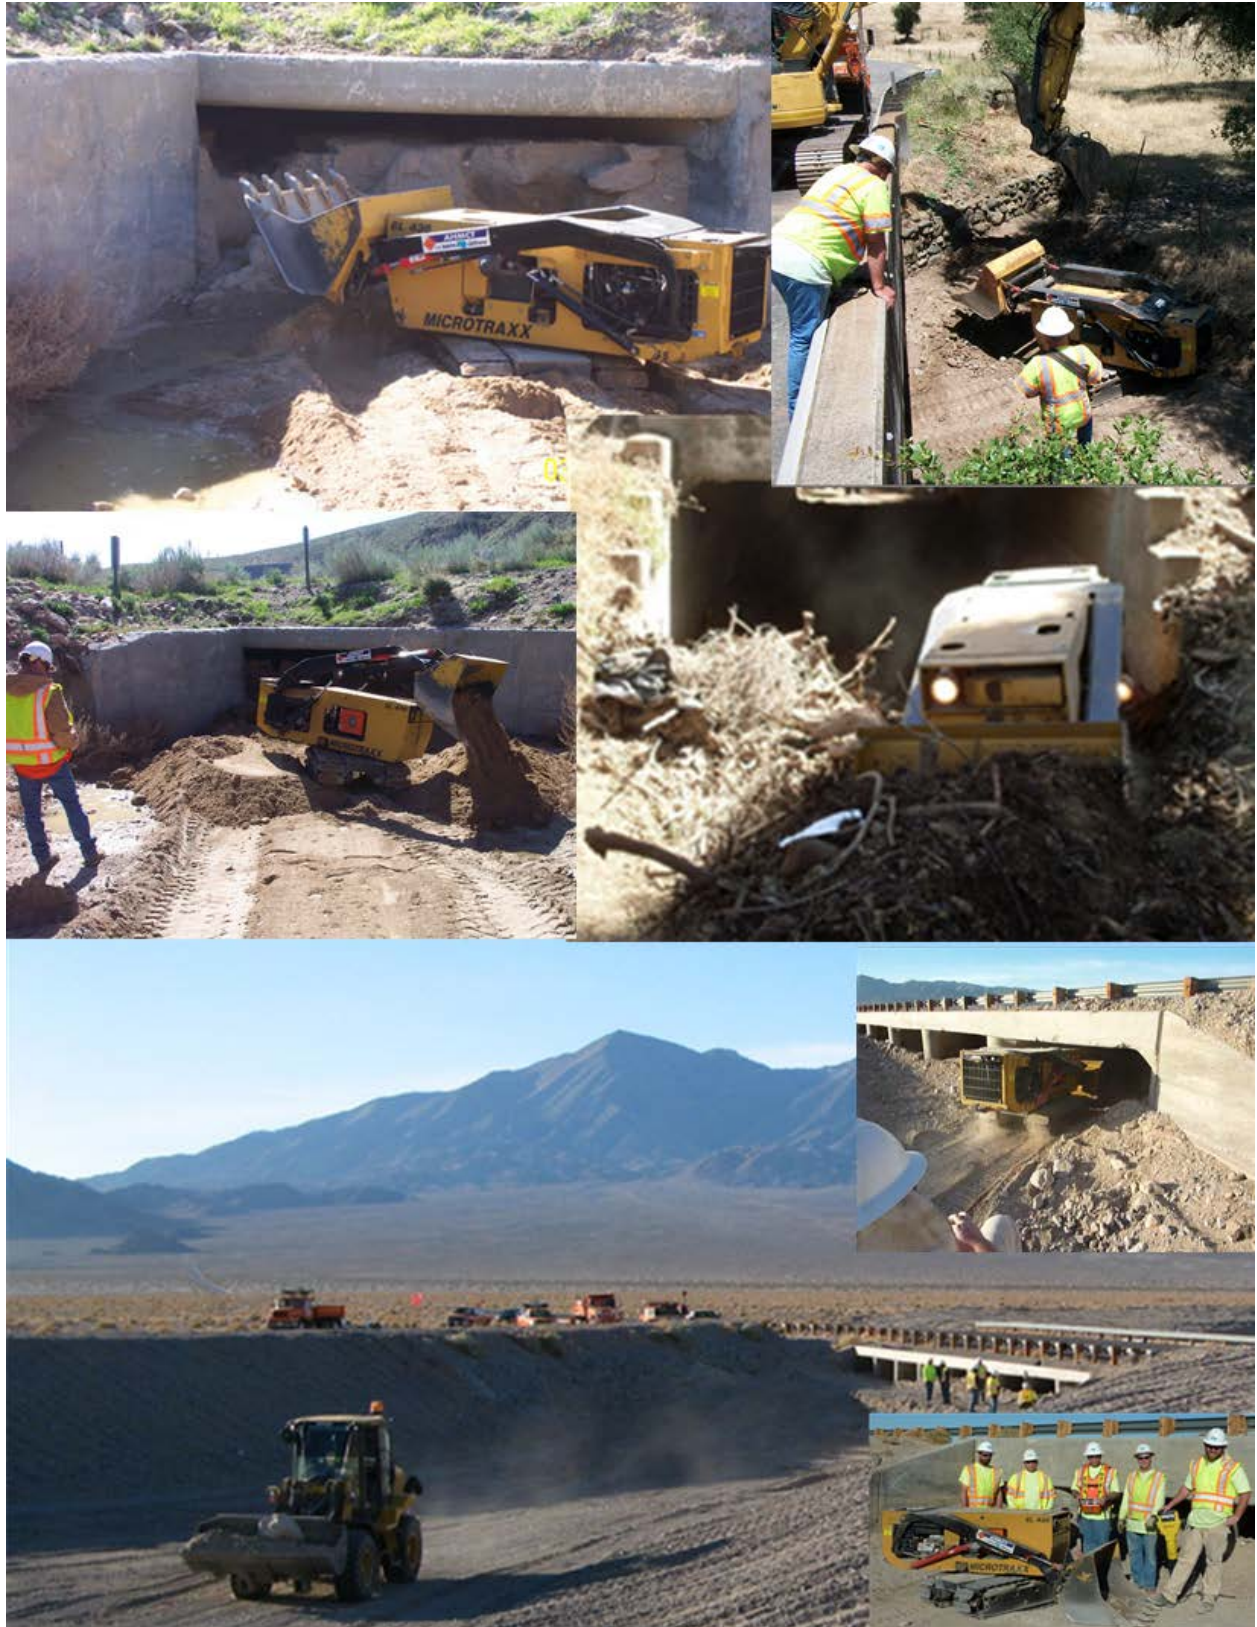
Figure 3.5: Assorted pictures of operations using mucker (Set A)

A wide variety of issues affect production rates and some are presented here. Figures 3.5 and 3.6 are collages of images that show the wide variety culvert cleaning scenarios. Production rates were tracked for the project and the results are provided in Chapter 4 along with a discussion of the issues affecting operations.

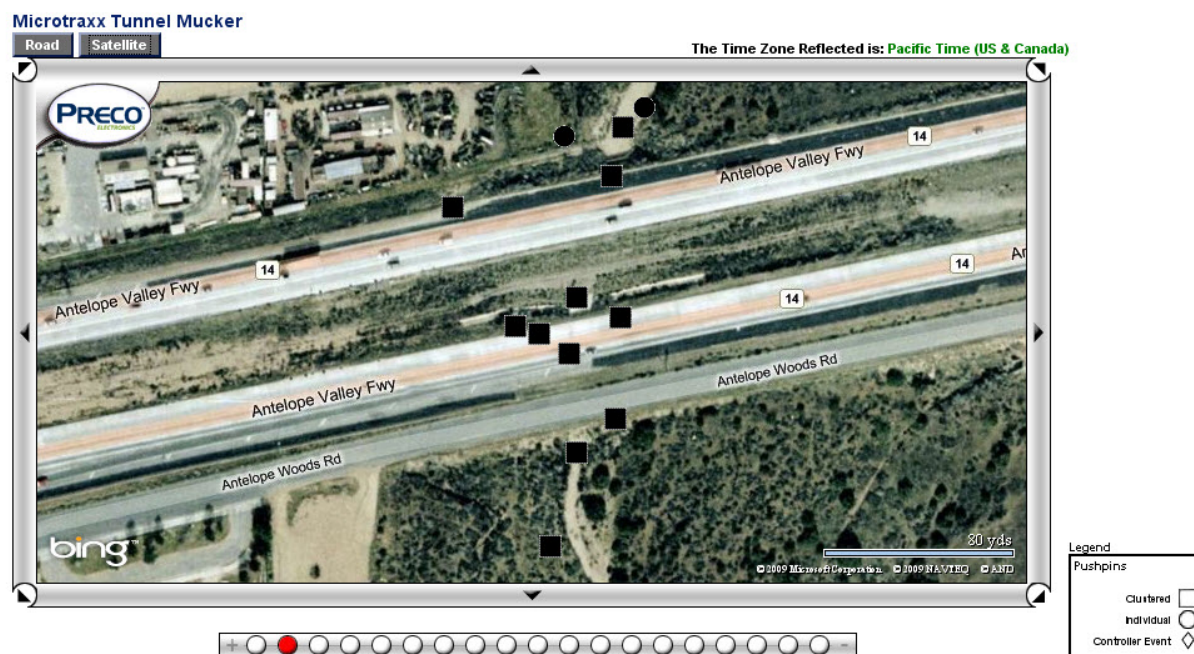
Figure 4.1: Example of output from data logger system

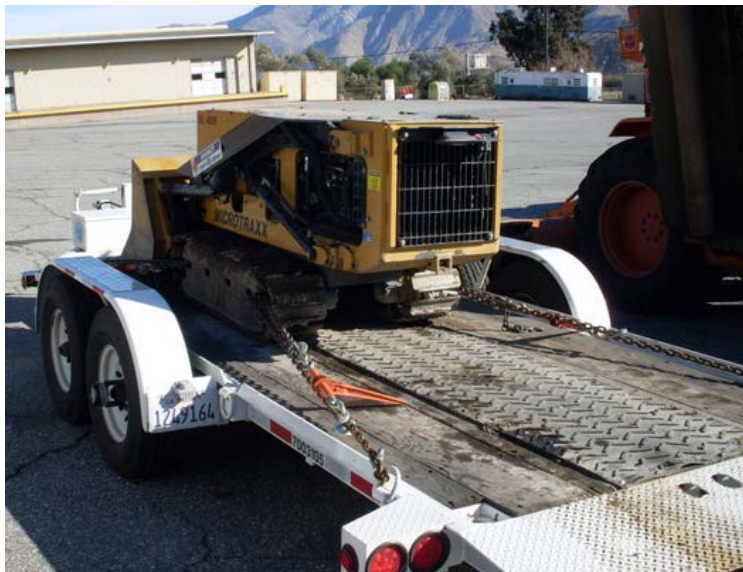
Figure 5.1: Mucker on dedicated trailer

The mucker was operated throughout the state and moved every 4-6 weeks between maintenance yards. Caltrans dedicated a 6 ton tilt trailer (Figure 5.1) to the project which made the logistics of deploying the mucker much simpler. Various items were carried with the mucker in a tool box permanently attached to the trailer. Additionally a carrying case was purchased for the radio unit and its charger.

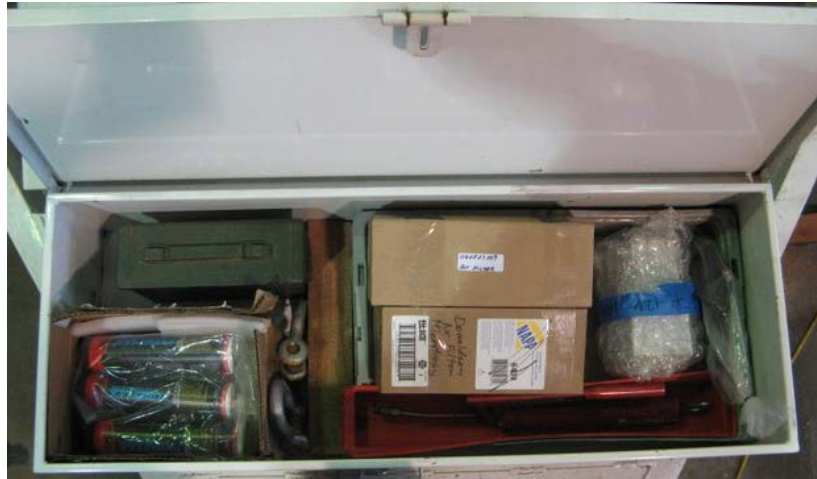
Figure 5.2: Tool box attached to the mucker trailer

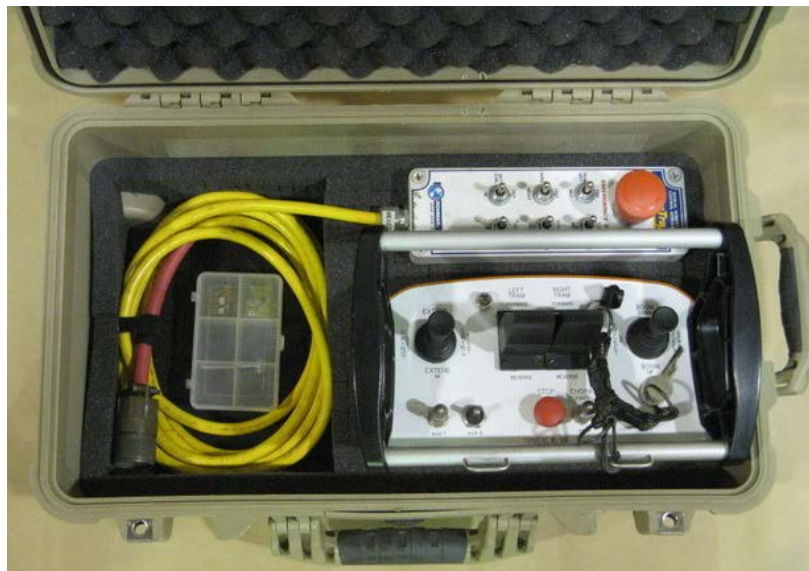
Figure 5.3: Hardened case used to carry radio components

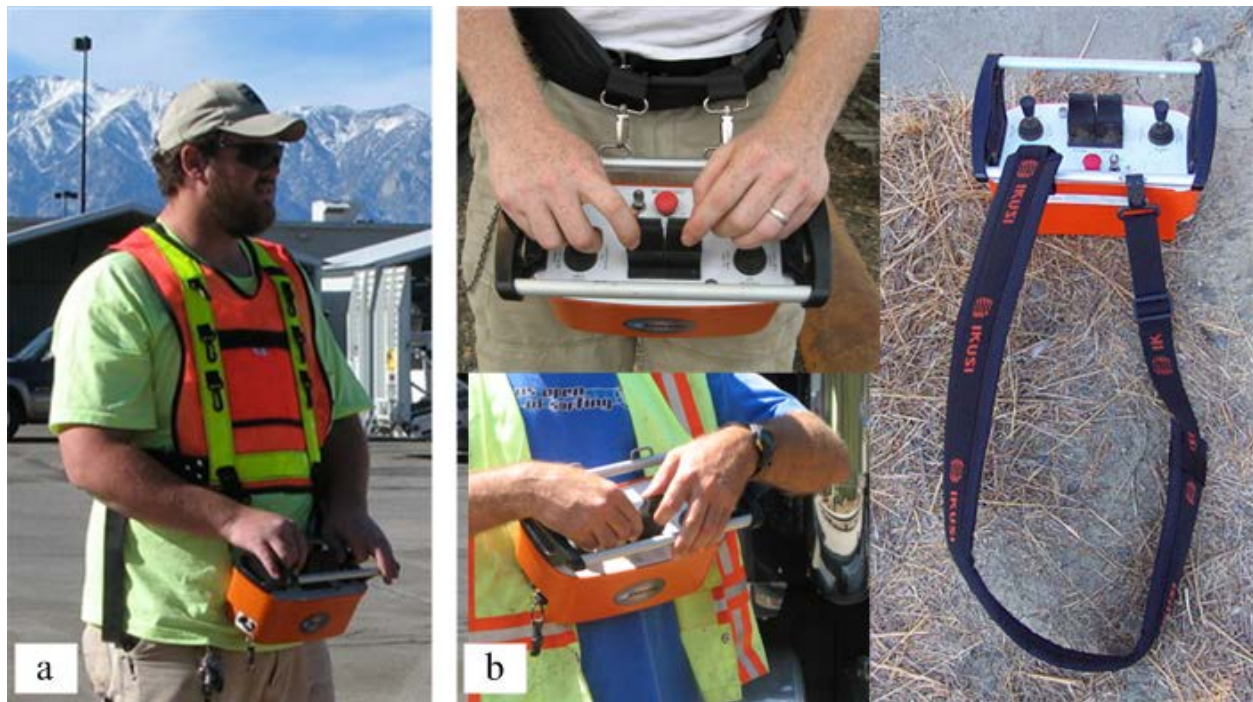
Figure 5.4: Controller carrying options: Vest (a) is much preferred over alternatives (b)

A neck strap was purchased and used in the field but this proved to be unsuccessful. Although the controller weighed only a few pounds, supporting it with the neck strap was not comfortable after using it for an extended time. The operator's hands would rest on the controller adding weight to the neck. Additionally when bent over to peer into the culvert, the weight was transferred to the operator's lower back muscles. The controller was also likely to swing away from the body especially when bent over. Caltrans suggested the use of a vest which distributes the weight of controller on the shoulders and keeps the controller close to the waist. Using the vest shown in Figure 5.4 resolved all the issues.

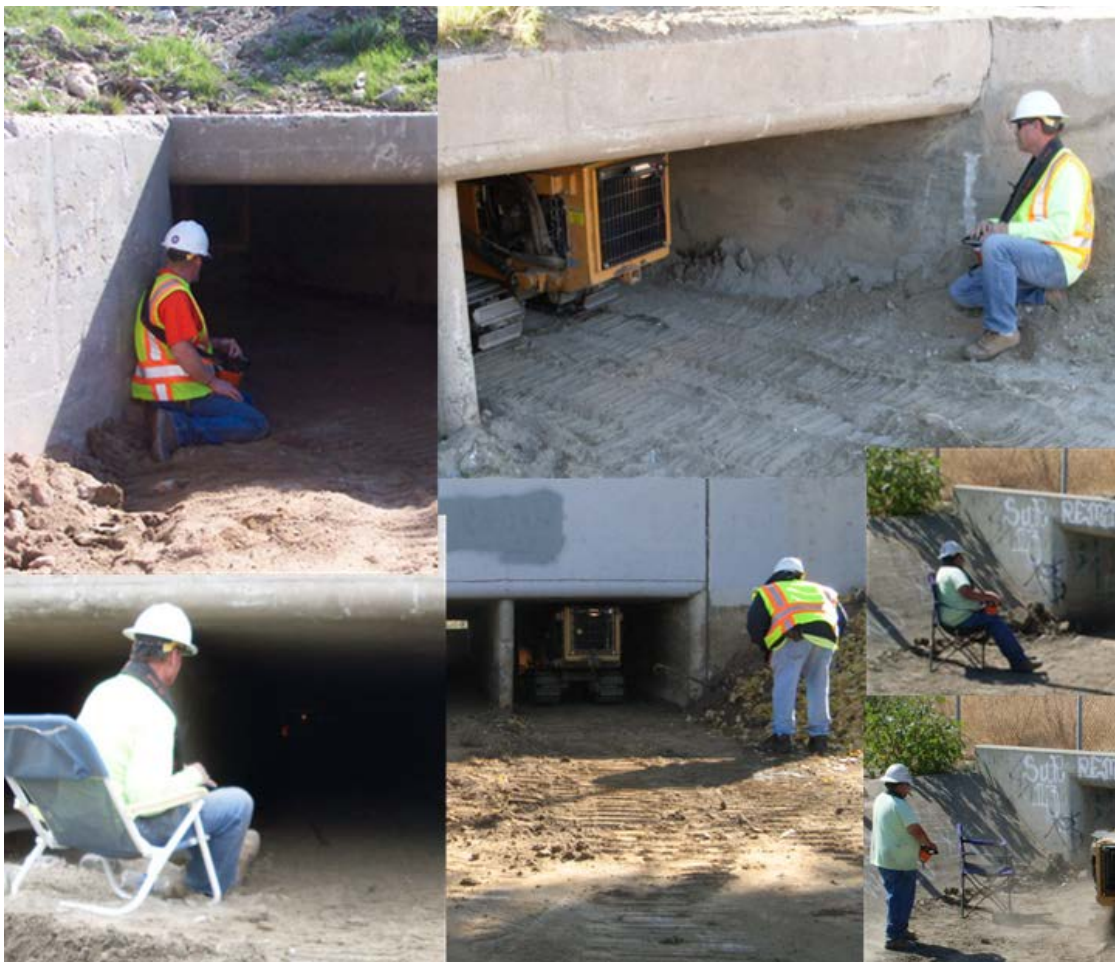
Generally when operating the mucker, it was most convenient to stand. Often when working in the 4 ft tall culverts or the long ones, it was more comfortable to kneel or be seated. Figure 5.5 shows examples of operators in various body configurations as they are looking into the culvert.

Figure 5.5: Operators in various body configurations

Operators were required to stay back from the mucker at least 10 ft when running the machine. The operators would usually stand up and back away from the entrance as the mucker was backing out to dump a load of debris. The use of a chair made it easier for some operators but others were hesitant to use one. When working on long low culverts, a large amount of the operator's time will be spent in the lowered position. There was no specific recommendation resulting from the field deployment but it is recommended that the operator be encouraged to find a comfortable configuration that will not strain muscles and joints.

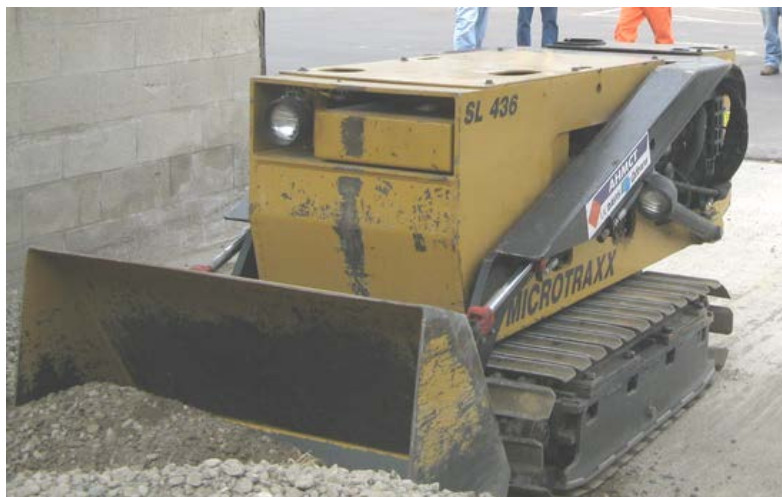
Figure 5.6: Original 3 forward facing lamps (right side hidden)

The original lighting consisted of 12V incandescent lamps. The three forward facing lamps (one on the front and one on each side) were 35W Par 36 tractor lamps (Figure 5.6) and the rear lamp was a lower wattage backup type lamp. Crews struggled with the low lighting condition when working within the long culverts. This was particularly problematic on sunny days in the desert landscapes where the contrast between inside and outside the culvert was extreme.
