1. REPORT NUMBER CA12-1954	2. GOVERNMENT ASSOCIATION NUMBER	3. RECIPIENT'S CATALOG NUMBER
4. TITLE AND SUBTITLE Evaluation of New Technology in Culvert Cleaning		5. REPORT DATE June 30, 2012

6. PERFORMING ORGANIZATION CODE AHMCT Research Center, UC Davis
7. AUTHOR Allyson E. Clark, Ben C. Creed, Wilderich A. White, & Steven A. Velinsky		8. PERFORMING ORGANIZATION REPORT NO. UCD-ARR-12-06-30-09

Advanced Highway Maintenance and Construction Technology Research Center

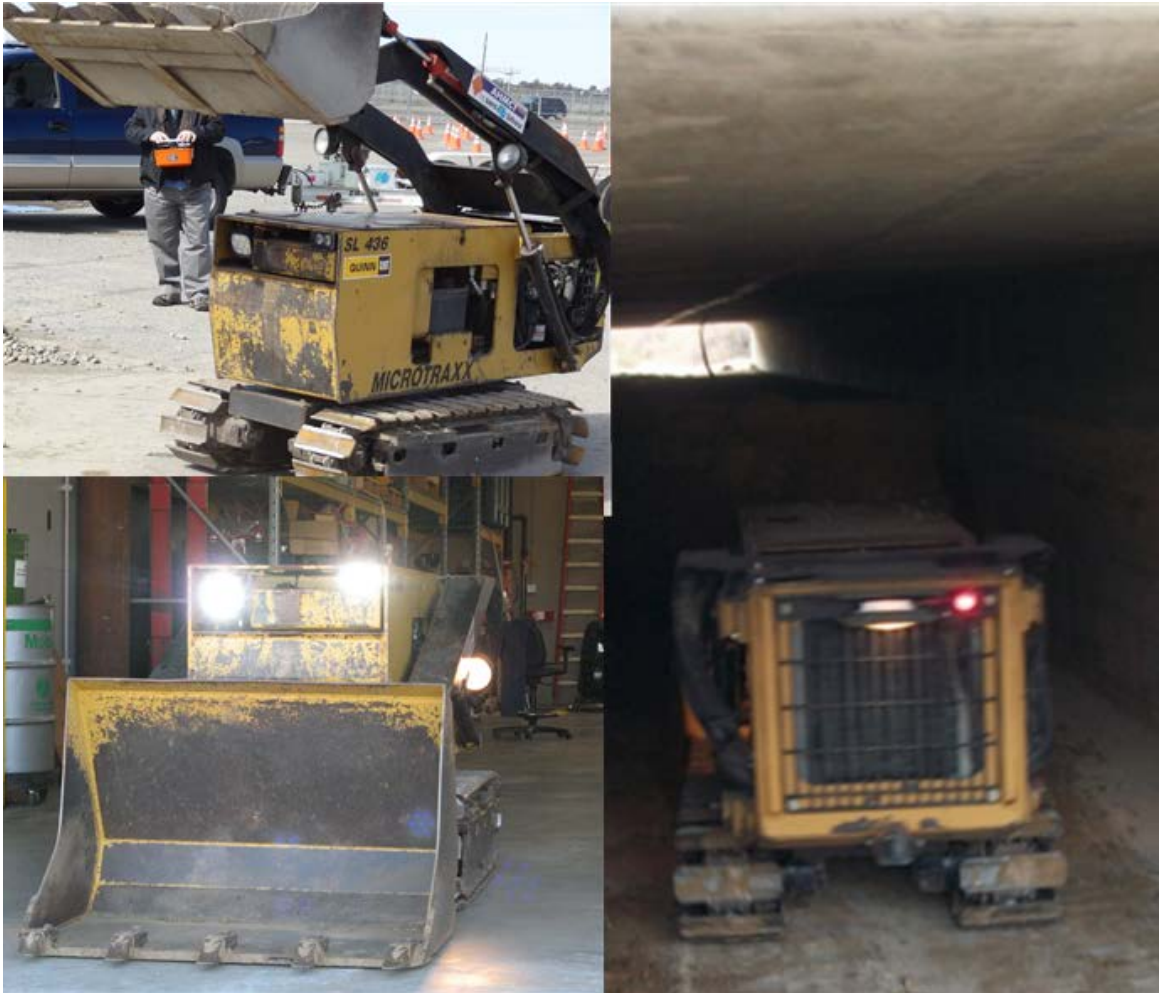
Figure 5.7: Lighting modifications: 2 LED lamps in front and red LED radio link indicator in rear

The single forward front lamp was replaced with two LED lamps that were selected based on the space available (Figure 5.7). A relay was added to avoid overloading the light switch. Each LED lamp was rated at 20W and 1,800 lumens. The need for strong lighting was requested repeatedly and it is recommended that the lights on the sides and rear also be replaced with high quality LEDs.

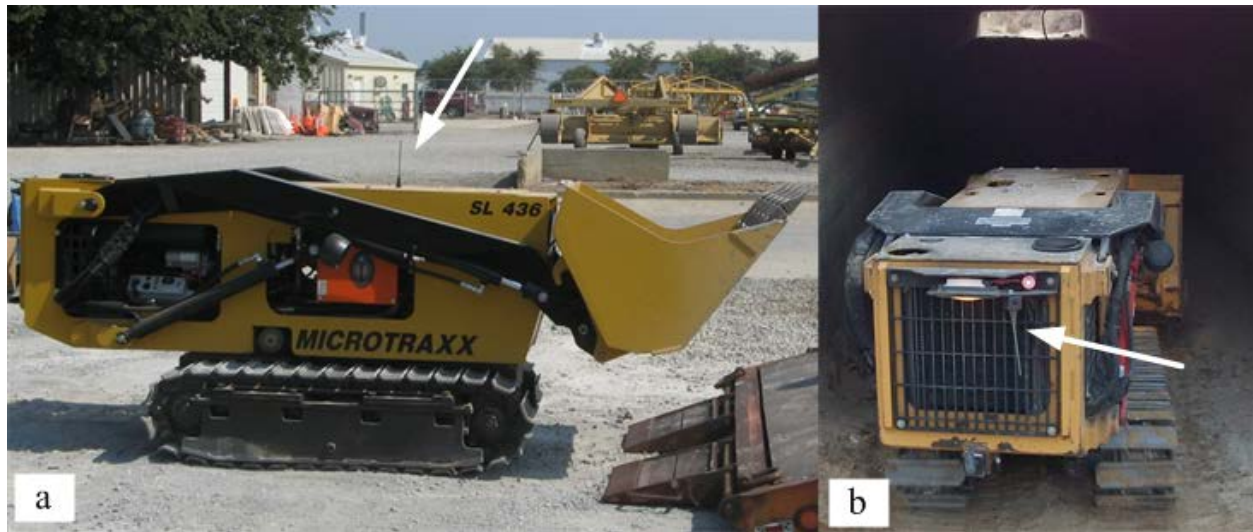
Figure 5.8: Relocation of radio control antenna from top (a) to rear (b)

As originally delivered, the main antenna was mounted to the top deck of the mucker. Although ideal for transmitting the signal, it had to be relocated to the rear as seen in Figure 5.8. Although more protected, the antenna was still broken off periodically. Additional investigation of the antenna configuration is discussed in Chapter 6.

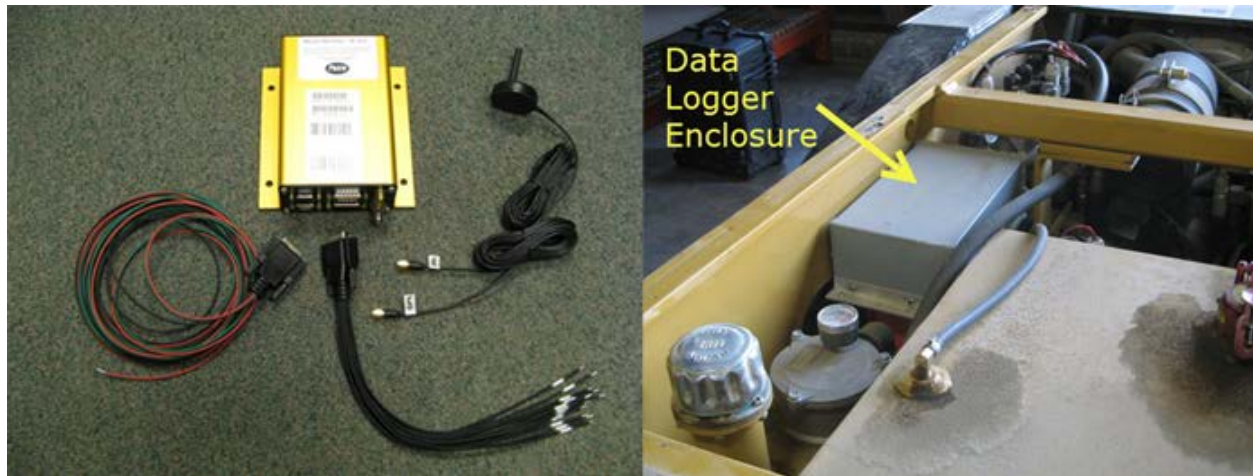
Figure 5.9: Data logger placed in custom enclosure in mucker

To support the research evaluation, a data logger (PreCise InfoX GSM/GPRS unit) was installed to track the location of the machine when it was running. In addition to the power circuit, an engine running signal was taken from the hour meter circuit to indicate the engine run time. It was installed in a customized sealed enclosure that was mounted in the body of the mucker as seen in Figure 5.9.

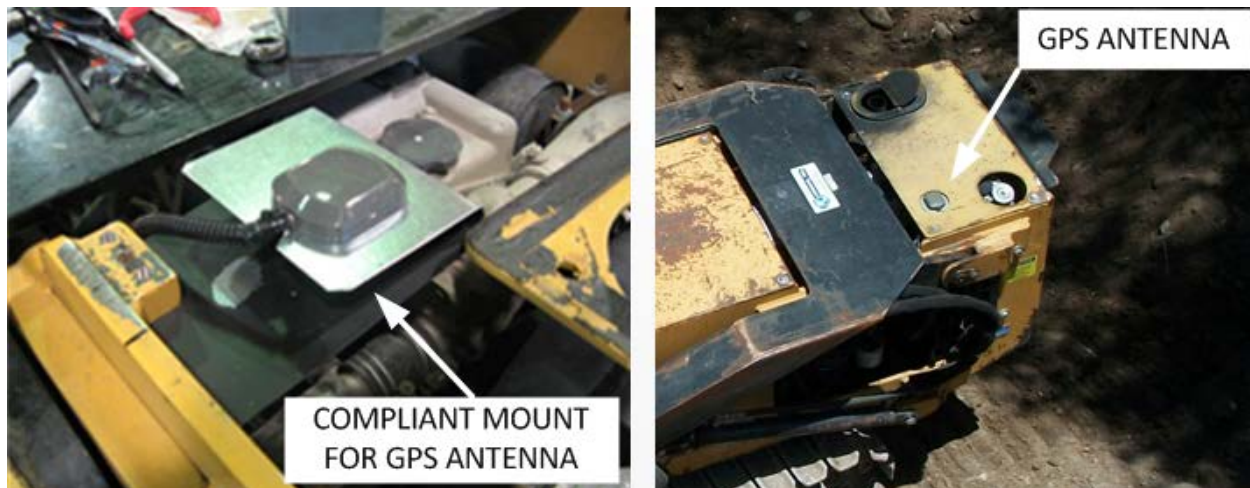
Figure 5.10: Locating the GPS Antenna

The antenna for the data logger GSM system was placed just within the open side of the engine compartment (not shown) and the GPS antenna was located on the top deck as shown in Figure 5.10. Placed on the top to maximize the signal reception, it was installed onto a flexible mount to minimize the chance that it would be damaged.

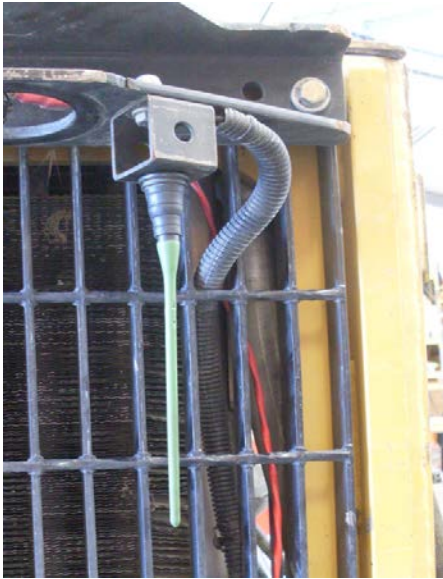
Figure 6.1: Antenna Configuration 1: Vertical, Center Offset, Close

Antenna Configuration	Maximum Range
Configuration 1: Vertical, Center Offset, Close (Figure 6.1)	2365 ft
Configuration 2: Vertical, Center Offset, Close, Ground Plane (Figure 6.2)	3022 ft
Configuration 3: Vertical, Centered, Far, Ground Plane (Figure 6.3)	3103 ft
Configuration 4: Horizontal, Centered, Far, Ground Plane (Figure 6.4)	3304 ft

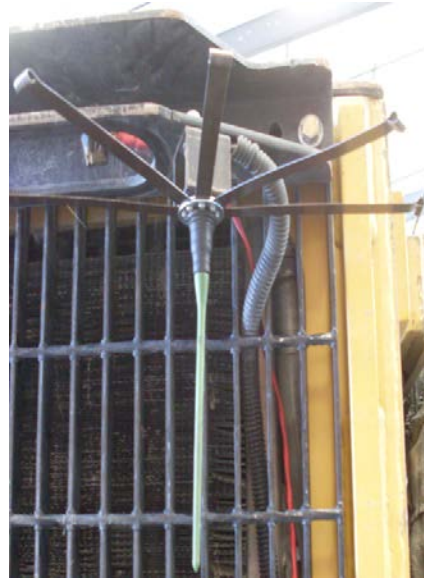
Figure 6.2: Antenna Configuration 2 : Vertical, Center Offset, Close, Ground Plane

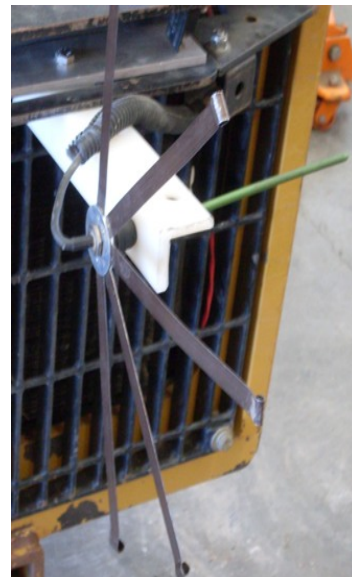
Figure 6.4: Antenna Configuration 4: Horizontal, Centered, Far, Ground Plane

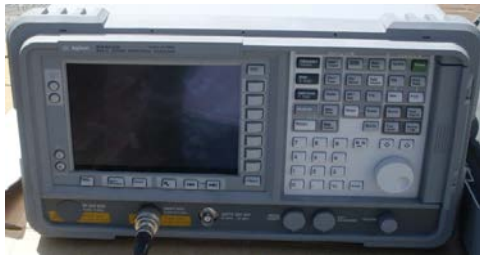
Figure 6.5: Spectrum analyzer

For this test, a spectrum analyzer (Figure 6.5) was connected to the receiving antenna. The transmitter was placed 100 ft from the vehicle and its signal strength was measured with the spectrum analyzer. This arrangement is shown in Figure 6.6. For each antenna configuration that was tested, the analyzer output was exported to a spreadsheet for later analysis.

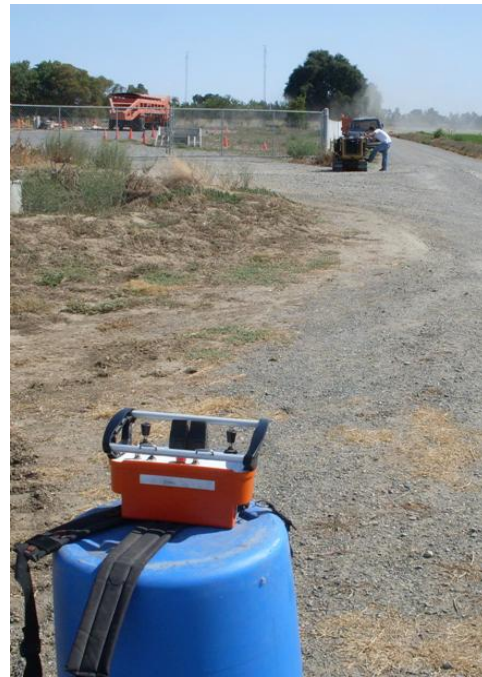
Figure 6.6: Open Air Testing transmitter configuration

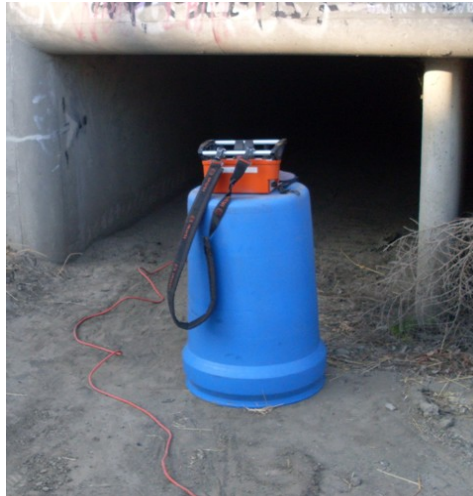
Figure 6.7: Culvert Testing transmitter configuration

This test is similar to Test 2, except the vehicle was located 100 ft inside of the culvert and the transmitter was placed at the culvert entrance (Figure 6.7), approximately where an operator would stand.

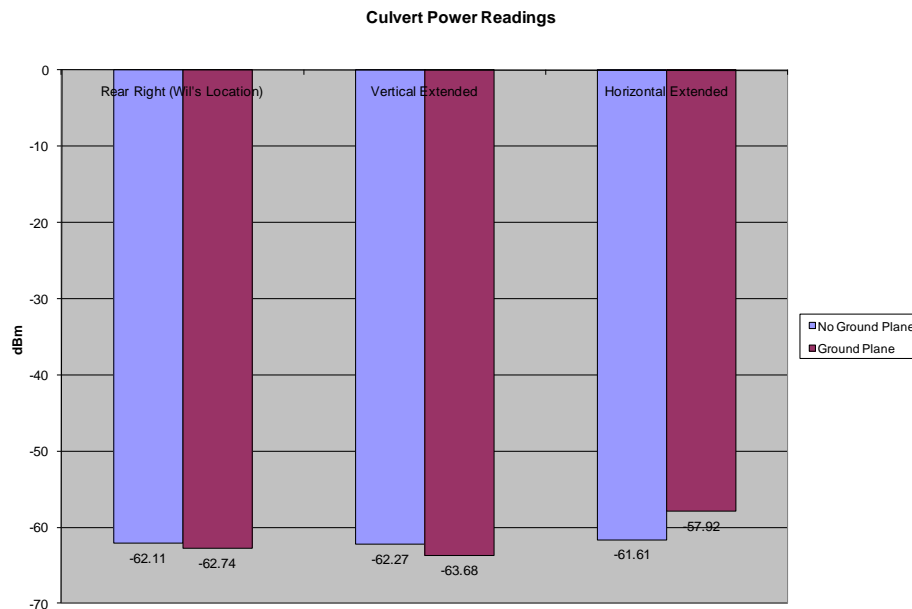
Figure 6.12: Quantitative Culvert Test results

Antenna Configuration	No Ground Plane (dBm)	With Ground Plane (dBm)
Configuration 1: Vertical, Center Offset, Close (Figure 6.1)	-62.11	-62.74
Configuration 3: Vertical, Centered, Far, Ground Plane (Figure 6.3)	-62.27	-63.68
Configuration 4: Horizontal, Centered, Far, Ground Plane (Figure 6.4)	-61.61	-57.92

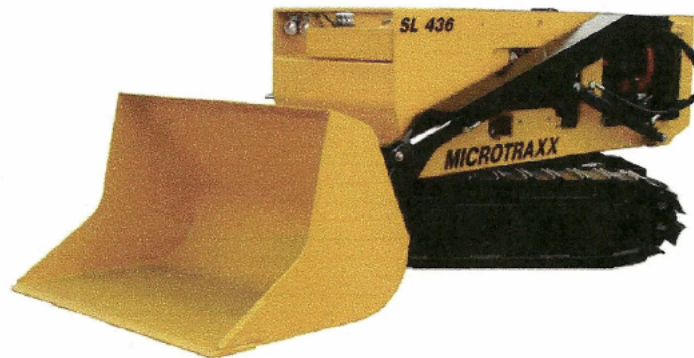
SL 436 Machine Specifications

Basic Dimensions	42"/1067mm (H), 42"/1067mm (W), 120"/3048mm (L)
Basic Unit Weight	5600 lbs / 2540 kg
Lift Capacity	1550 lbs / 703 kg
Controls	7 function Radio Remote Controls.

The Microtraxx SL436 is a radio remote controlled front end loader measuring 42 in high, 42 in wide and 120 in long. It weighs approximately 5600 lbs and has a $\frac{1}{3}$ yd³ loader bucket with a lifting capacity of 1550 lb. It is controlled by a commercially available seven-function wireless remote control with industry standard safety top features. It was provided with an Isuzu diesel engine that met the current tier 4 emissions requirements. The hydraulic system oil and grease are biodegradable. A specification sheet in Appendix A contains additional details.
