Evaluation of the University of Minnesota GPS Snowplow Driver Assistance System

Report Number: CA16-2167

AHMCT Research Report: UCD-ARR-15-08-30-01

August 30, 2015

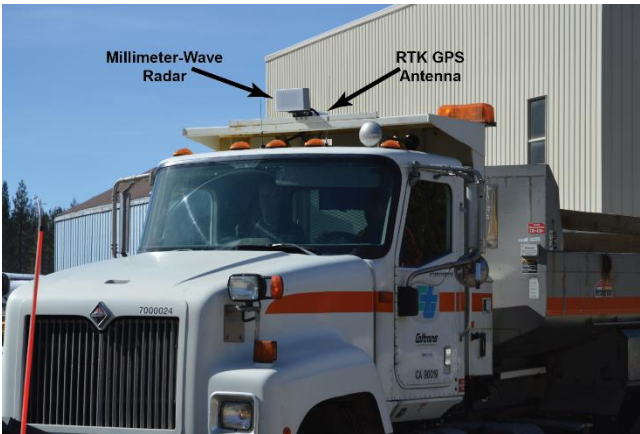
Figure 1.1: University of Minnesota (UM) DAS exterior components

The snowplow DAS functions include lane position indication, lane departure warning, and forward collision warning. The DAS interior and exterior components are shown in Figures 1.1, 1.2, and 1.4. Lane position indication and lane departure warning are displayed on a HUD, as shown in Figures 1.3 (simulated) and 1.5 (actual). The Collision Warning System (CWS) uses a millimeter-wave radar which performs well in the snow environment as it detects vehicles and other inorganic objects. Azimuth angle data allows the system to map detected obstacles to their lateral location, i.e. the system can show the driver what lane the obstacle is located in relative to the snowplow. The system also stores the location of fixed roadside objects in a geospatial database to eliminate false negative collision warnings. Highly accurate vehicle position is provided by the RTK GPS receiver, which can deliver sub-centimeter accuracy under fairly ideal conditions. However, its accuracy is generally recognized to be only centimeter-level under normal operating conditions. Producing a high-accuracy RTK GPS solution requires data from two dual-frequency (L1 and L2) GPS receivers—one stationary base station and one rover—collecting signals from at least five GPS satellites at the same time. The solution can be calculated in real-time by the rover GPS (on the snowplow) when it receives the base station data in real-time through a cellular radio data link.

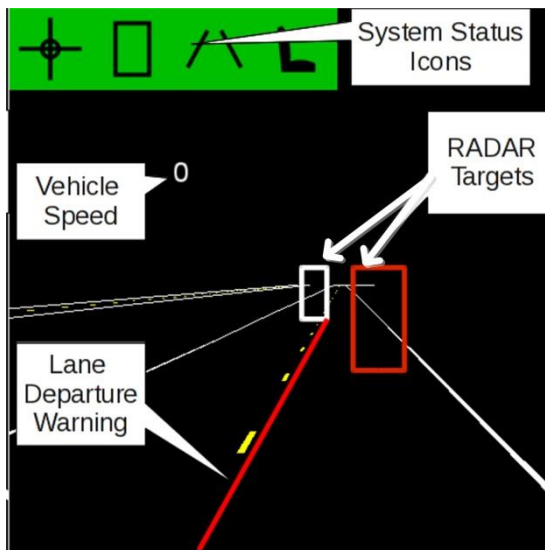
Figure 1.3: UM DAS simulated HUD view

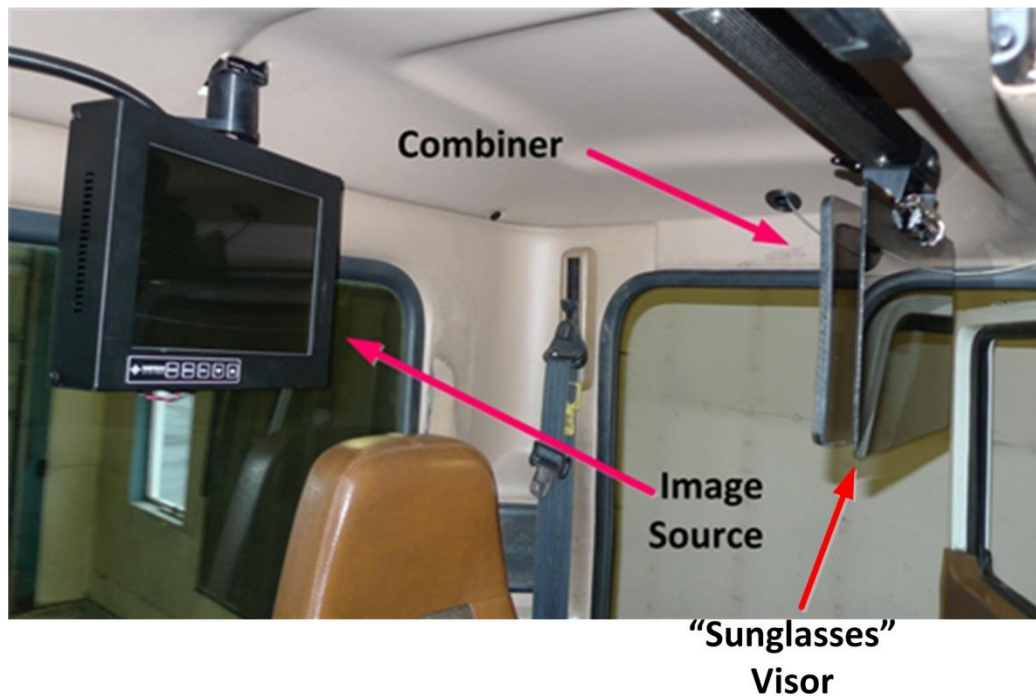
Figure 1.4: UM DAS HUD image source and display combiner

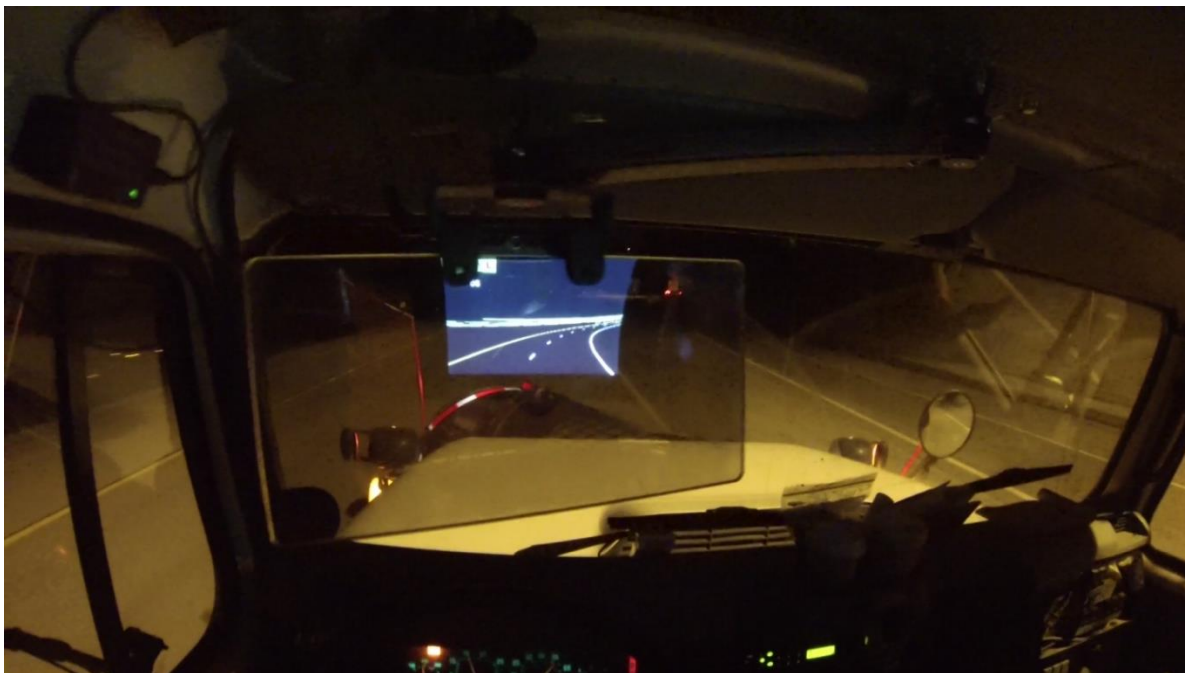
Figure 1.5: DAS viewed from behind driver's seat in a snowplow operating at night. The lane lines and road features are overlaid on the road using the HUD.

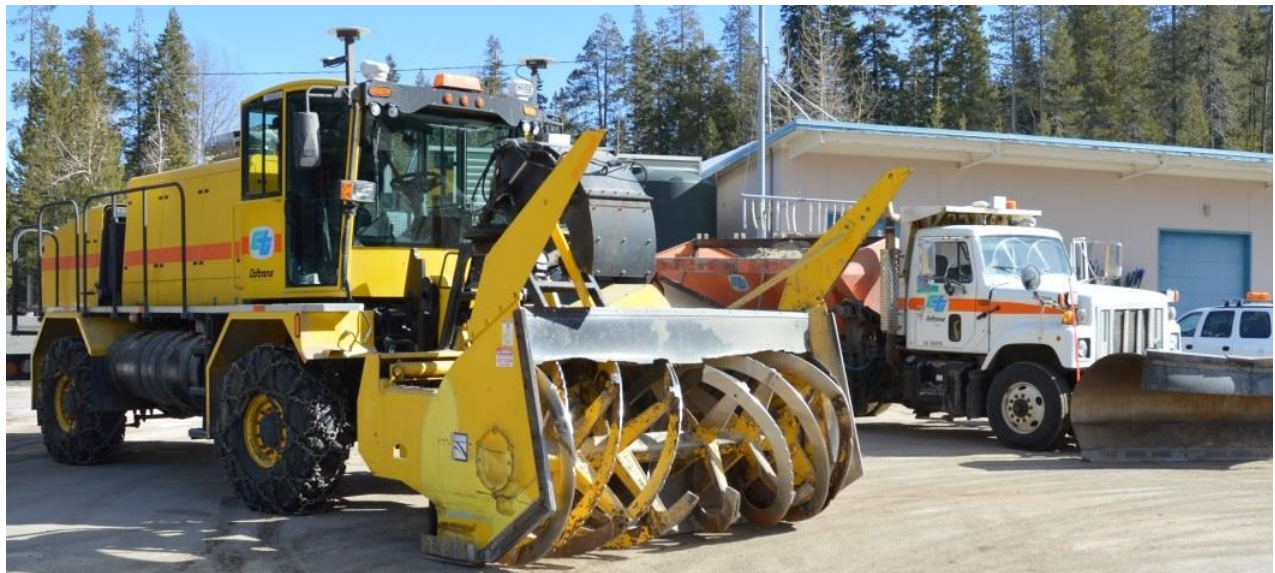
Figure 2.1: Snowplow DAS installed on Caltrans snow blower (left, yellow) and snowplow (right, white)

In 2012, DAS were installed in two snowplows (Caltrans vehicle # 7000506 and 7000024) and one snow blower (Caltrans vehicle # 7005039). Figure 2.1 show the snow blower and one snowplow (7000506) with the DAS installed. All equipment and subsystems were procured by AHMCT so that the system would become AHMCT/Caltrans instrumentation for scientific evaluation and experimentation. When possible, AHMCT tested all components and subsystems to assure they would perform the required operations before installation on the vehicles. The vehicles were provided by Caltrans from their winter maintenance fleet.

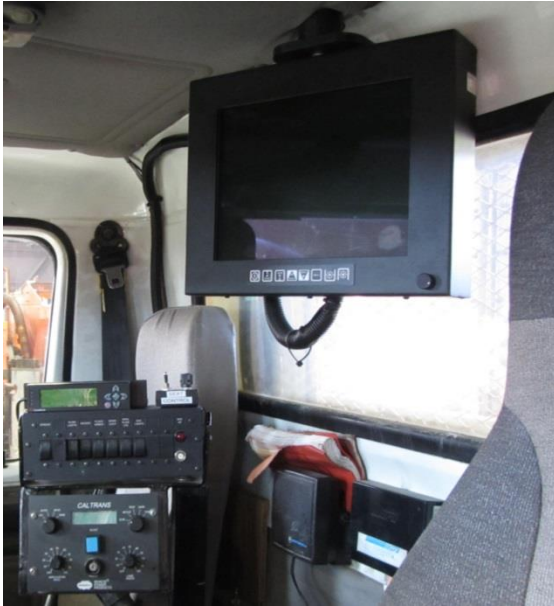
Figure 2.2: DAS user interface and LCD imager display on snowplow

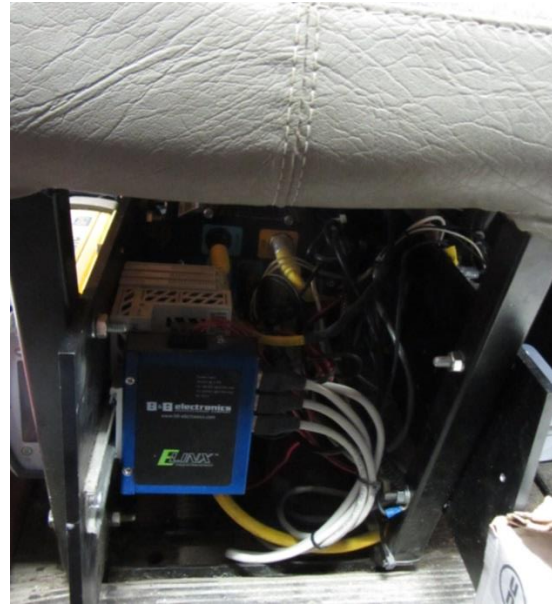
Figure 2.3: DAS installed under the passenger seat on snowplow

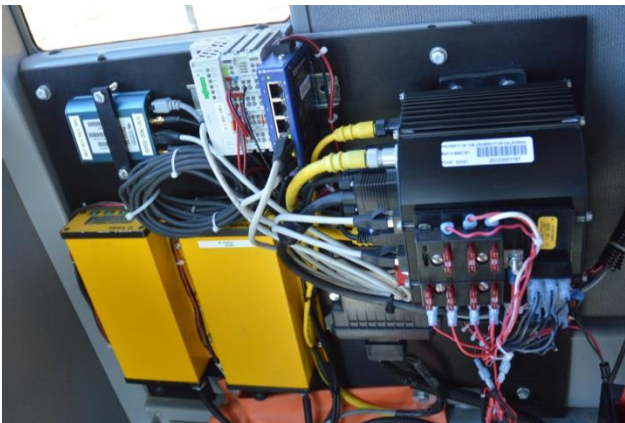
Figure 2.12: DAS equipment mounted next to the operator's seat in the snow blower

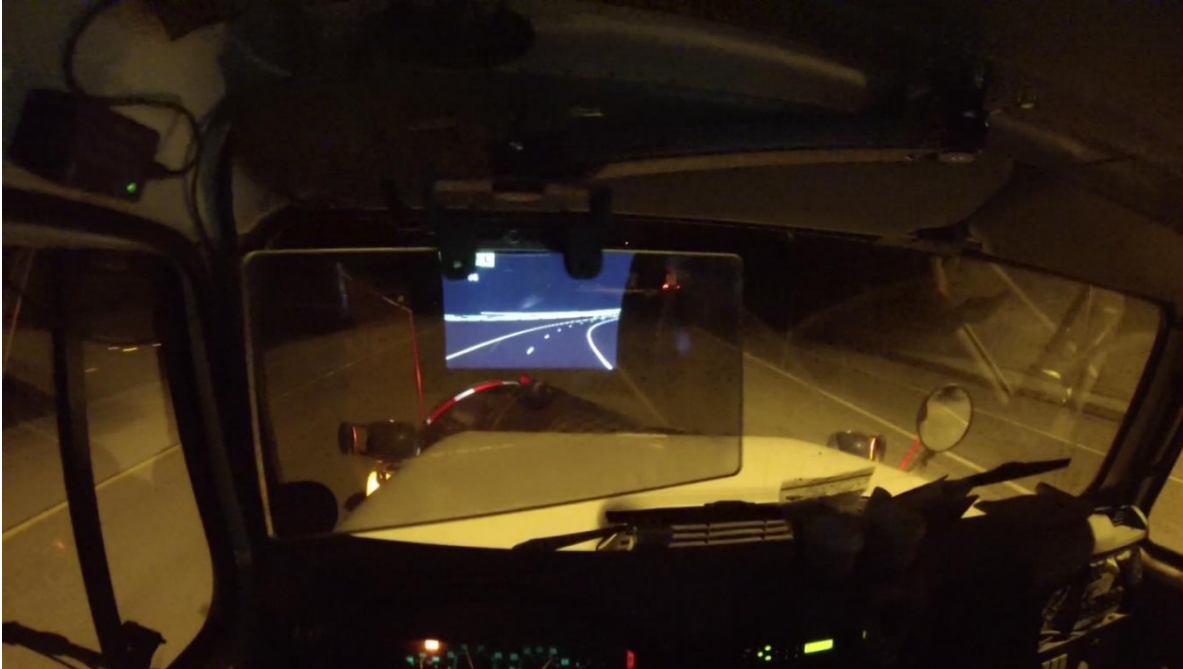
Figure 2.14: DAS viewed from behind driver's seat in a snowplow operating at night. The lane lines and road features are overlaid on the road using the HUD.

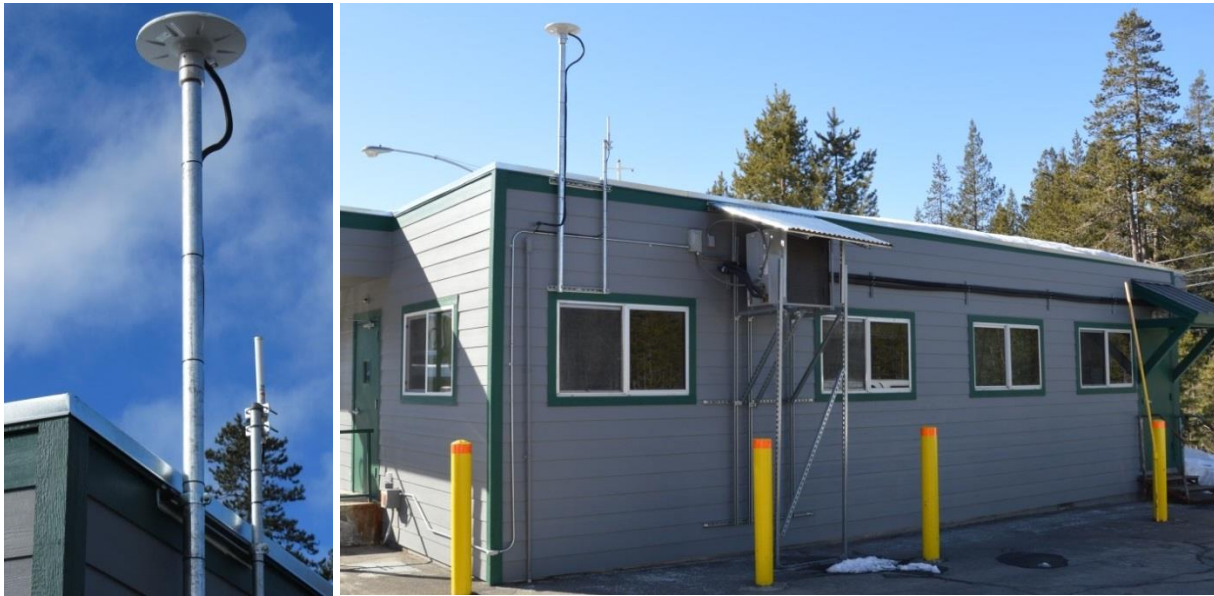
Figure 2.15: GNSS base station antenna and mobile network antenna installation at Kingvale Command Center

A cell modem provides Internet connection to the GNSS base station. AT&T was the initial cellular service provider. However, their mobile Internet service does not allow their AT&T modems to talk directly to each other. Thus, the snowplow or snow blower (i.e. the rover) GNSS receiver could not receive differential GNSS data from the base station. AT&T technical support was unable to resolve this problem. AHMCT then tested Verizon modems and mobile network services. The Verizon setup worked without any special configuration. Thus, Verizon modems and service were used in this research.

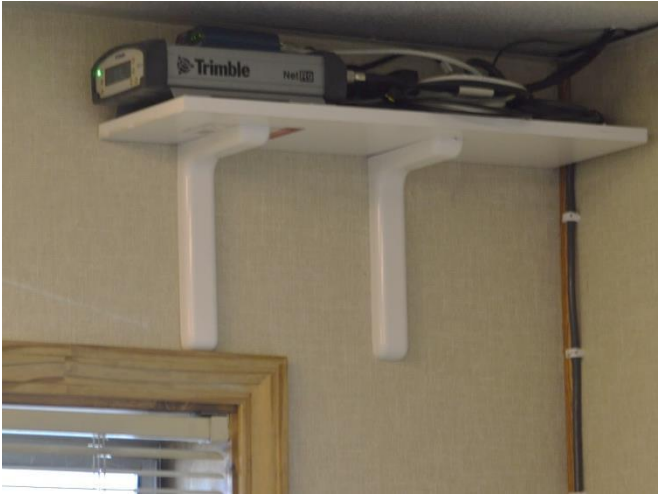
Figure 2.16: GNSS base station receiver and mobile network modem installation at Kingvale Command Center

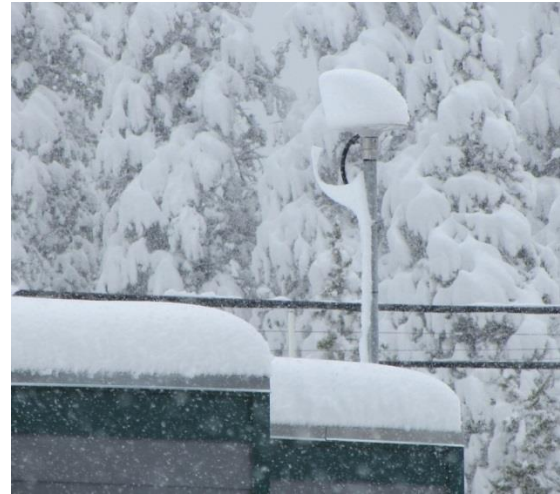
Figure 2.17: GNSS base station antenna functioning under heavy snow cover

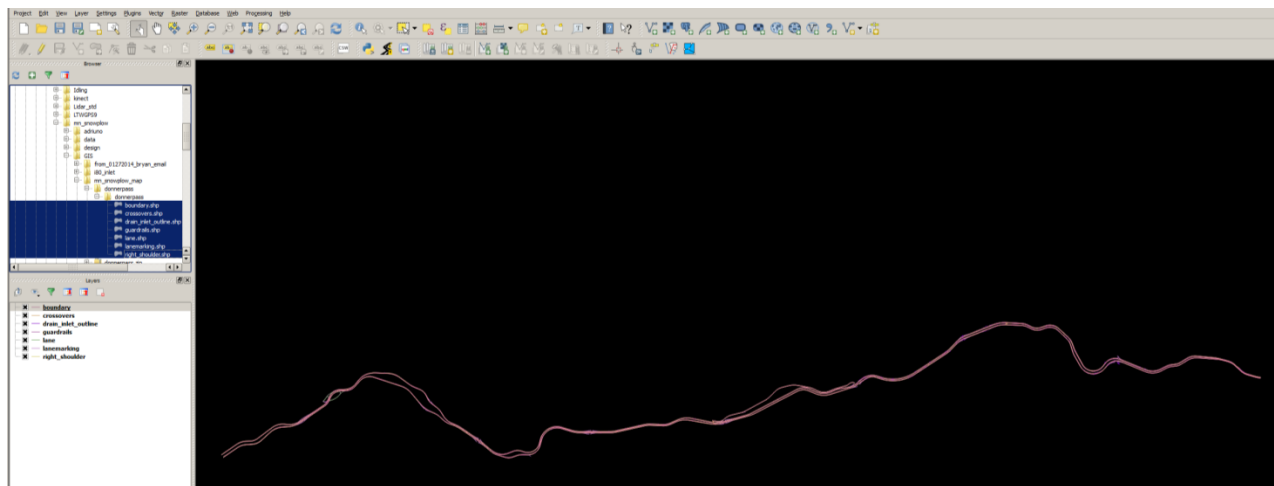
Figure 3.1: All DAS map layers SHP files displayed on QGIS

The project area was later surveyed and mapped using the Caltrans Mobile Terrestrial Laser Scanner (MTLS) [13-16]. The resulting point cloud was used to extract the inlet locations and outlines for the snow blower. The inlet .shp (Shapefile, a popular geospatial vector data format for geographic information system (GIS) software, developed and regulated by Esri²) files were first created in the EPSG:2767, NAD83 (HARN) / California Zone 2 State Plane map projection³. QGIS open-source software was used in the data conversion and post-processing⁴. The inlet .shp files were then sent to MTS for verification and final processing. A donnerpass.zip digital file, which contains all the DAS digital maps files, was returned for unloading onto the snow blower computer. The contents of the donnerpass.zip file are available in Appendix I. Appendix I also illustrates the map updating process for the snow blower.

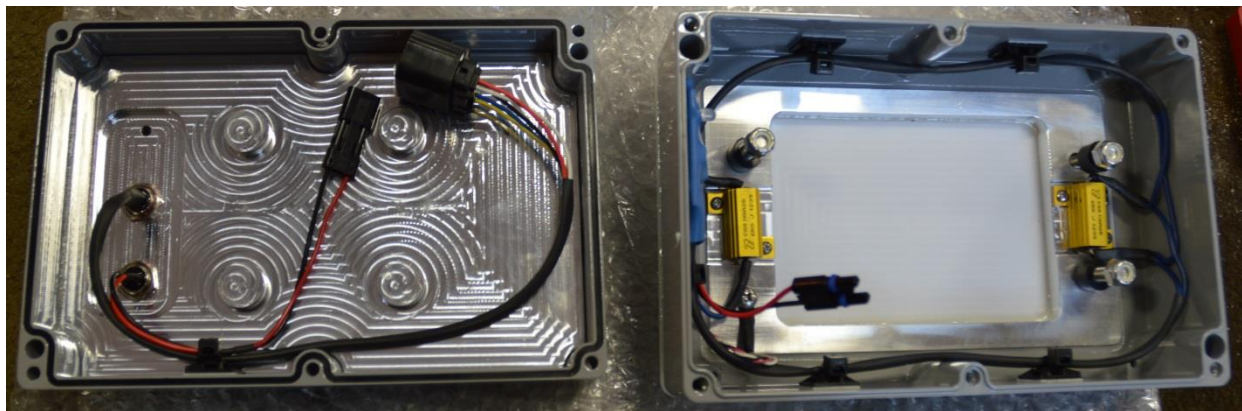
Figure 4.3: Inside of the ESR heated enclosure

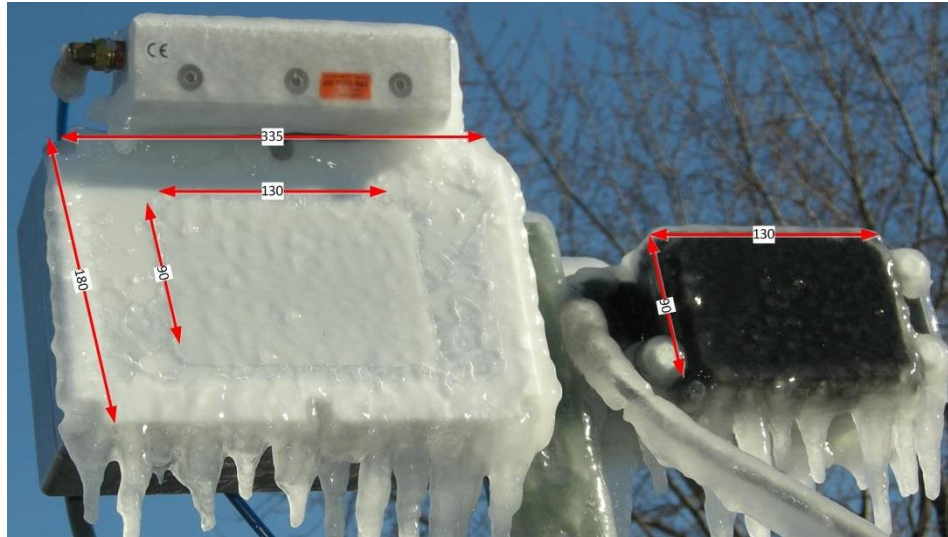
Figure 4.4: AutonomouStuff radar enclosure test setup (photo provide by AutonomouStuff)

Finally, AutonomouStuff tried a couple of different anti-ice and hydrophobic coatings on the fascia. They found that the coatings were reasonably durable, but long-term testing is needed. They sent samples to Delphi for them to characterize the RF attenuation from several different anti-ice and hydrophobic coatings. Delphi found that the best coating had unacceptable attenuation (> 3 dB). The products tested were from MicroPhase Coatings, PhaseBreak HT, TP, and Flex. MTS researchers did try mounting the radar behind glass in Minnesota, but the glass attenuated too much RF signal. Rust-Oleum NeverWet hydrophobic treatment was also tested and found not sufficiently durable.

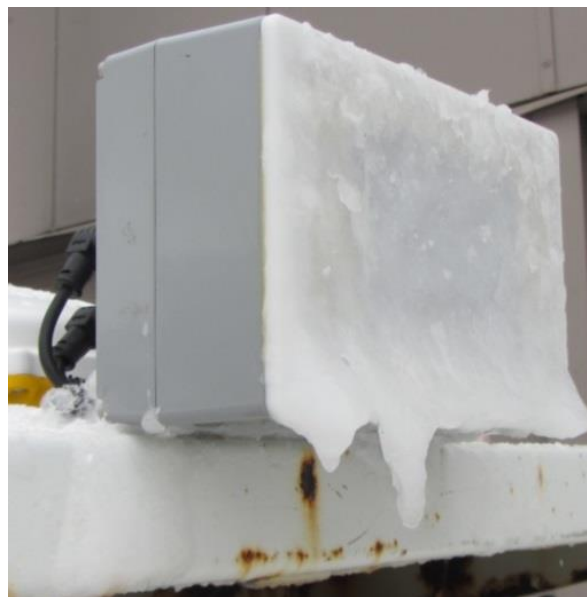
Figure 4.5: Icing on the heated radar enclosure

ESRs were mounted inside the heated enclosures purchased from AutonomouStuff for testing on the snowplow and an AHMCT test vehicle. Subsequent testing showed that the heaters were underpowered to melt and eliminate the wet snow build-up when the vehicle speed is high (~35 mph) and under heavy snowfall. Figure 4.5 shows icing on the heated fascia after driving in a heavy snow storm at about 30 mph. However, the heater was adequate in keeping ice from forming when the vehicle is stationary. Because of the slow speed of the snow blower, the heated radar enclosure should be effective in keeping the wet snow and ice build-up under control on the snow blower; however due to the lack of heavy snow storm, the snow blower was not used in the past few years. This testing showed that the heated enclosure from AutonomouStuff does not solve the radar icing problem for the snowplows.

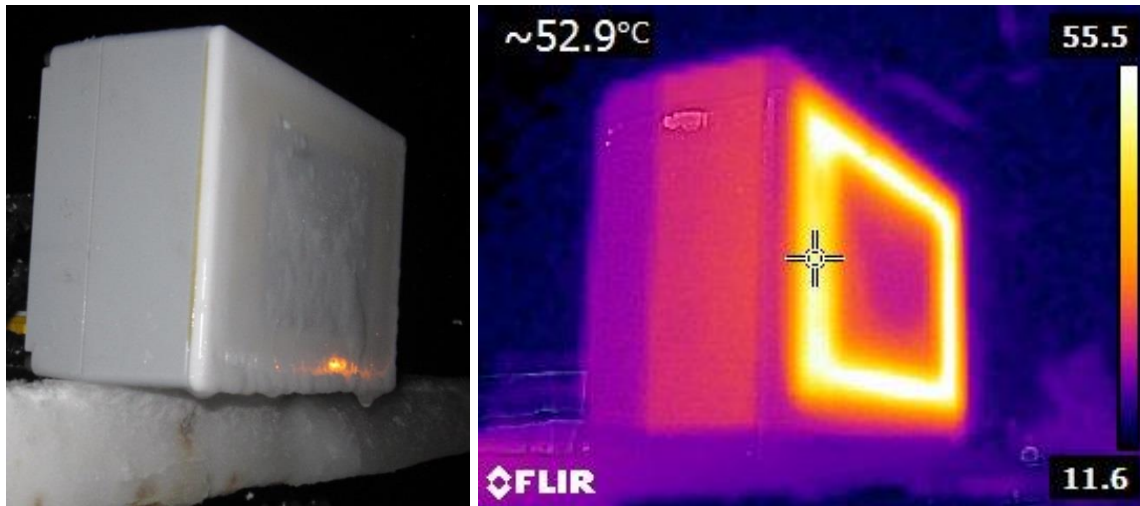
Figure 4.6: Icing on the heated radar enclosure, including thermal image on right

Figure 4.6 showed a thermal image of the heated fascia (on the right) next to a photo of the enclosure. The thermal image illustrates that the center of the fascia is cold (registering at freezing temperature) while the temperature near the heating element is hot. This distribution is due to the poor thermal conductivity of the fascia plastic. The temperature of the aluminum housing side is also higher than that of the fascia plastic front. Therefore, significant heat is lost to the side of the higher thermal conductivity aluminum housing. The heating element should be insulated so that all the heat generated is transferring to the front fascia.

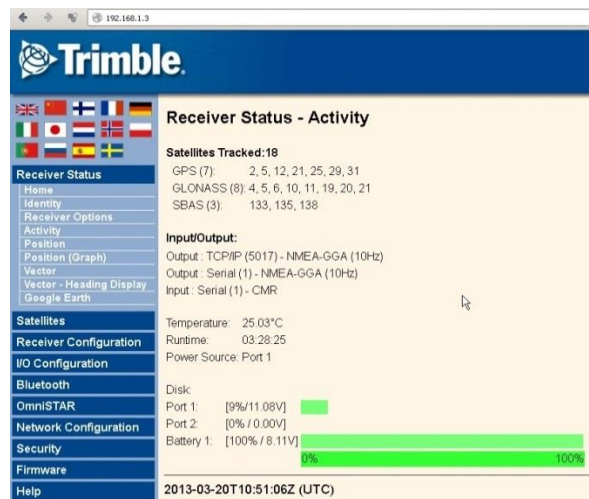
Figure 4.7: Trimble GNSS receiver web user interface showing power supply voltage at 11.08 v when heater is running

Due to additional current draw by the enclosure heater, there was significant voltage drop in the power supply (to about 11 volts), as shown in Figure 4.7. This was caused by undersized wiring. The supply voltage drop caused the GNSS receiver to shut down when the enclosure heater was on for a period of time. The GNSS receiver was programmed to automatically shut down when the power supply voltage drops below 11.4 volts, resulting in system failure. Once this problem was identified, the GNSS receiver was reconfigured to shut down at 10.8 volts. In addition, heavier gauge (10-gauge) wires were used to replace the original, undersized wiring. The GNSS receiver did not shut down after these revisions.

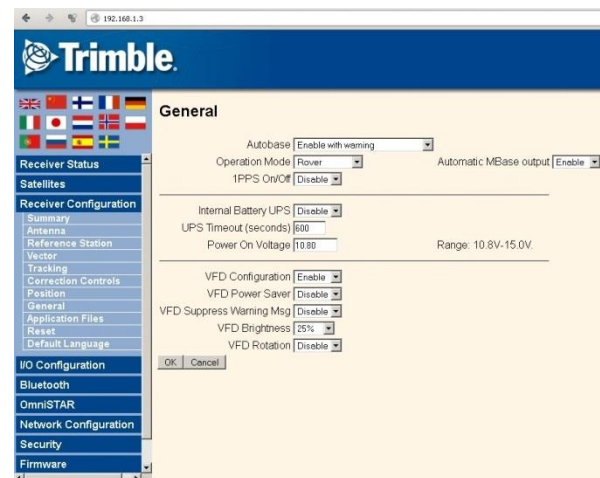
Figure 4.8: Trimble GNSS receiver web user interface showing power on voltage set to 10.8 v

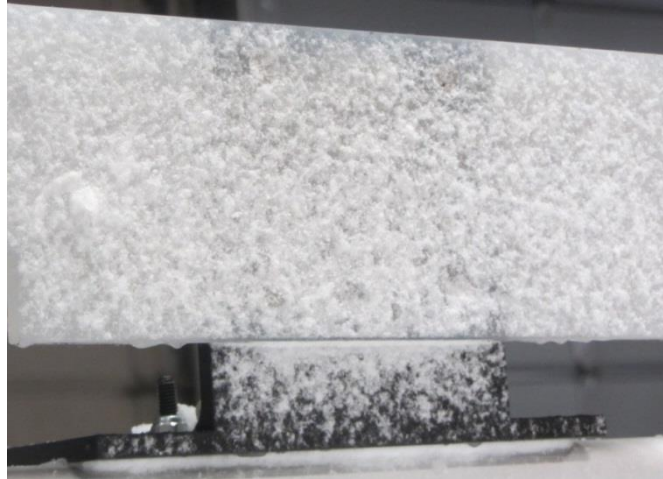
Figure 4.9: Icing on polycarbonate plastic coated with Rust-Oleum NeverWet after driving in a snow storm

AHMCT, MTS, and the radar vendor also explored various hydrophobic coatings as an additional component of addressing the radar freezing problem. Figure 4.9 shows that ice and snow sticks to the polycarbonate plastic coated with Rust-Oleum NeverWet hydrophobic coating. A hydrophobic coating alone may not solve the icing problem.

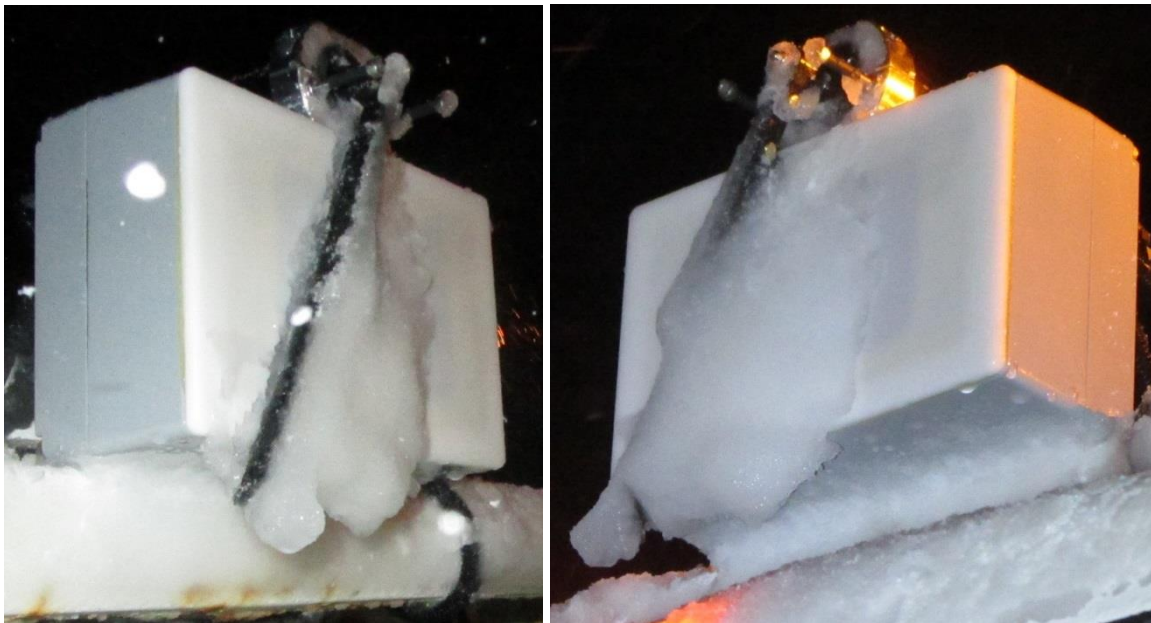
Figure 4.10: First-generation wiper / heated enclosure system

AHMCT, MTS, and the radar vendor explored additional solutions to the icing problem. Delphi Automotive was consulted through AutonomouStuff. A wiper blade was mounted to the heated radar enclosure to determine its effectiveness, as shown in Figure 4.10. The first-generation wiper system failed due to snow and ice sticking to the wiper blade, and the wiper blade did not apply sufficient pressure onto the fascia to push snow away. Furthermore, the wiper motor was a COTS system developed for the military market. It was highly programmable in its range of motion, but very expensive. Nevertheless, the first generation design provided important insight to future wiper design improvement:

- A heated wiper blade is required
- The wiper blade must also move to an open area to allow the wind to blow away the snow on the wiper blade.

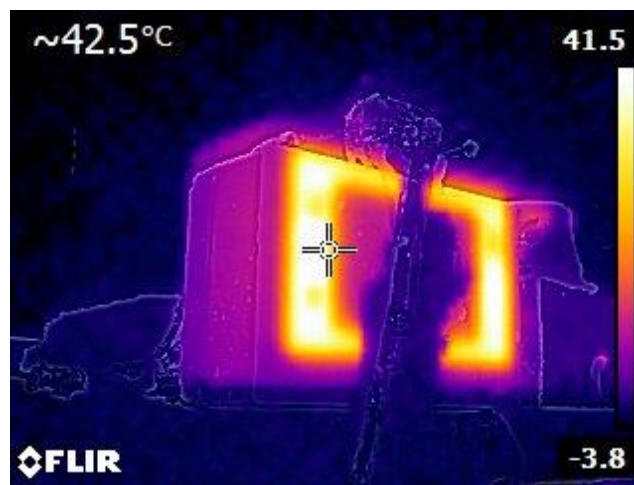
Figure 4.11: Thermal image of the first-generation wiper / heated enclosure system

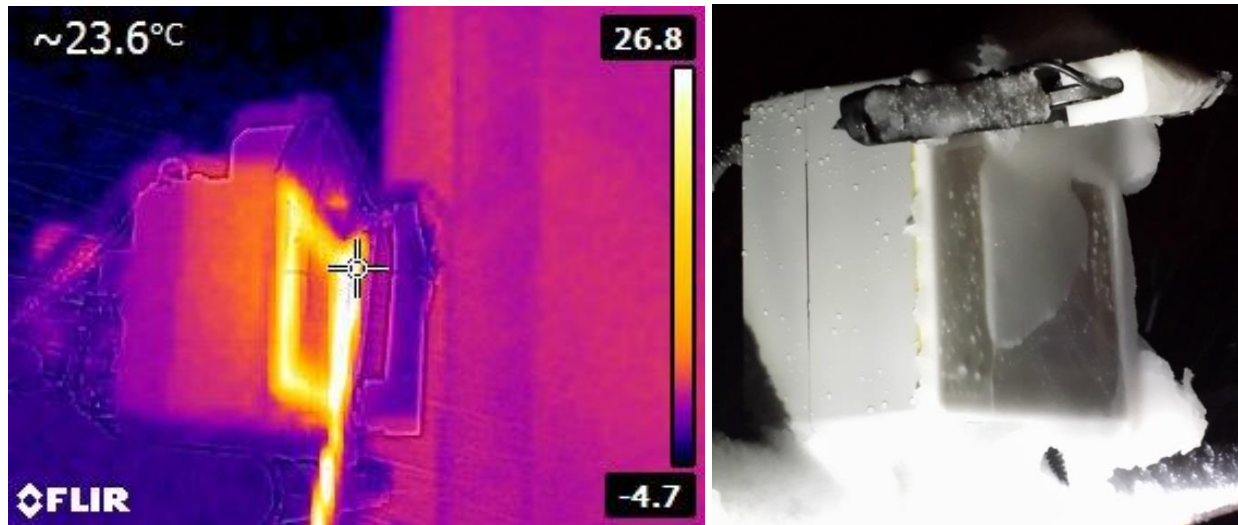
Figure 4.12: Second-generation wiper design (wiper motor mounted on top) with heated wiper blade, including thermal image on left

The second- and third-generation designs failed when the snow fall was heavy for an extended period. The cause of failure is snow accumulation on the side of the fascia by the wiper blade pushing snow to the accumulation area. The snow build-up diminished the ability of the wiper blade to push snow from the center of the fascia.

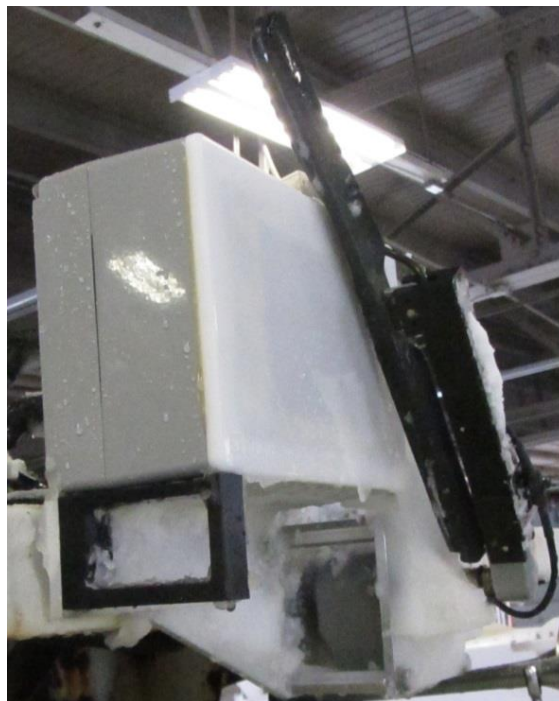
Figure 4.13: Third-generation wiper design (wiper motor mounted on bottom) with heated wiper blade

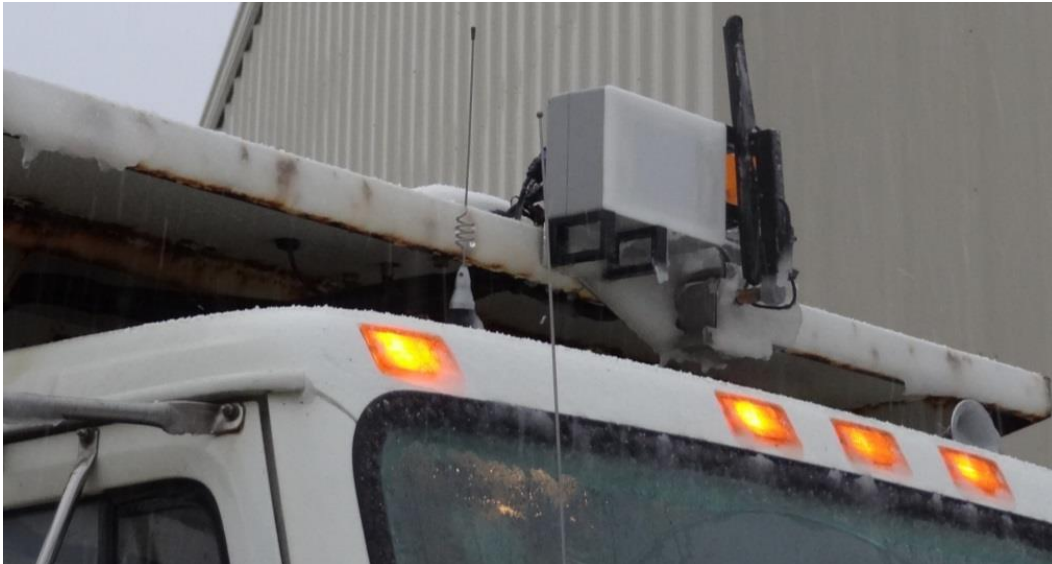
Figure 4.14: Final wiper design with heated wiper blade

ice on the motor face and mount will not hinder the wiper operation. In addition, two black narrow plastic supports were added to the bottom and side of the enclosure. The supports allow wind to blow the snow and ice off the wiper blade and themselves, preventing snow and ice accumulation. Insulation was added behind and to the side of the heating element to focus the heat transfer toward the front fascia. Figure 4.15 shows that the final wiper design with heated wiper blade passed operational tests. Snow accumulated in areas surrounding the radar, but not on the fascia. The final radar wiper system was installed and tested on both 700024 and 700506. The final radar wiper system seems to work well and prevented ice from forming during the testing in the 2014 - 2015 snow season.

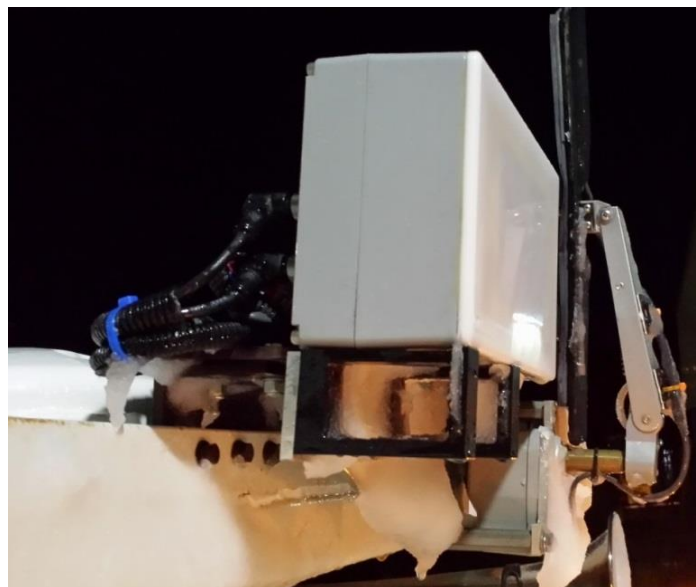
Figure 4.15: Final wiper design with heated wiper blade. This design passed operational testing. Snow accumulated in areas surrounding the radar, but not on the fascia.

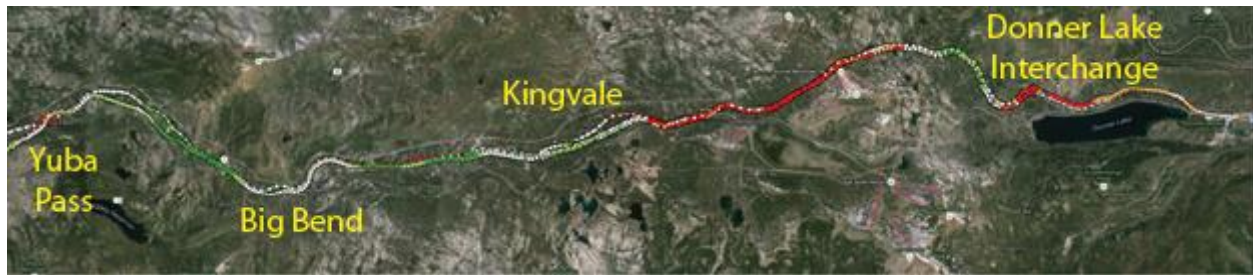
Figure 5.1: RSSI on I-80 from SR 20 to DLI overlaid a Google hybrid map

The received signal strength indicator (RSSI) in dBm was logged in the DAS log file along with the vehicle position. The data were overlaid on a Google hybrid map and analyzed in QGIS. Each color dot represents different RSSI range as listed in Table 5.1. RSSI below -100 dBm is considered poor signal with limited connectivity. Figure 5.1 shows the Verizon mobile network coverage of the entire test area (on I-80 from SR 20 interchange to DLI). The red dotted areas (at, and east of, Soda Spring and DLI) shows poor signal strength.

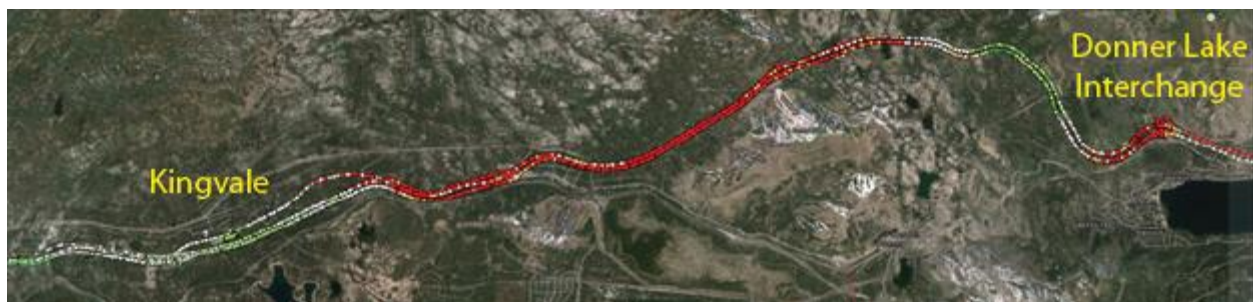
Figure 5.3: RSSI on I-80 from Kingvale to DLI overlaid on a Google hybrid map

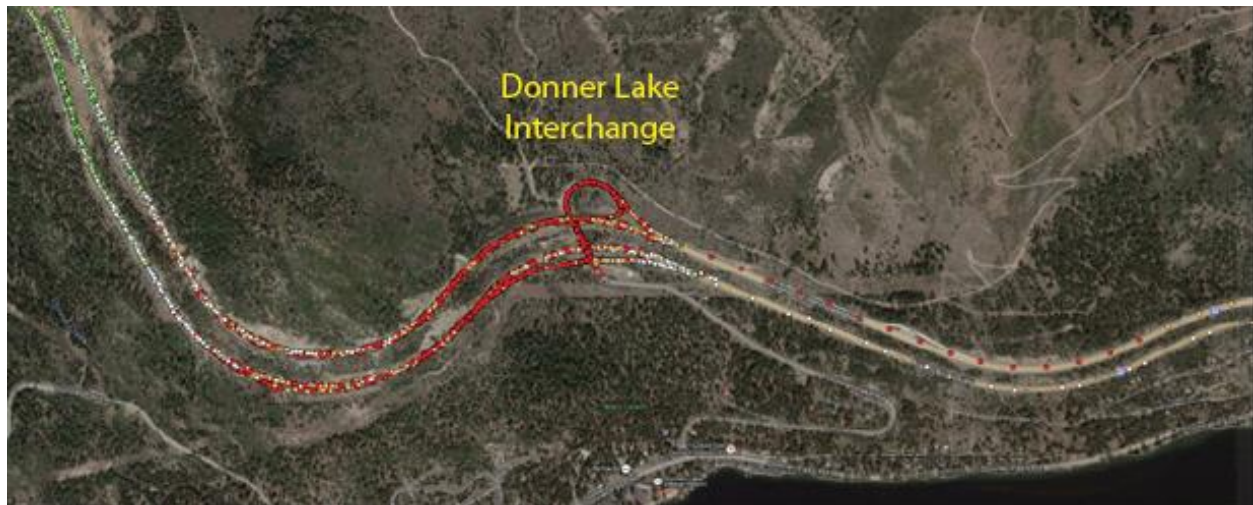
Figure 5.4: RSSI on I-80 at DLI overlaid on a Google hybrid map

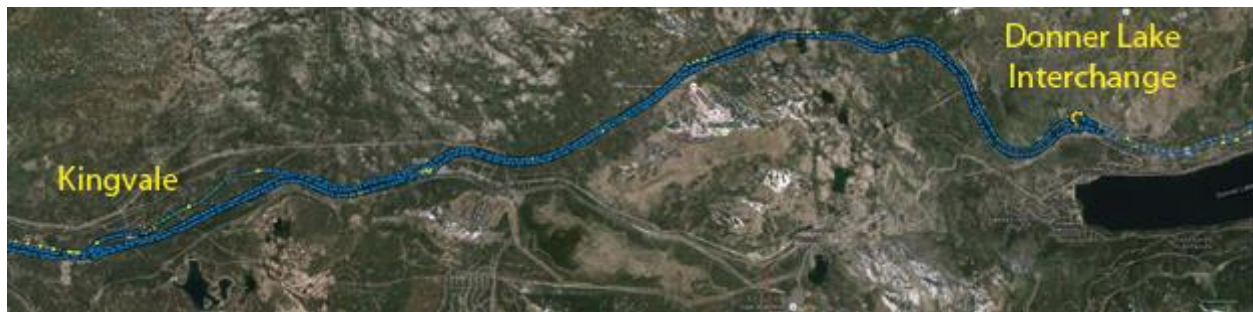
Figure 5.5: GNSS RTK solution status on I-80 from Kingvale to DLI overlaid on a Google hybrid map

Color	Solution ID	GNSS Solution Status
Red	0	No solution
Orange	1	Autonomous (no correction)
Yellow	2	DGPS (3.3 ft-level, meter-level accuracy)
Green	3	RTK float (4 in-level, decimeter-level accuracy)
Blue	4	RTK fixed (0.4 in-level, centimeter-level accuracy)

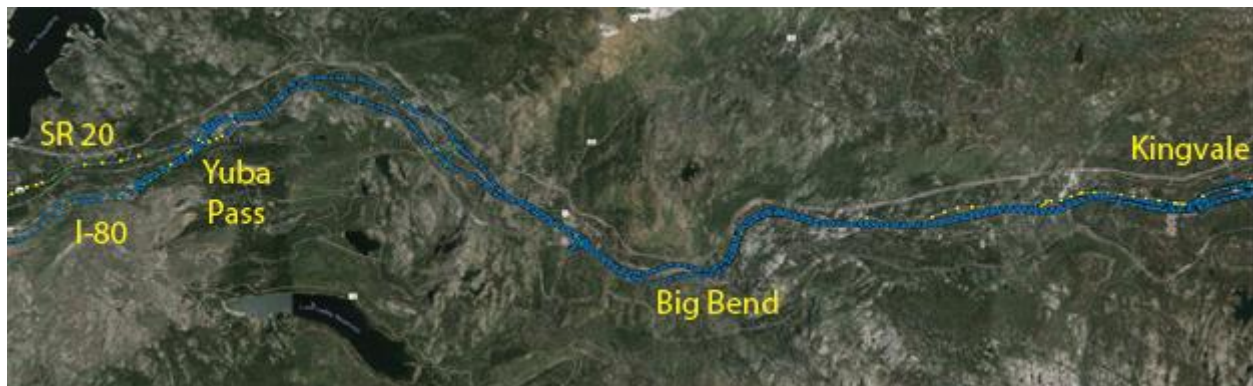
Figure 5.6: GNSS RTK solution status on I-80 from SR 20 intersection to Kingvale overlaid on a Google hybrid map

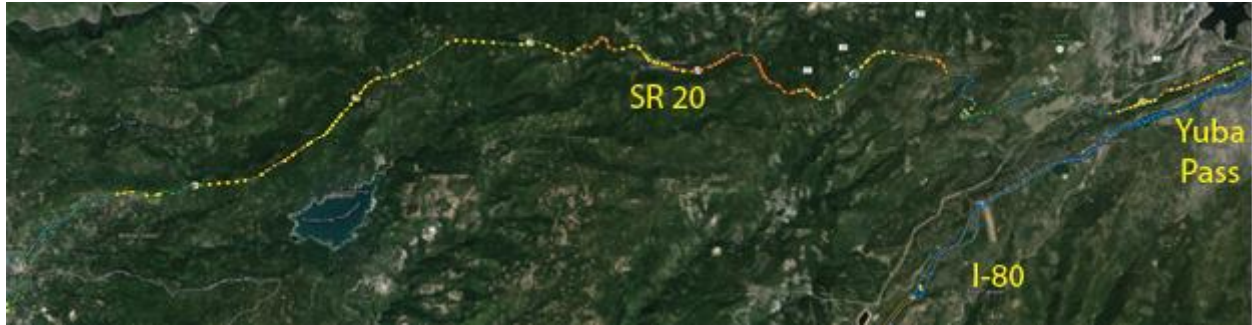
Figure 5.7: GNSS RTK solution status on SR 20 overlaid on Google hybrid map

Figure 5.7 shows that the GNSS receivers were not providing accurate solution on SR 20. Thus, the DAS does not work well on SR 20. However, SR 20 was not an area of interest for the DAS. Figures 5.8-5.10 display small areas where the GNSS solution is not accurate for DAS due to GNSS signal blockage when the snowplow drives under a bridge. This issue is discussed below.

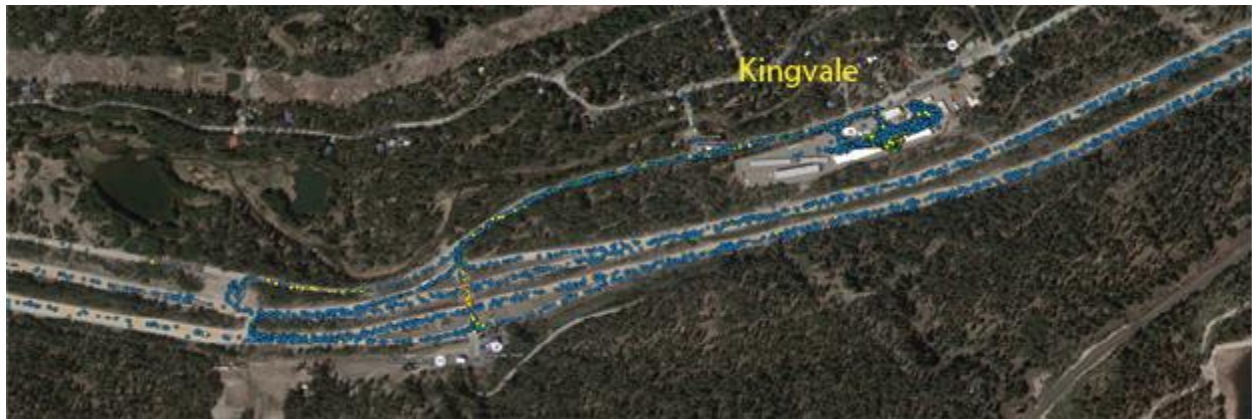
Figure 5.8: GNSS RTK solution status on I-80 at Kingvale area overlaid on a Google hybrid map

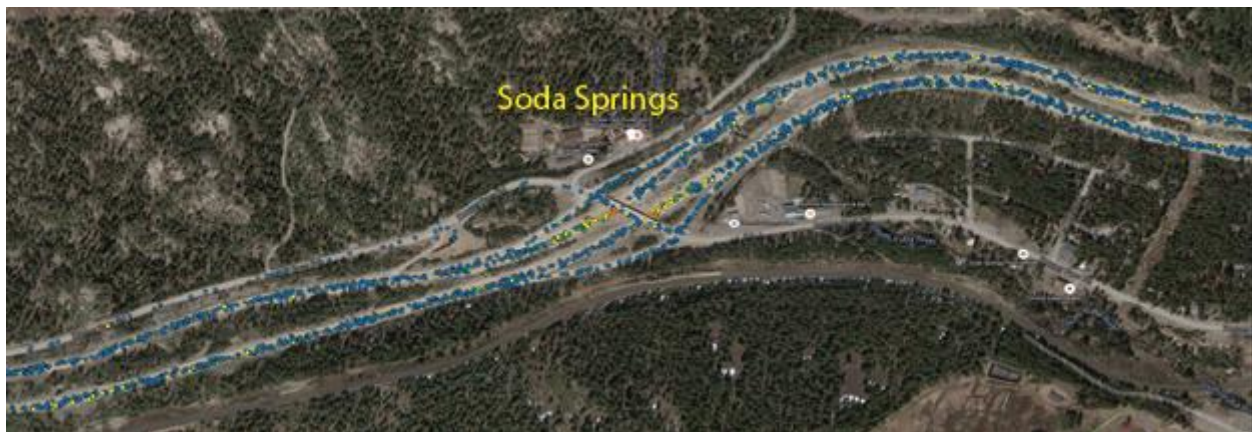
Figure 5.9: GNSS RTK solution status on I-80 at Soda Spring overlaid on a Google hybrid map

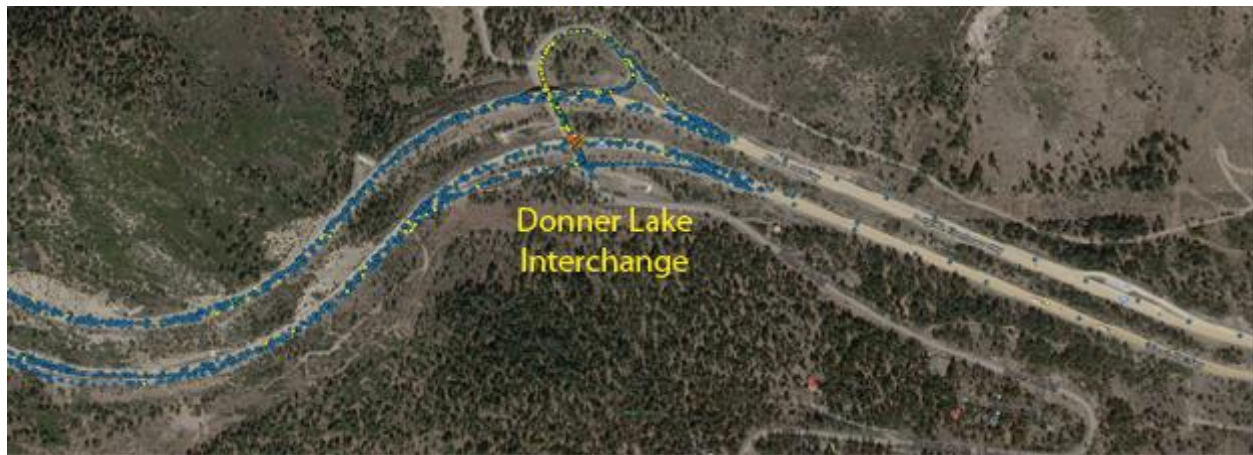
Figure 5.10: GNSS RTK solution status on I-80 at DLI overlaid on a Google hybrid map

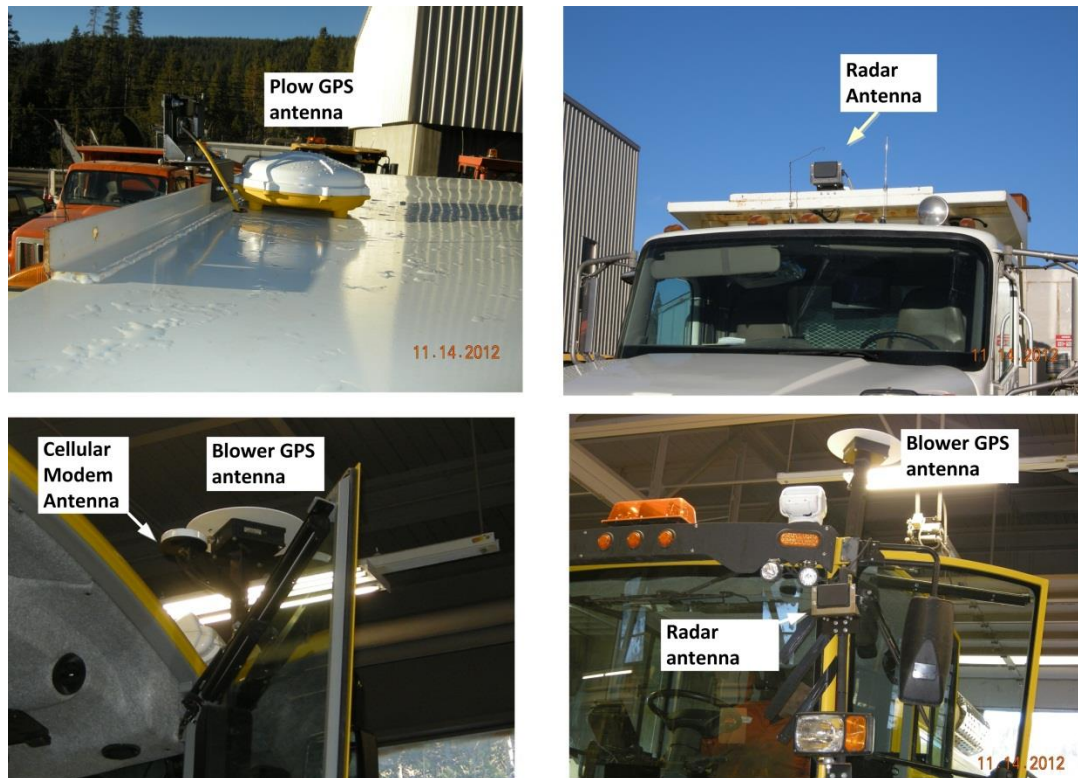
Figure B.1: System components mounted on the outside of the vehicles

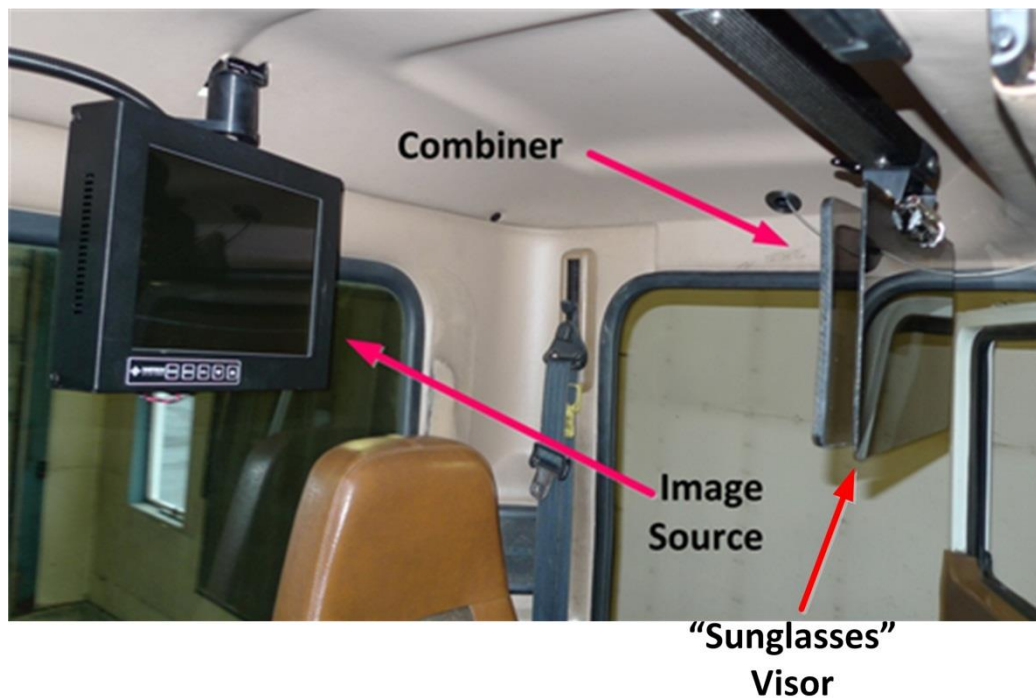
Figure B.2: Head-Up Display components

Combiner - “Combines” the actual road with the computer generated road. The driver can see through the combiner and also see a reflection of the image presented by the image source. The combiner is made from a heat-formed acrylic, and treated with a reflective coating on the concave side, and an anti-reflective coating on the convex side. **It is important to note that these coatings are relatively delicate, and cannot tolerate any sort of chemical cleaner (Windex, Sparkle, etc.) or any sort of rubbing.** The cleaning process is described below.

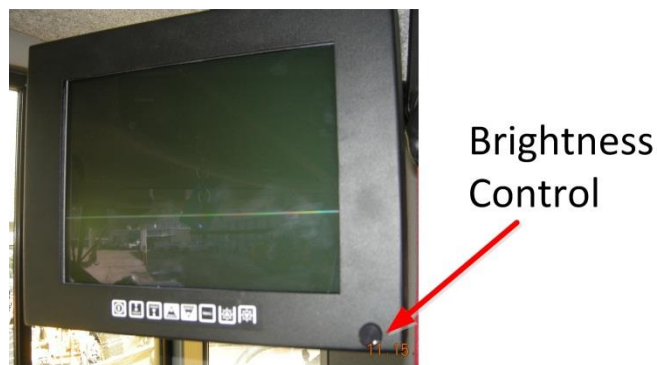
Figure B.3: Brightness control for HUD image source

Image Source: – Generates the image which is seen by the driver when looking through the combiner. The display has a brightness control used to allow the system to be bright during high ambient light conditions, and very dim during nighttime operation when stray light in the cab is undesirable. The brightness control is shown in Figure B.3.

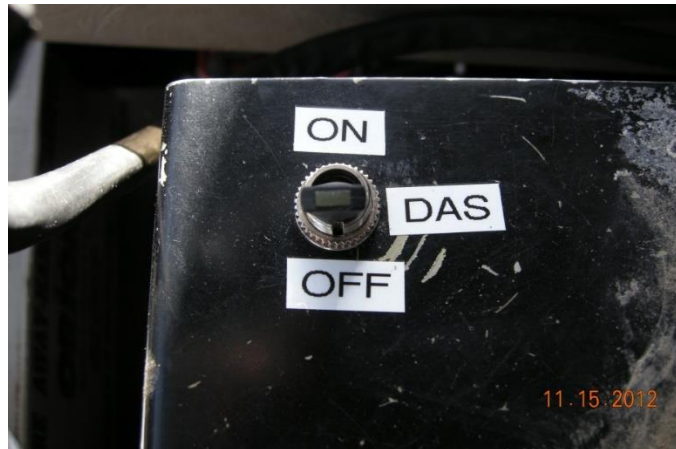
Figure B.4: Driver Assist System (DAS) ON/OFF switch for plow 0530506 located beneath the Muncie spreader controls
