Evaluation of the University of Minnesota GPS Snowplow Driver Assistance System

Report Number: CA16-2167

AHMCT Research Report: UCD-ARR-15-08-30-01

August 30, 2015

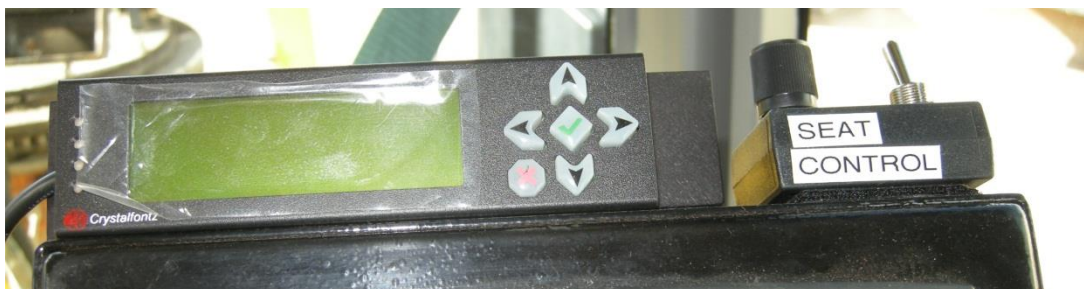
Figure B.5: DAS user interface. The Crystalfontz LCD touchpad is on the left, and the seat controller is on the right.

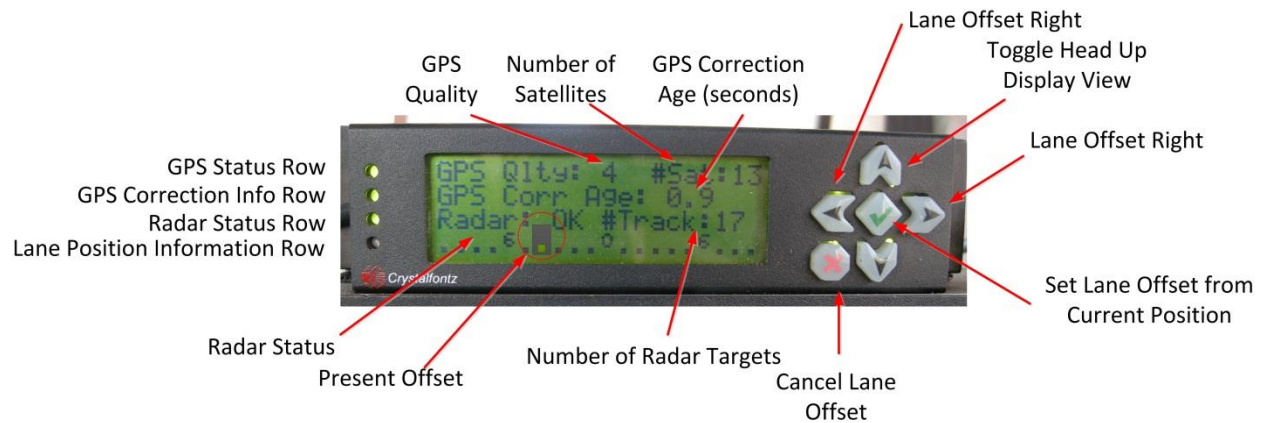
Figure B.6: DAS LCD control panel. Display shows status, and the buttons allow the driver to change the desired location of the virtual lane boundary to facilitate the plowing of shoulders or clearing over the centerline.

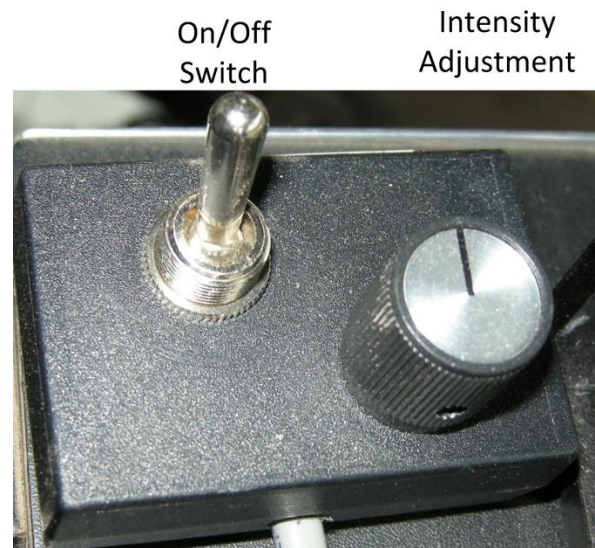
Figure B.7: Seat controller showing seat switch and intensity adjustment

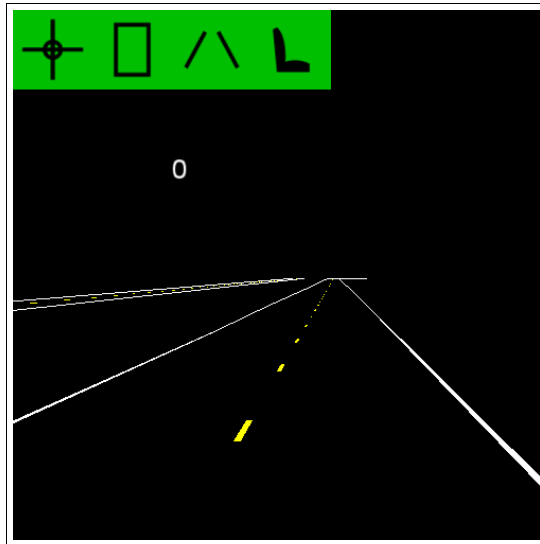
This image represents the typical computer generated view seen through the HUD. In this view the driver can see two lanes of traffic in their direction, separated by a yellow skip line and delineated by white fog lines. More traffic lanes can be seen across the median.

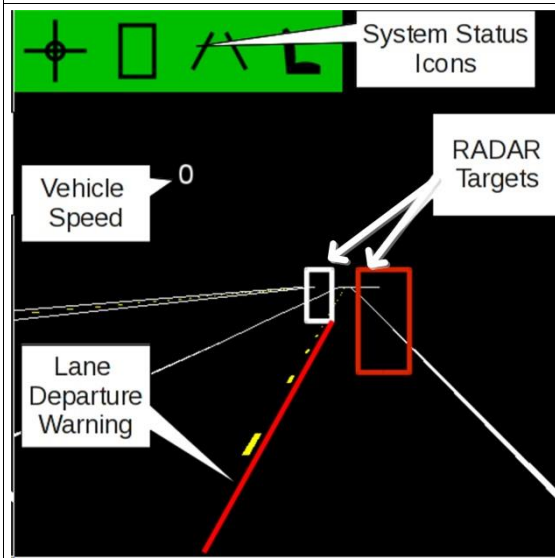
Here the different components of the HUD are highlighted.

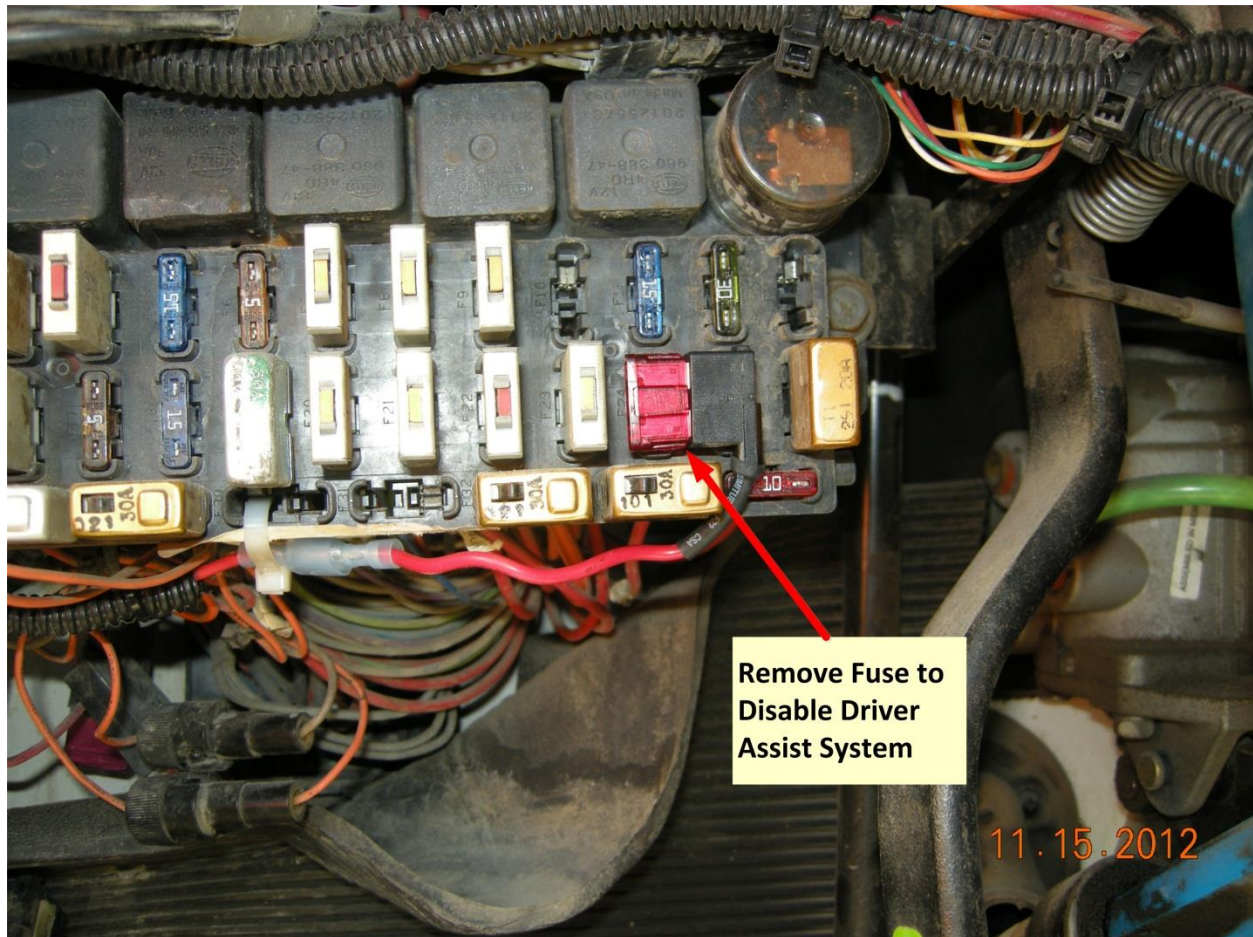
Figure B.8: DAS power connection for plow 0530506. This fuse block is located to the left of the clutch pedal in front of the driver's seat.

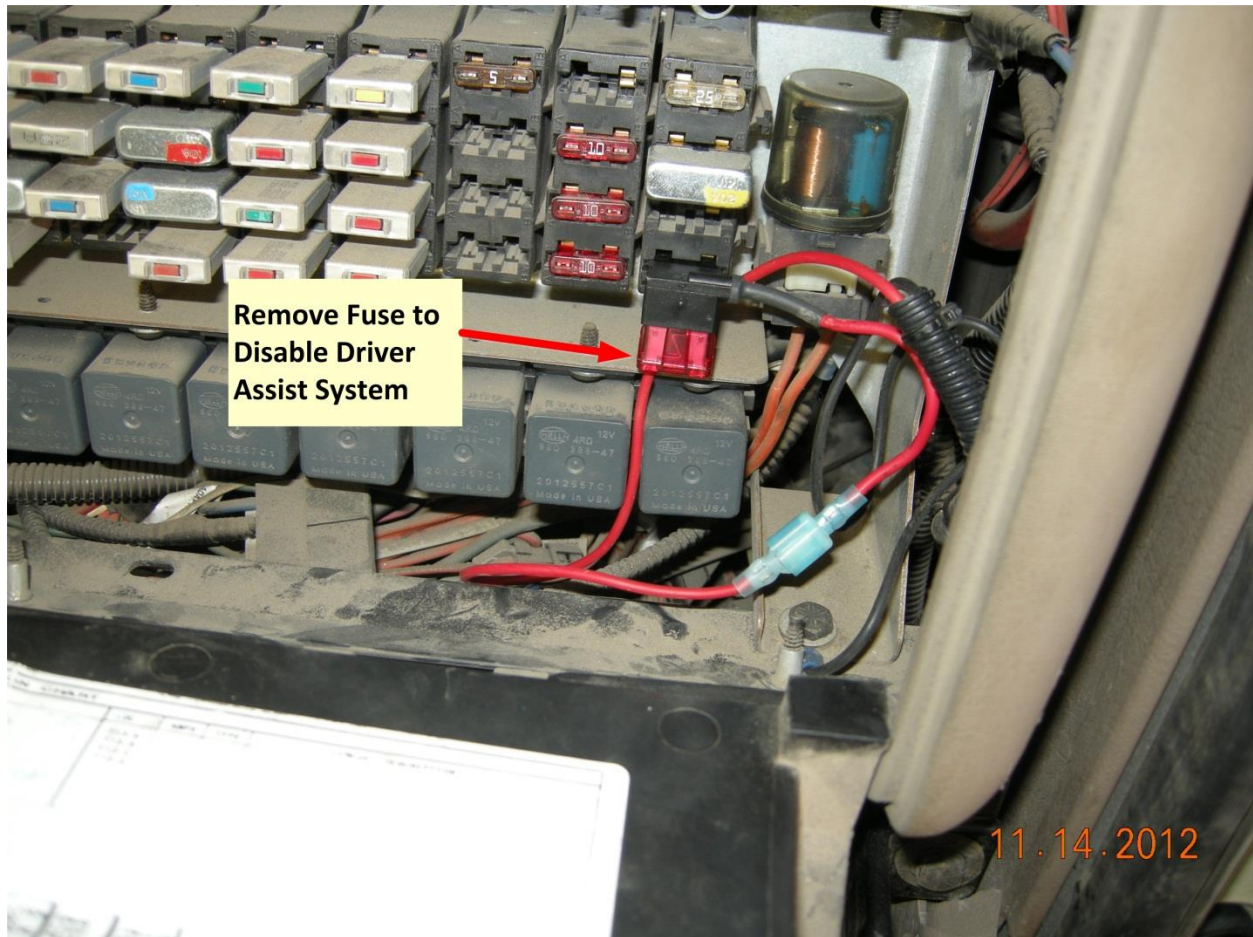
Figure B.9: DAS power connection for plow 7000024. This fuse block is located behind the glove box which is in front of the passenger seat.

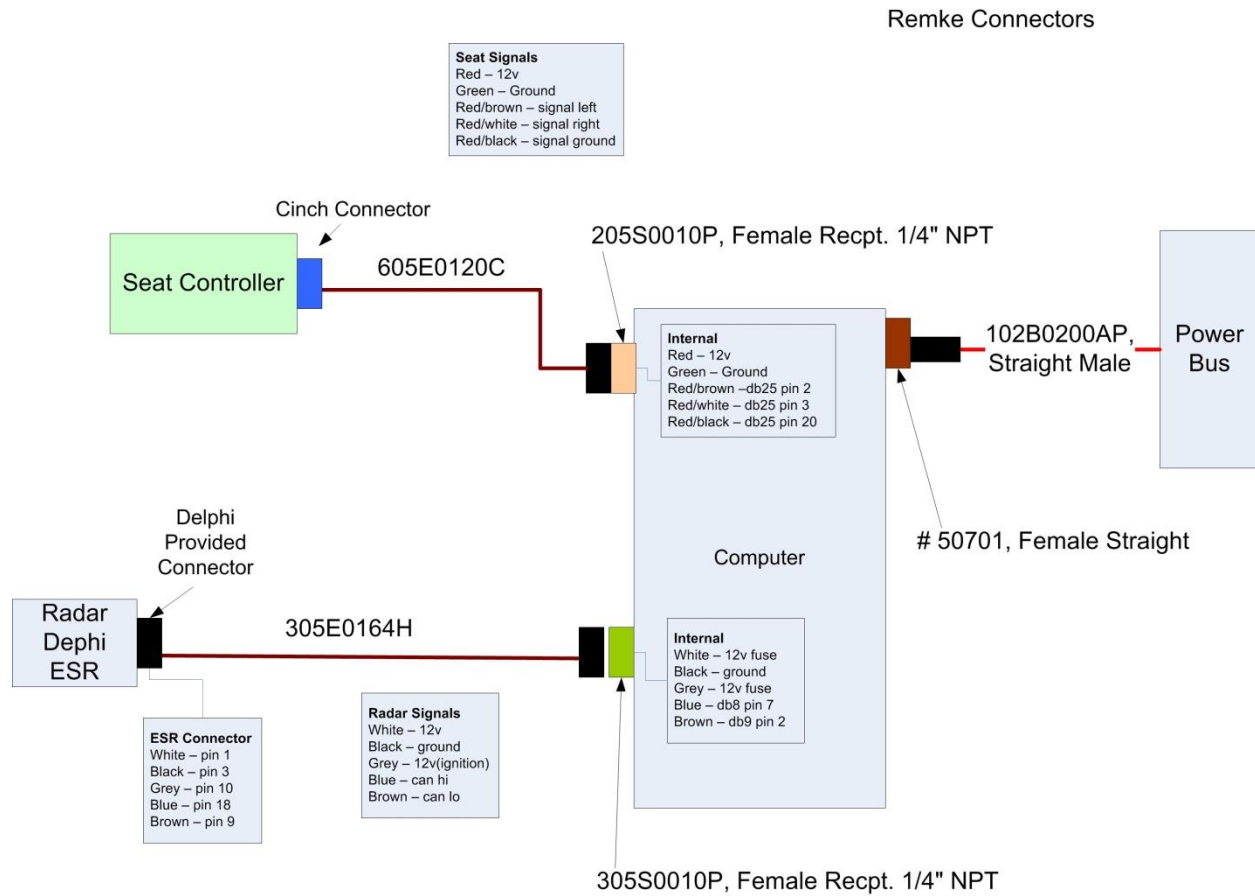
Figure B.12: Remke cabling for radar, seat controller, and computer power for all three vehicles (plows 0530506 and 7000024, and blower 7005039)

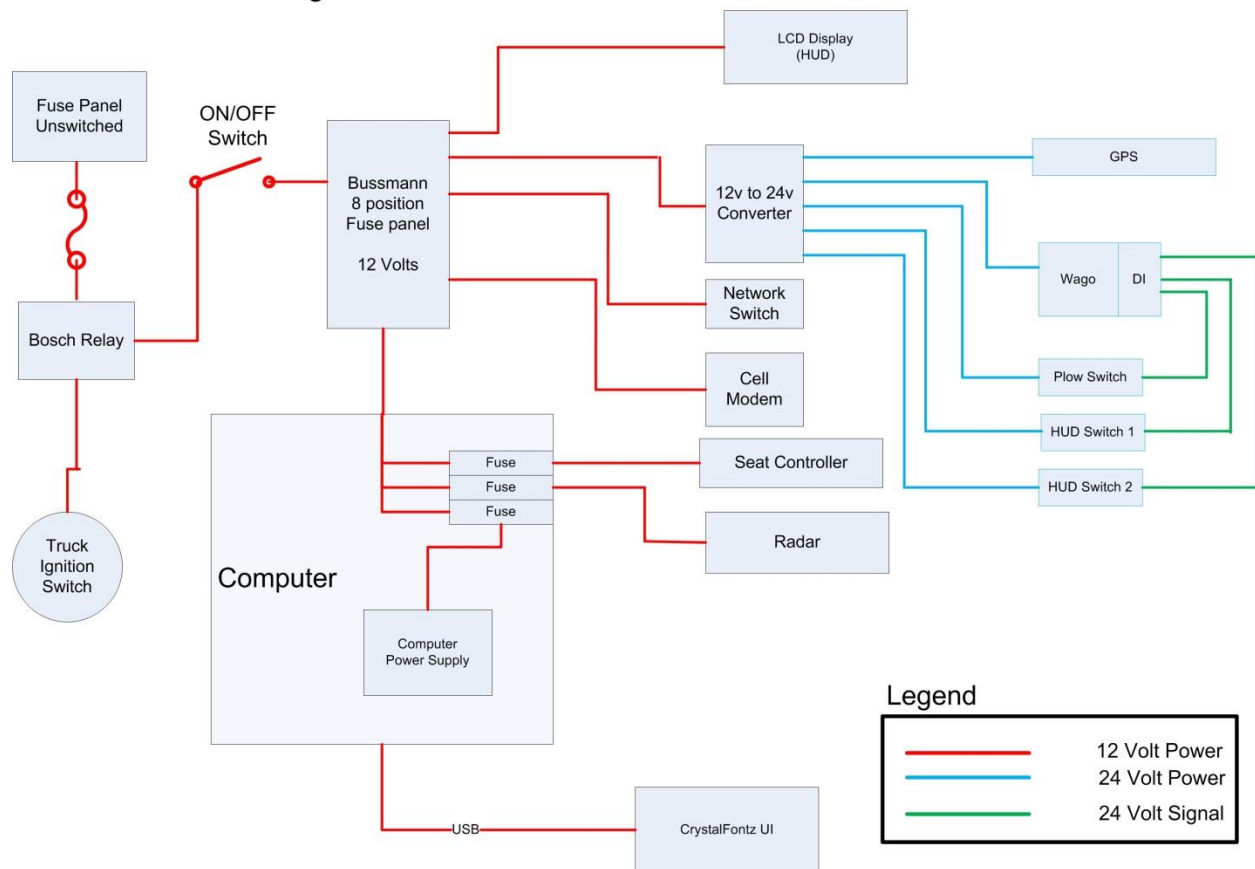
Figure B.13: Power wiring diagram for plow 0530506. The plow switch is used by AHMCT to determine how often the DAS is used while plowing snow.

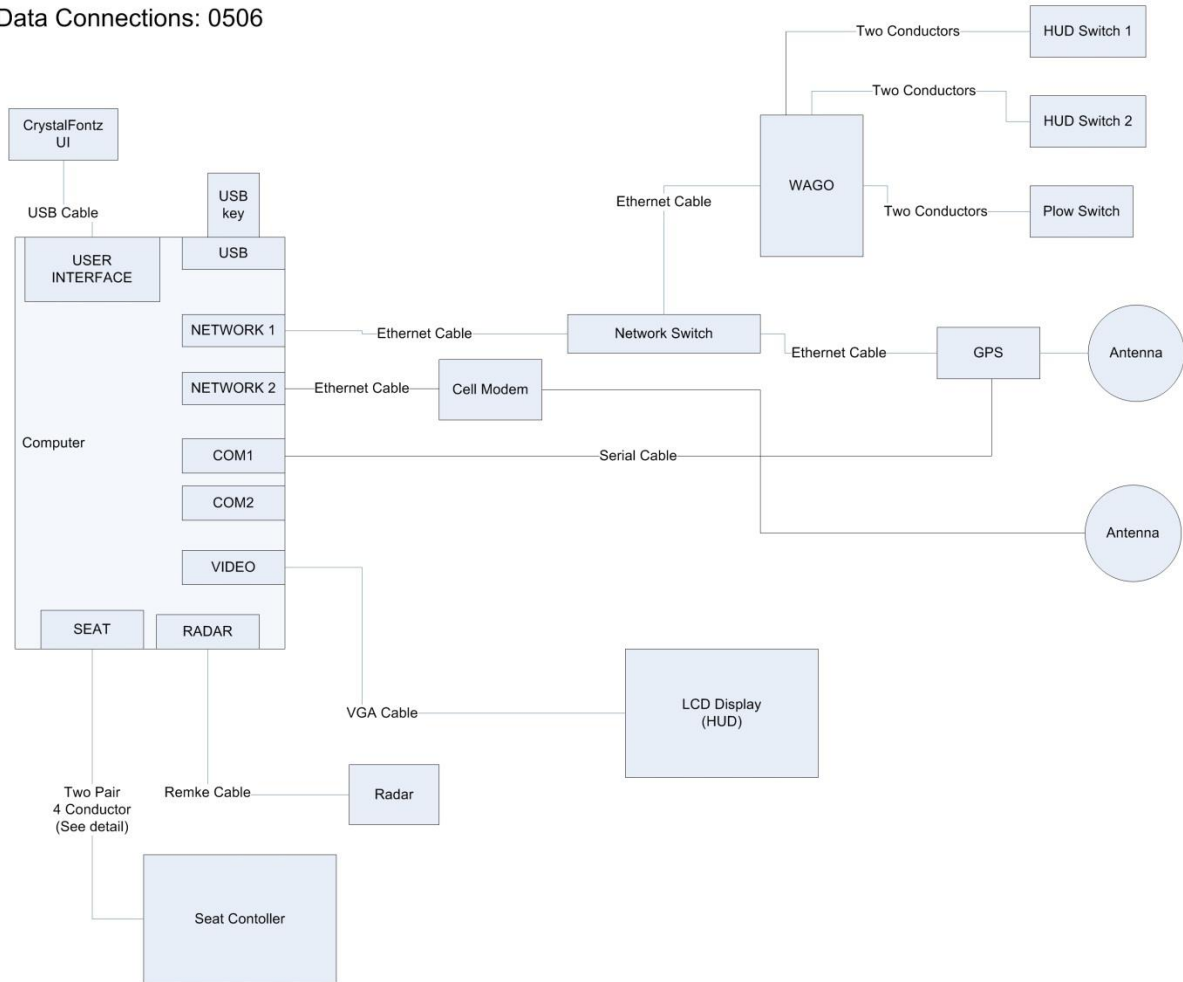
Figure B.14: Data wiring for plow 0530506. This vehicle has two HUD switches. GPS data is transferred via serial communications.

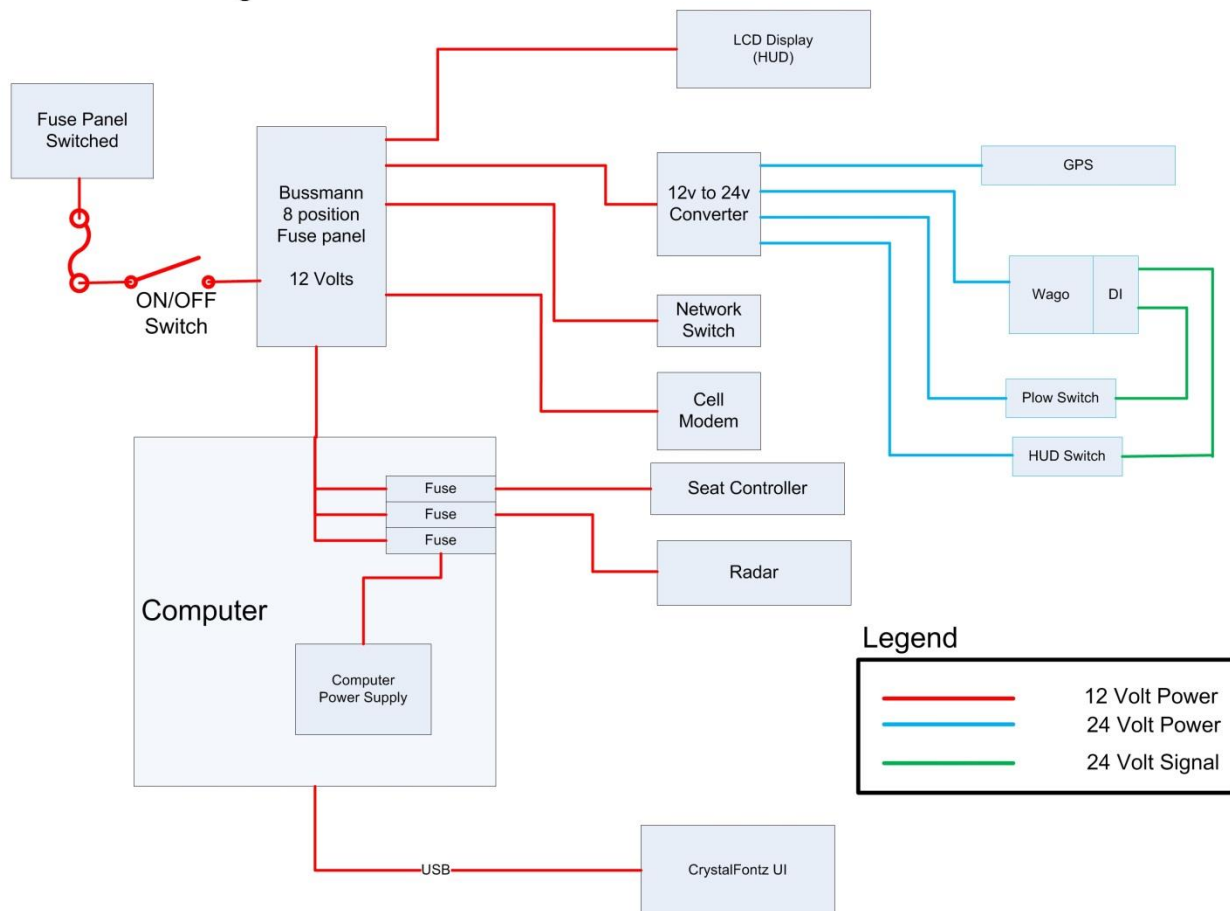
Figure B.15: Power wiring diagram for plow 7000024. The plow switch is used by AHMCT to determine how often the DAS is used while plowing snow.

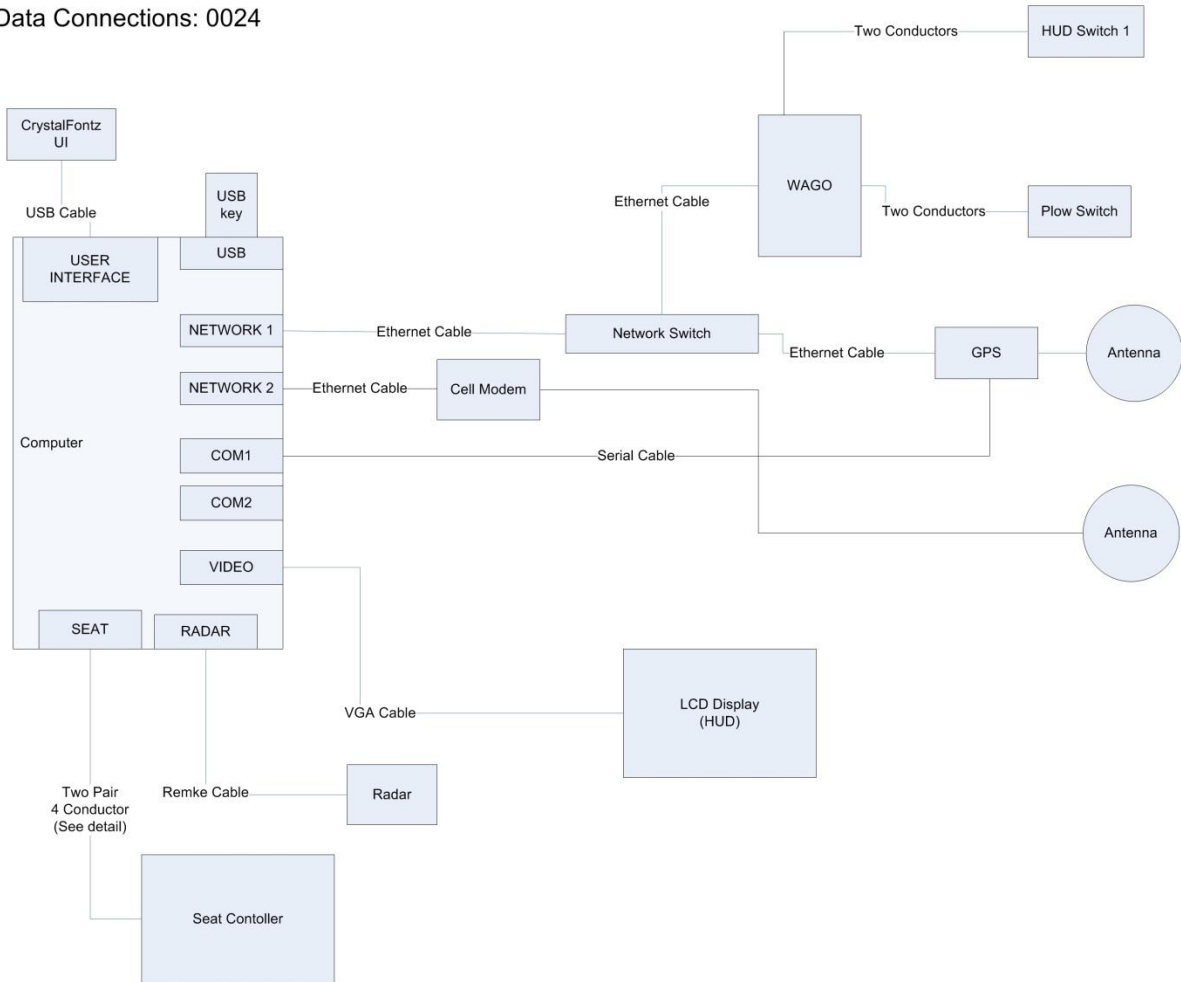
Figure B.16: Data wiring for plow 7000024. This vehicle has one HUD switch. GPS data is transferred via serial communications.

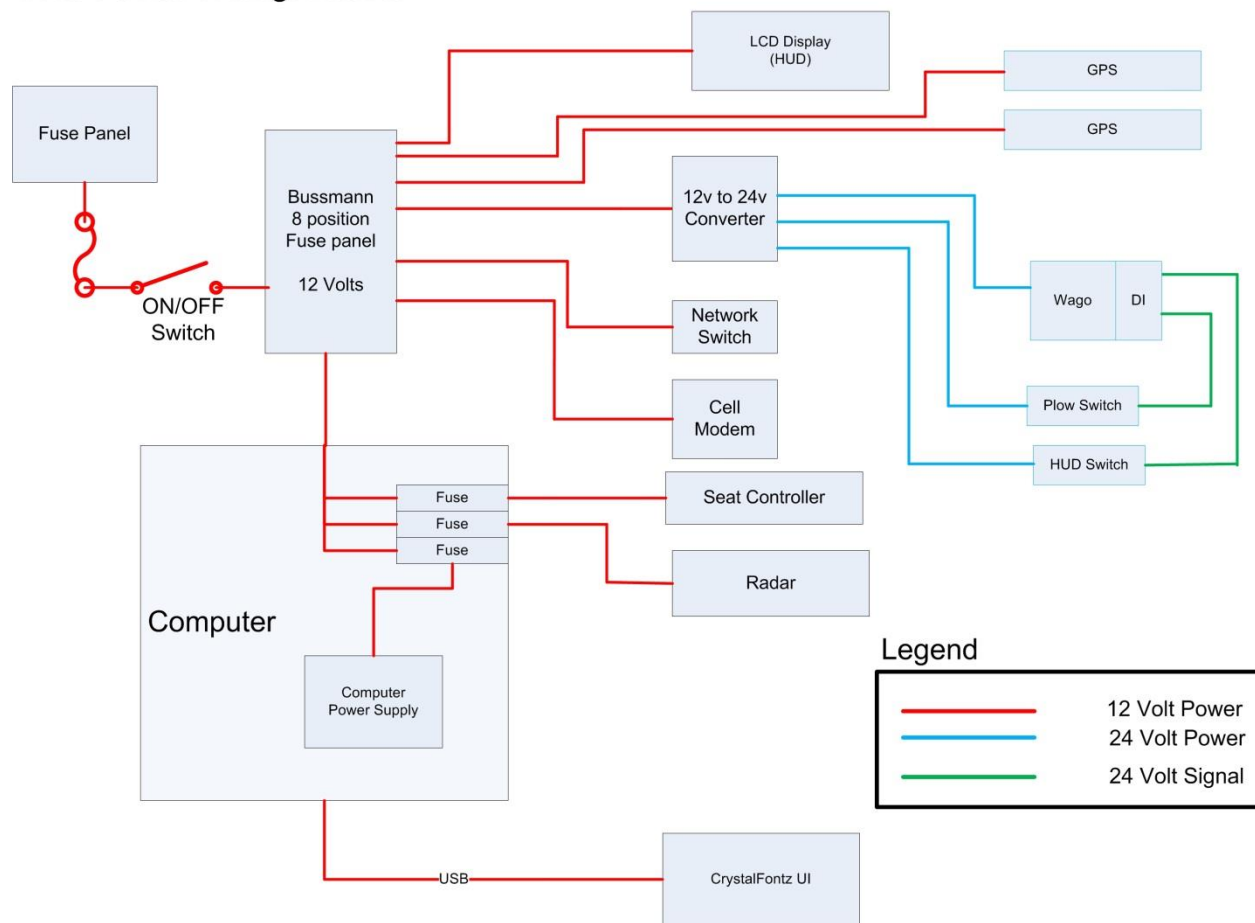
Figure B.17: Power wiring diagram for Wausau blower 7005039

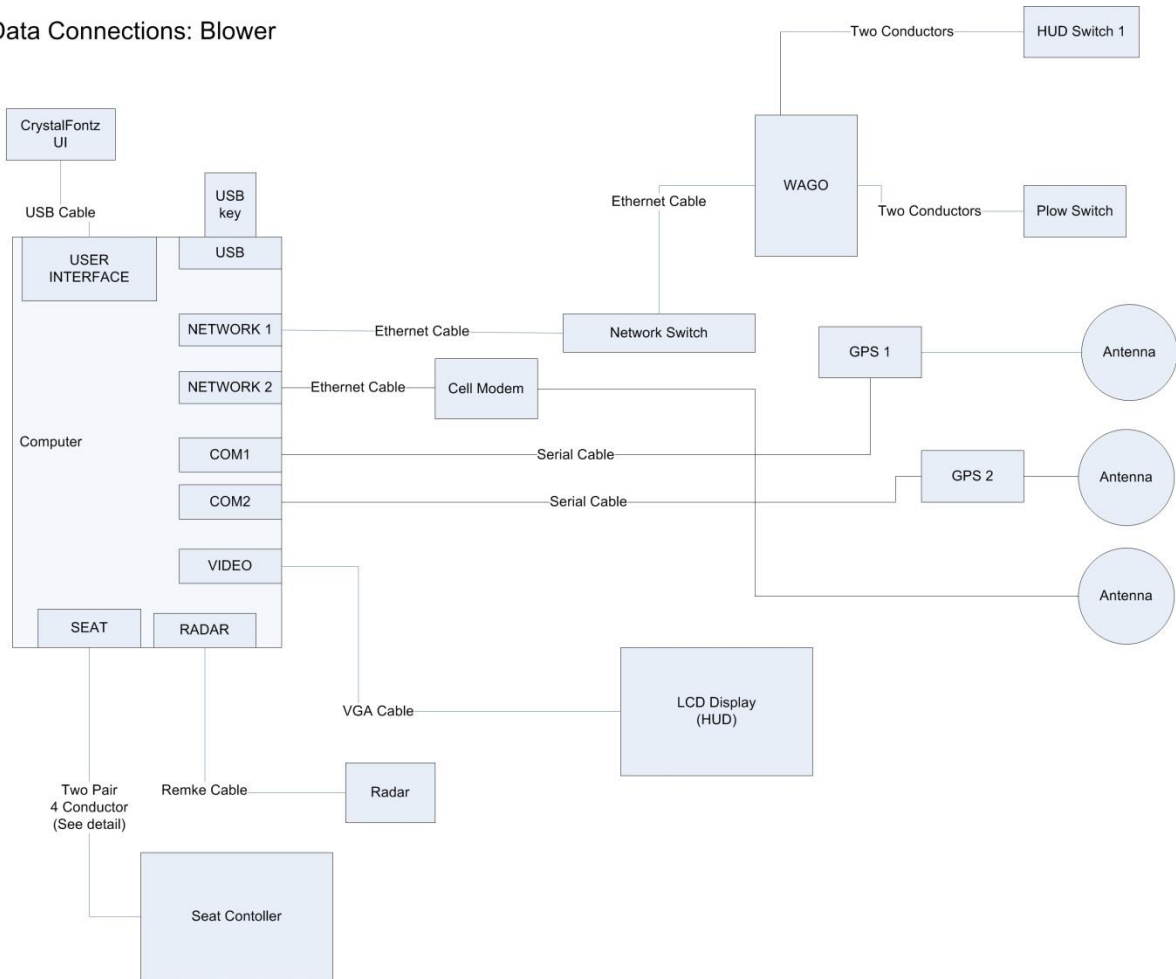
Figure B.18: Data wiring for Wausau blower 7005039. This vehicle has two GPS receivers. GPS data is transferred via serial communications.

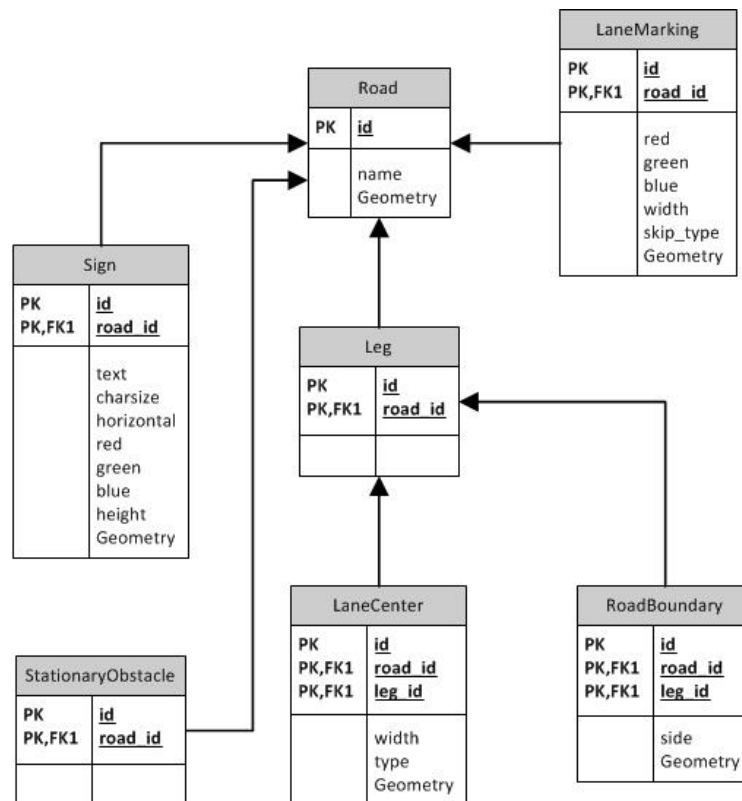
Figure D.2: DAS Data Model with entity relationships and attributes. PK is primary key; FK1 is foreign key (a primary key from another entity). Together the primary key and the foreign keys uniquely identify the object with the database.

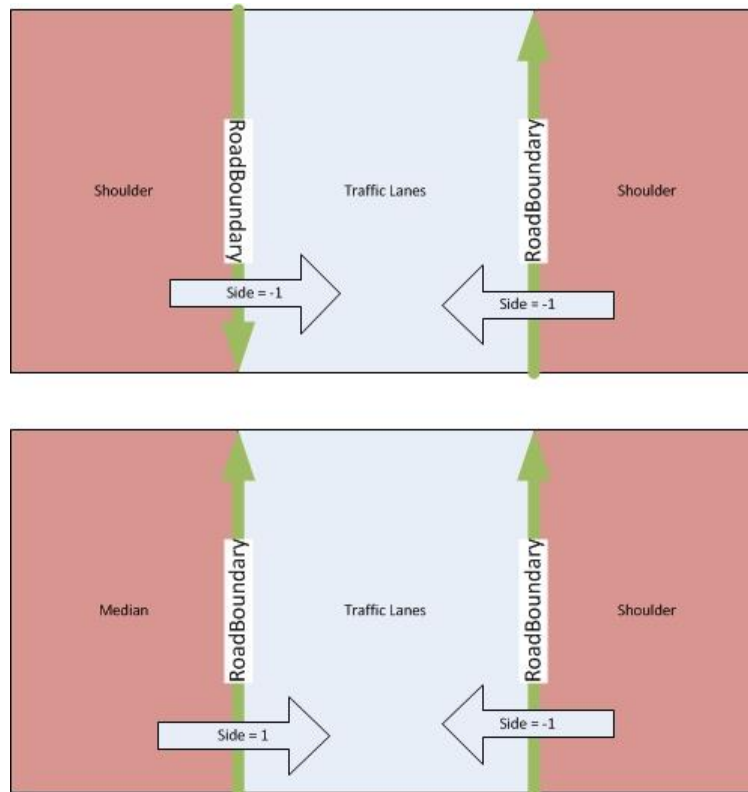
Figure D.3: RoadBoundary Side attribute

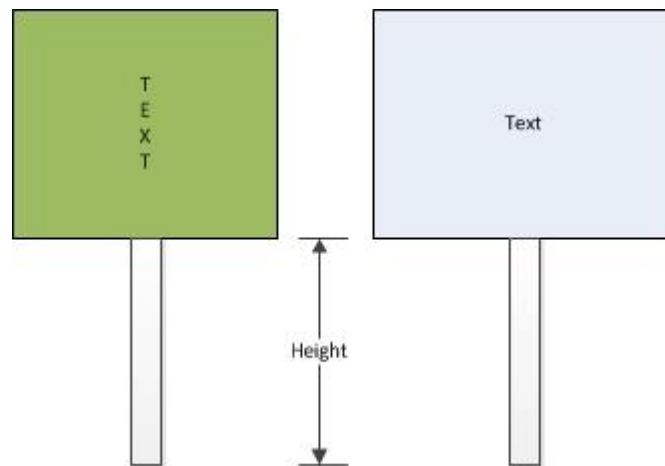
Figure D.4: Two Signs with vertical text (Horizontal = 0) on the left and horizontal text (Horizontal=1) on the right

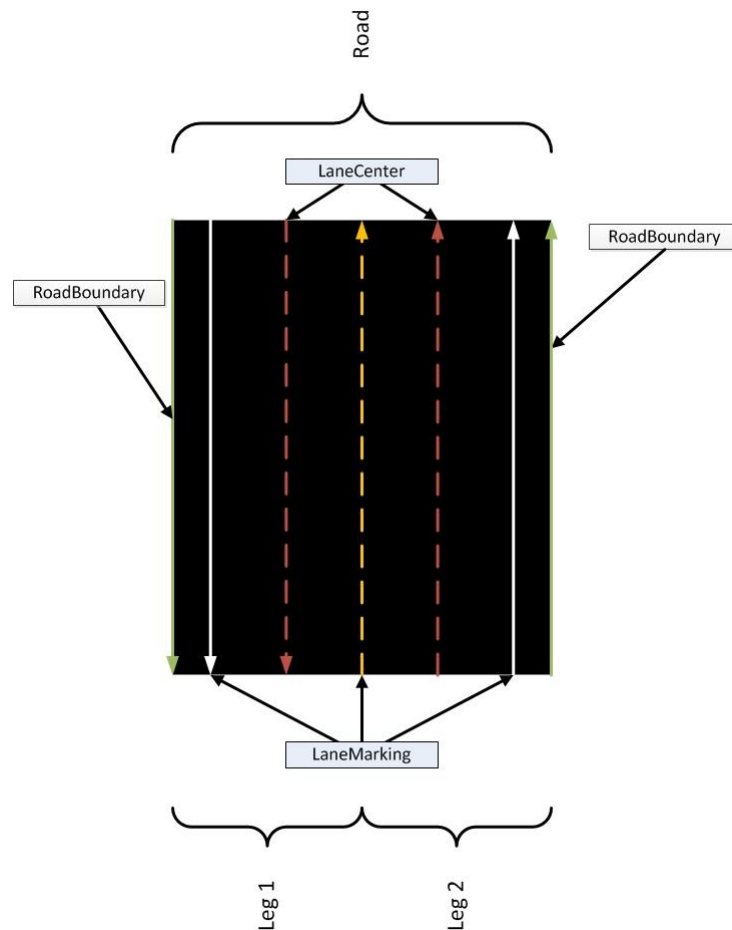
Figure D.5: Two-lane road

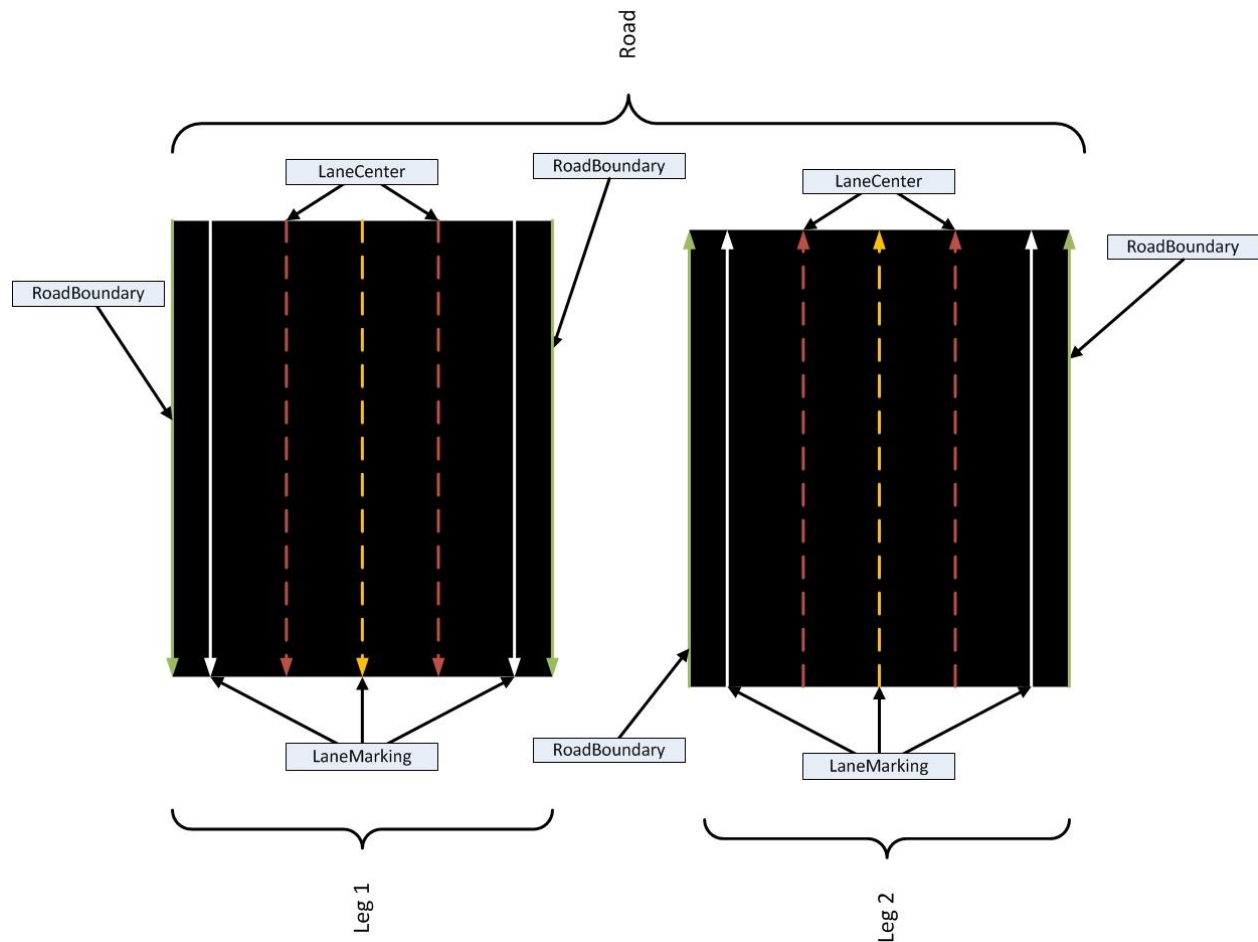
Figure D.6: Four-lane divided road

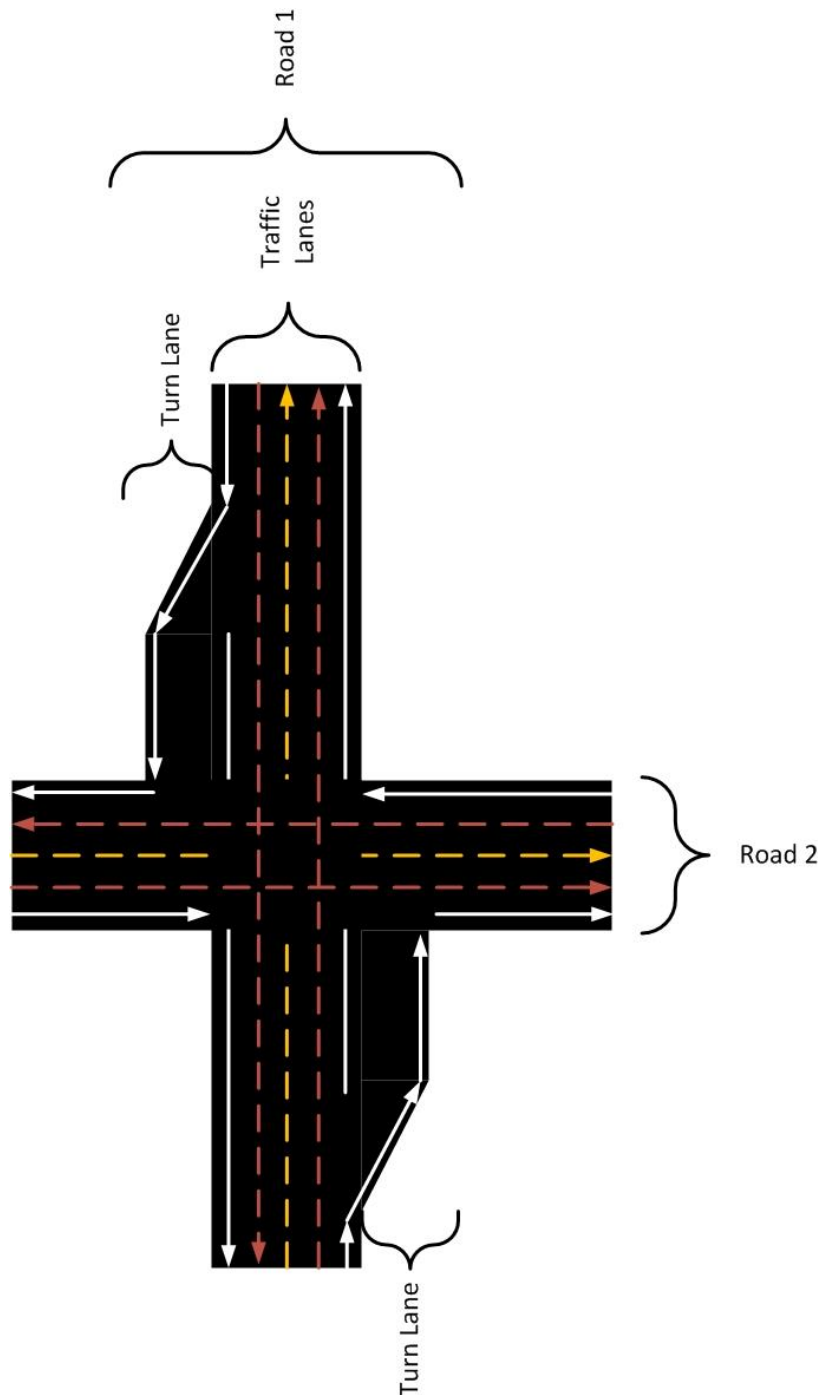
Figure D.7: An intersection of 2 two-lane roads

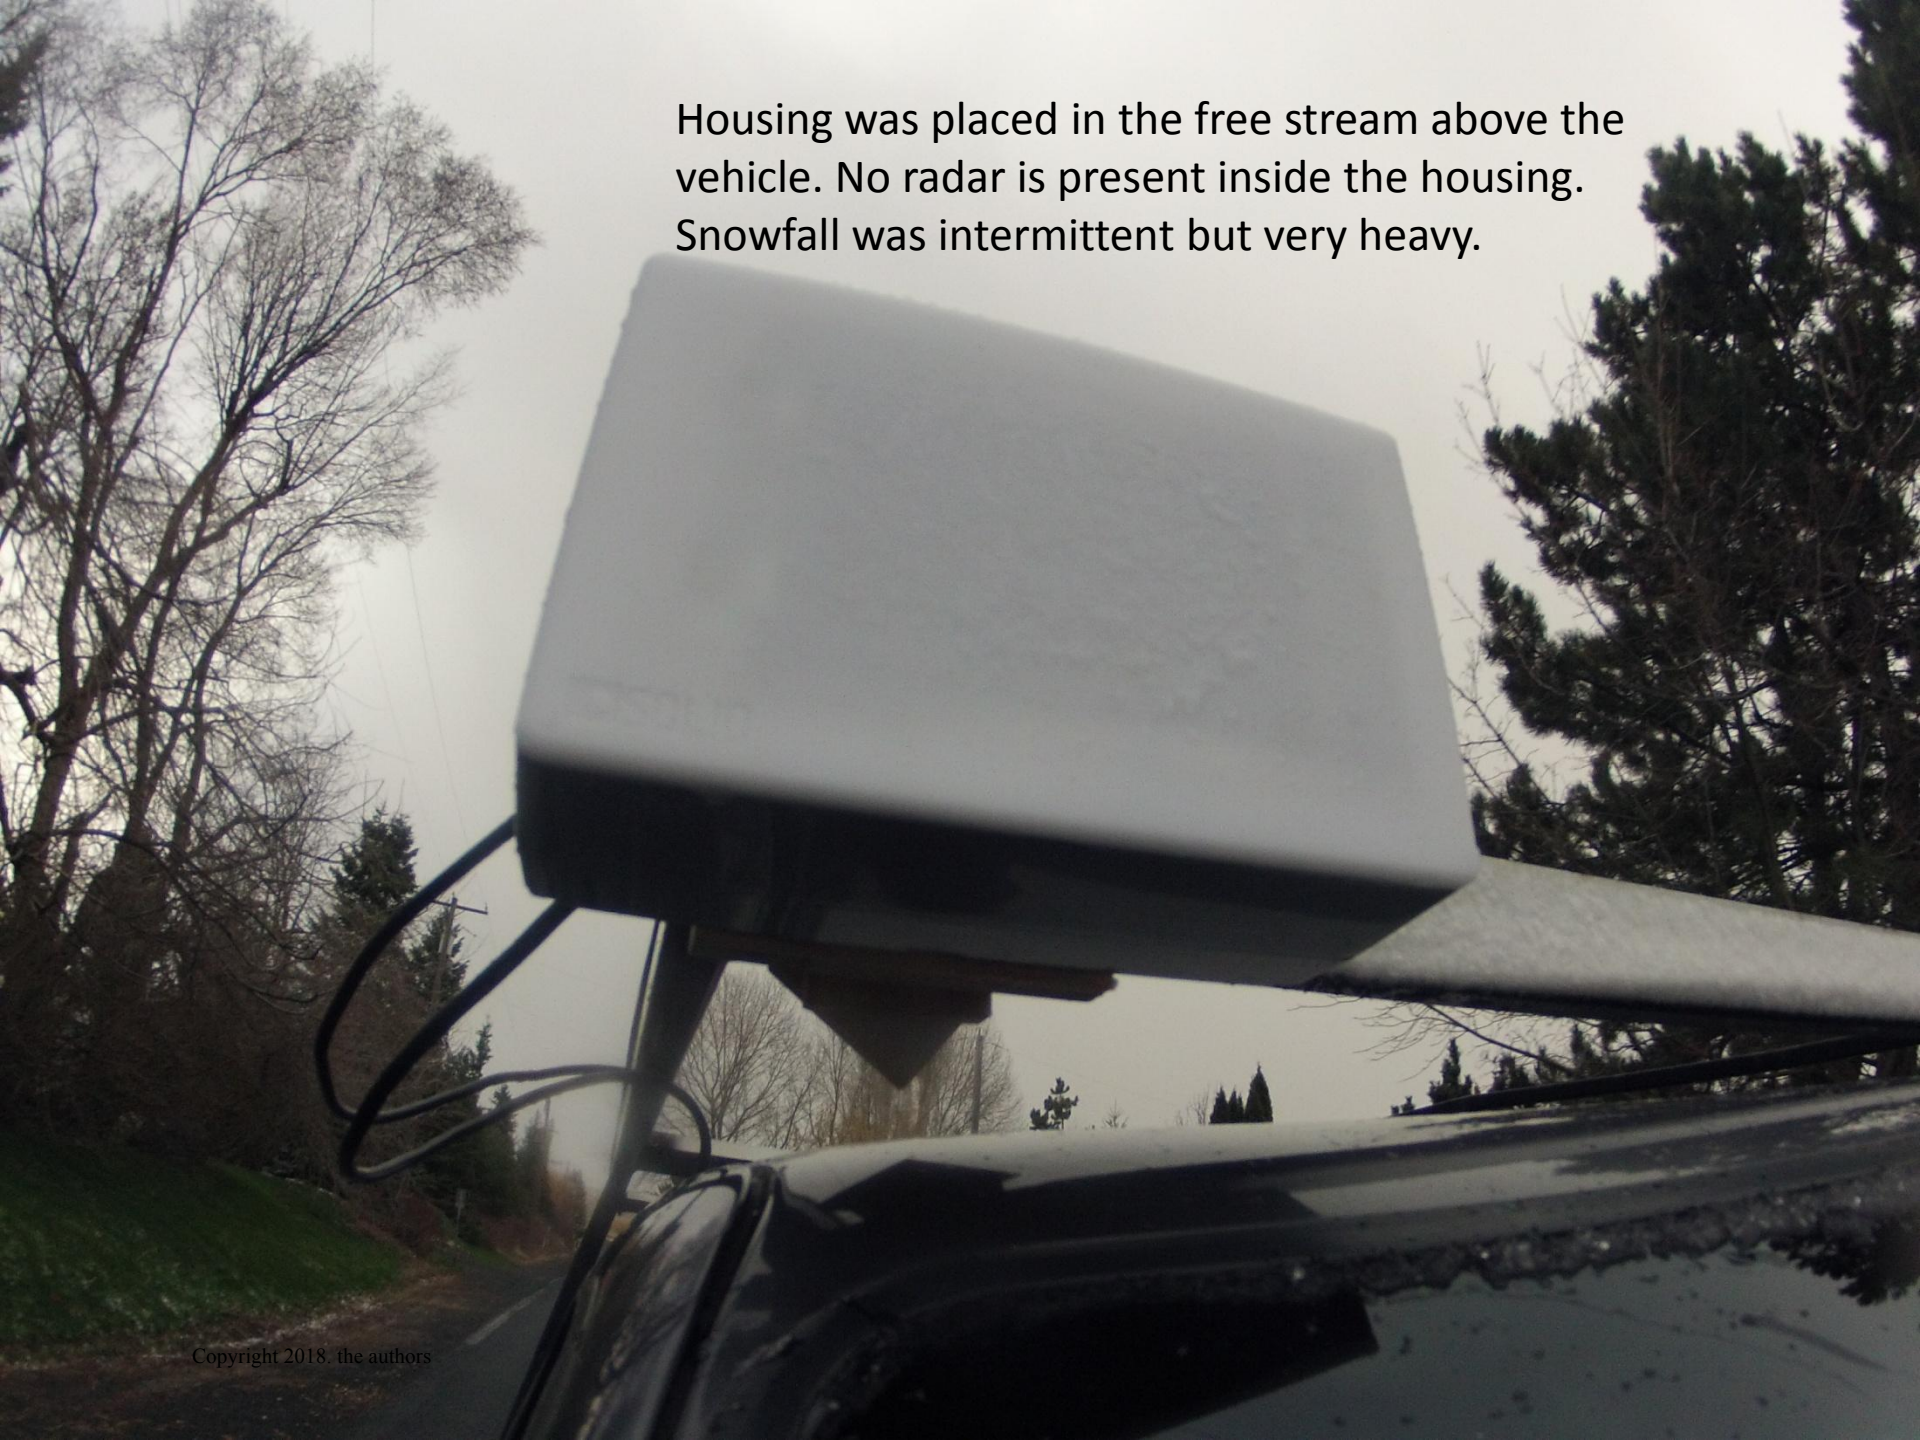
Wet snow collected on the unheated radar window

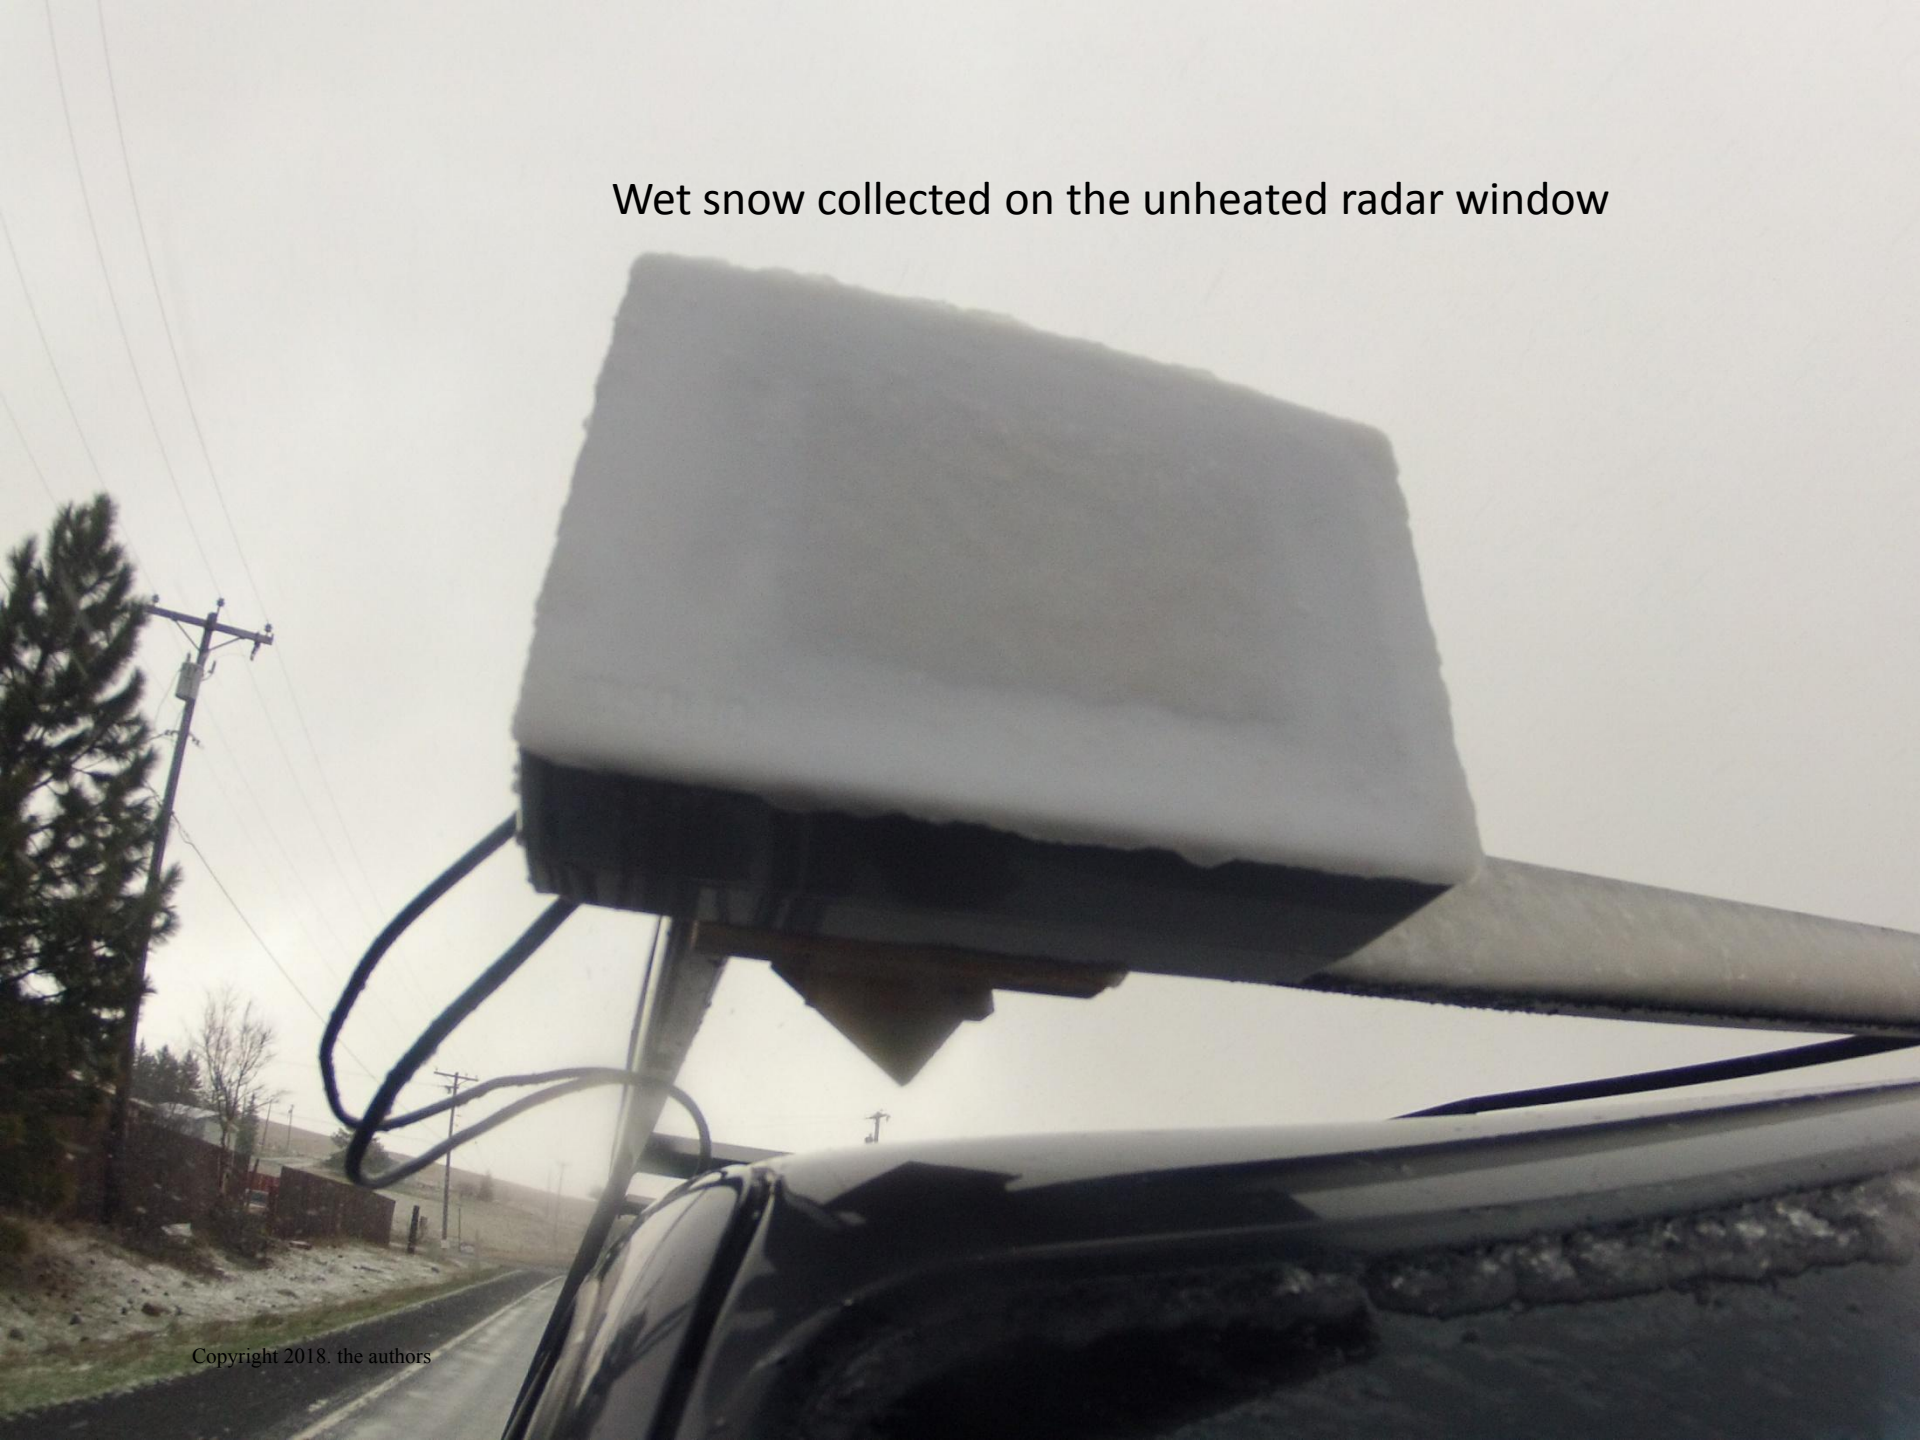
And eventually built up around the perimeter
