Evaluation of the University of Minnesota GPS Snowplow Driver Assistance System

Report Number: CA16-2167

AHMCT Research Report: UCD-ARR-15-08-30-01

August 30, 2015

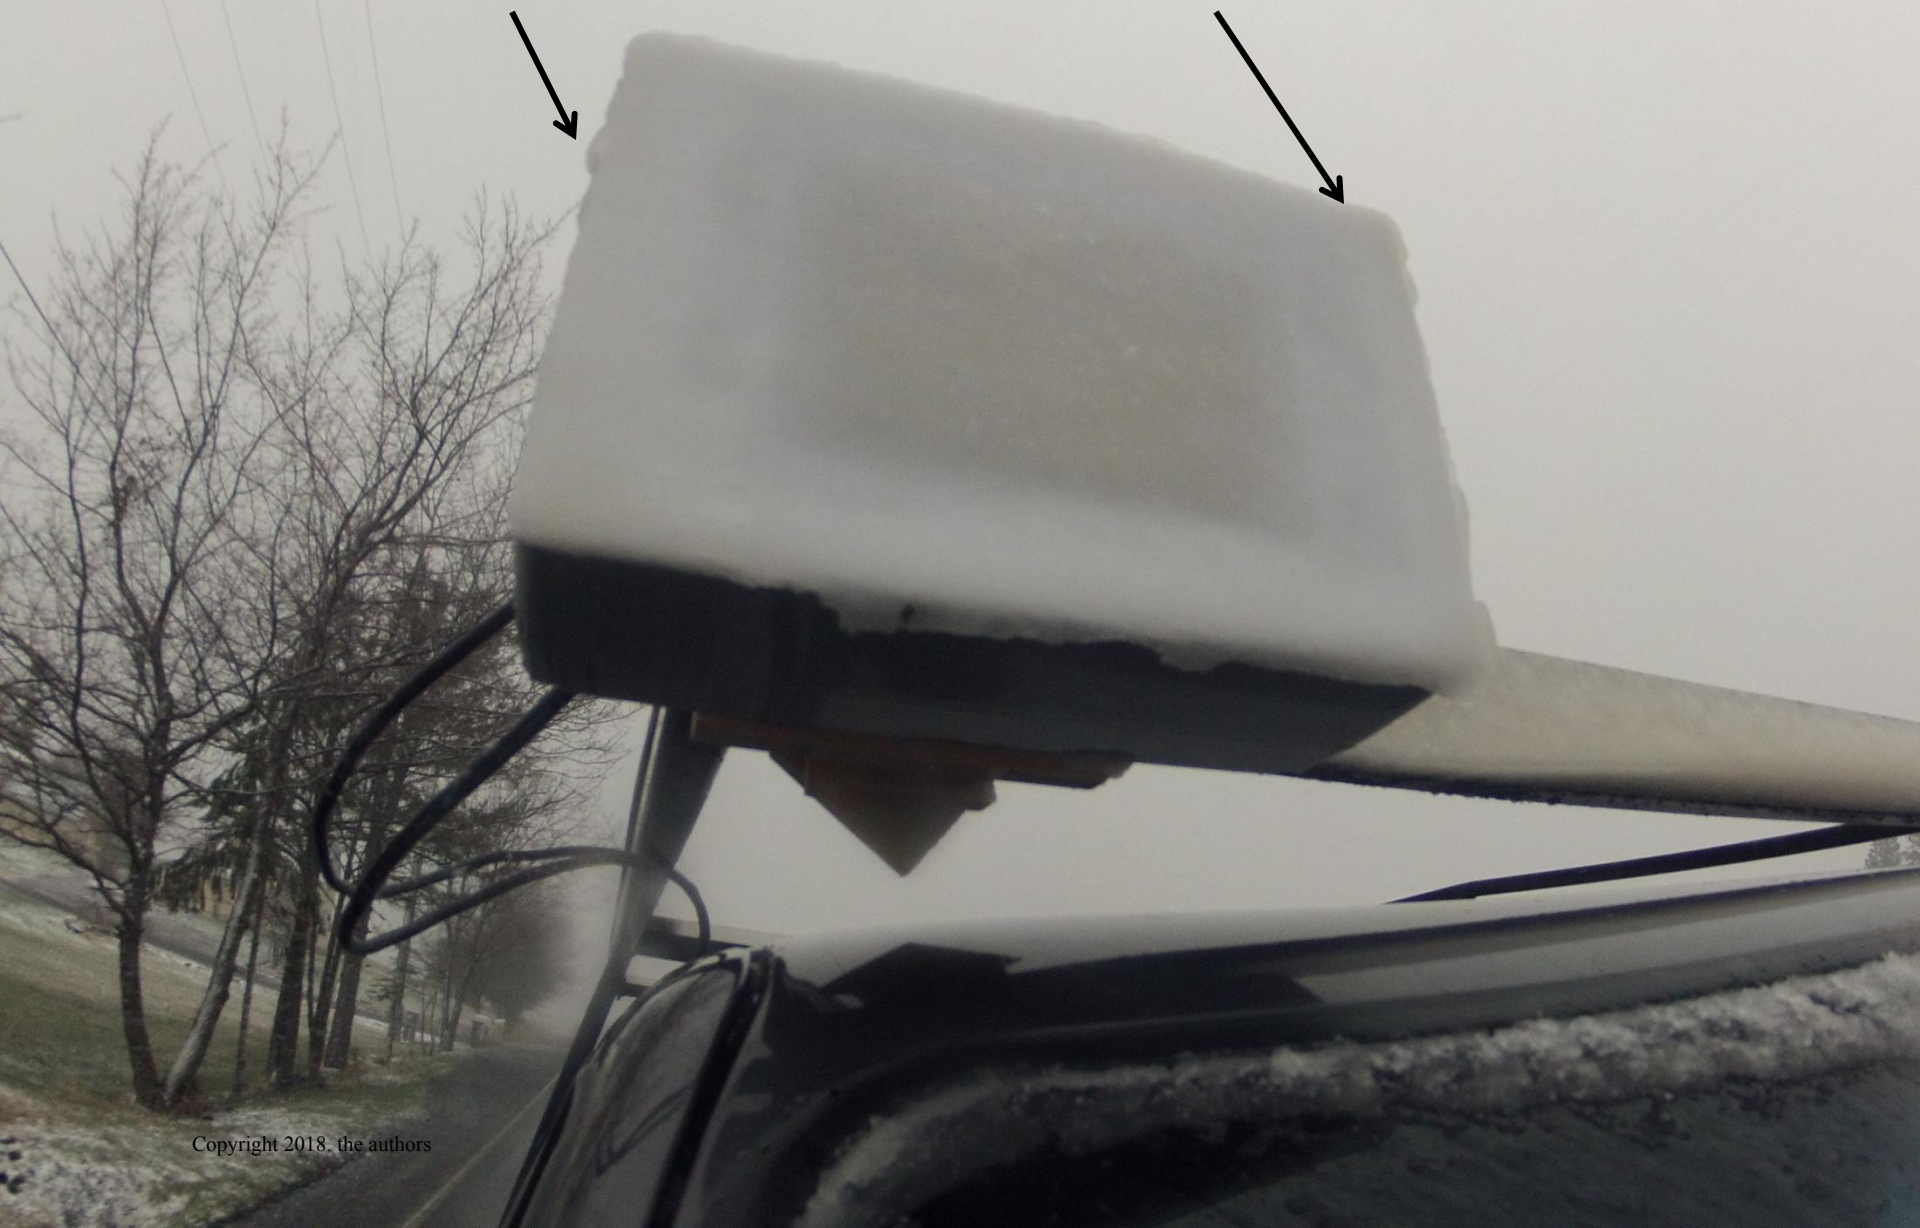
The thermoblock catches up and breaks the bridge

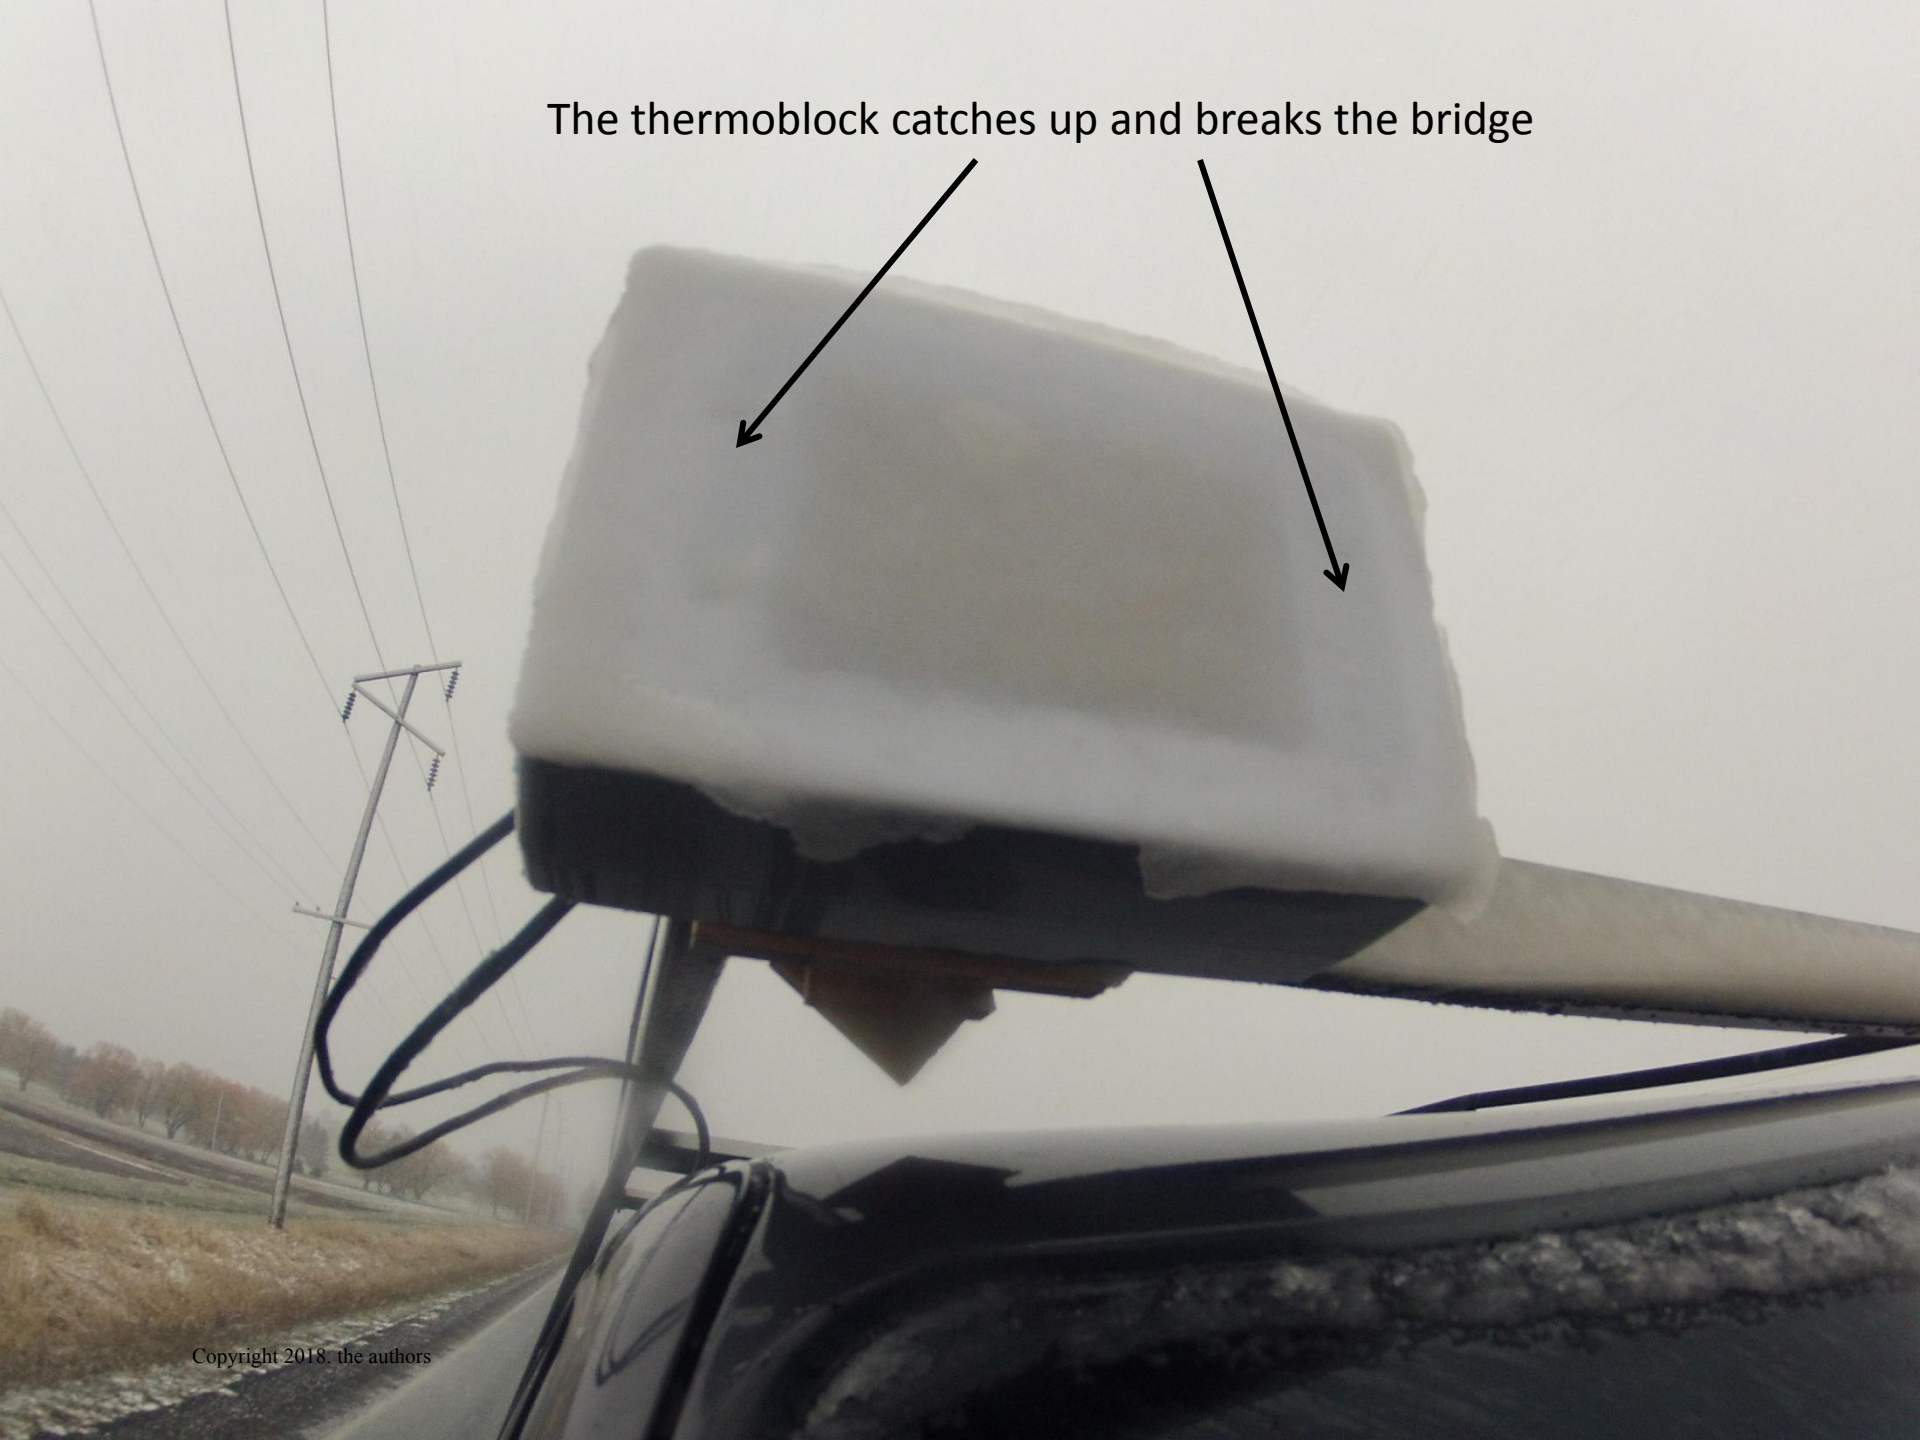
Allowing the perimeter buildup to break away

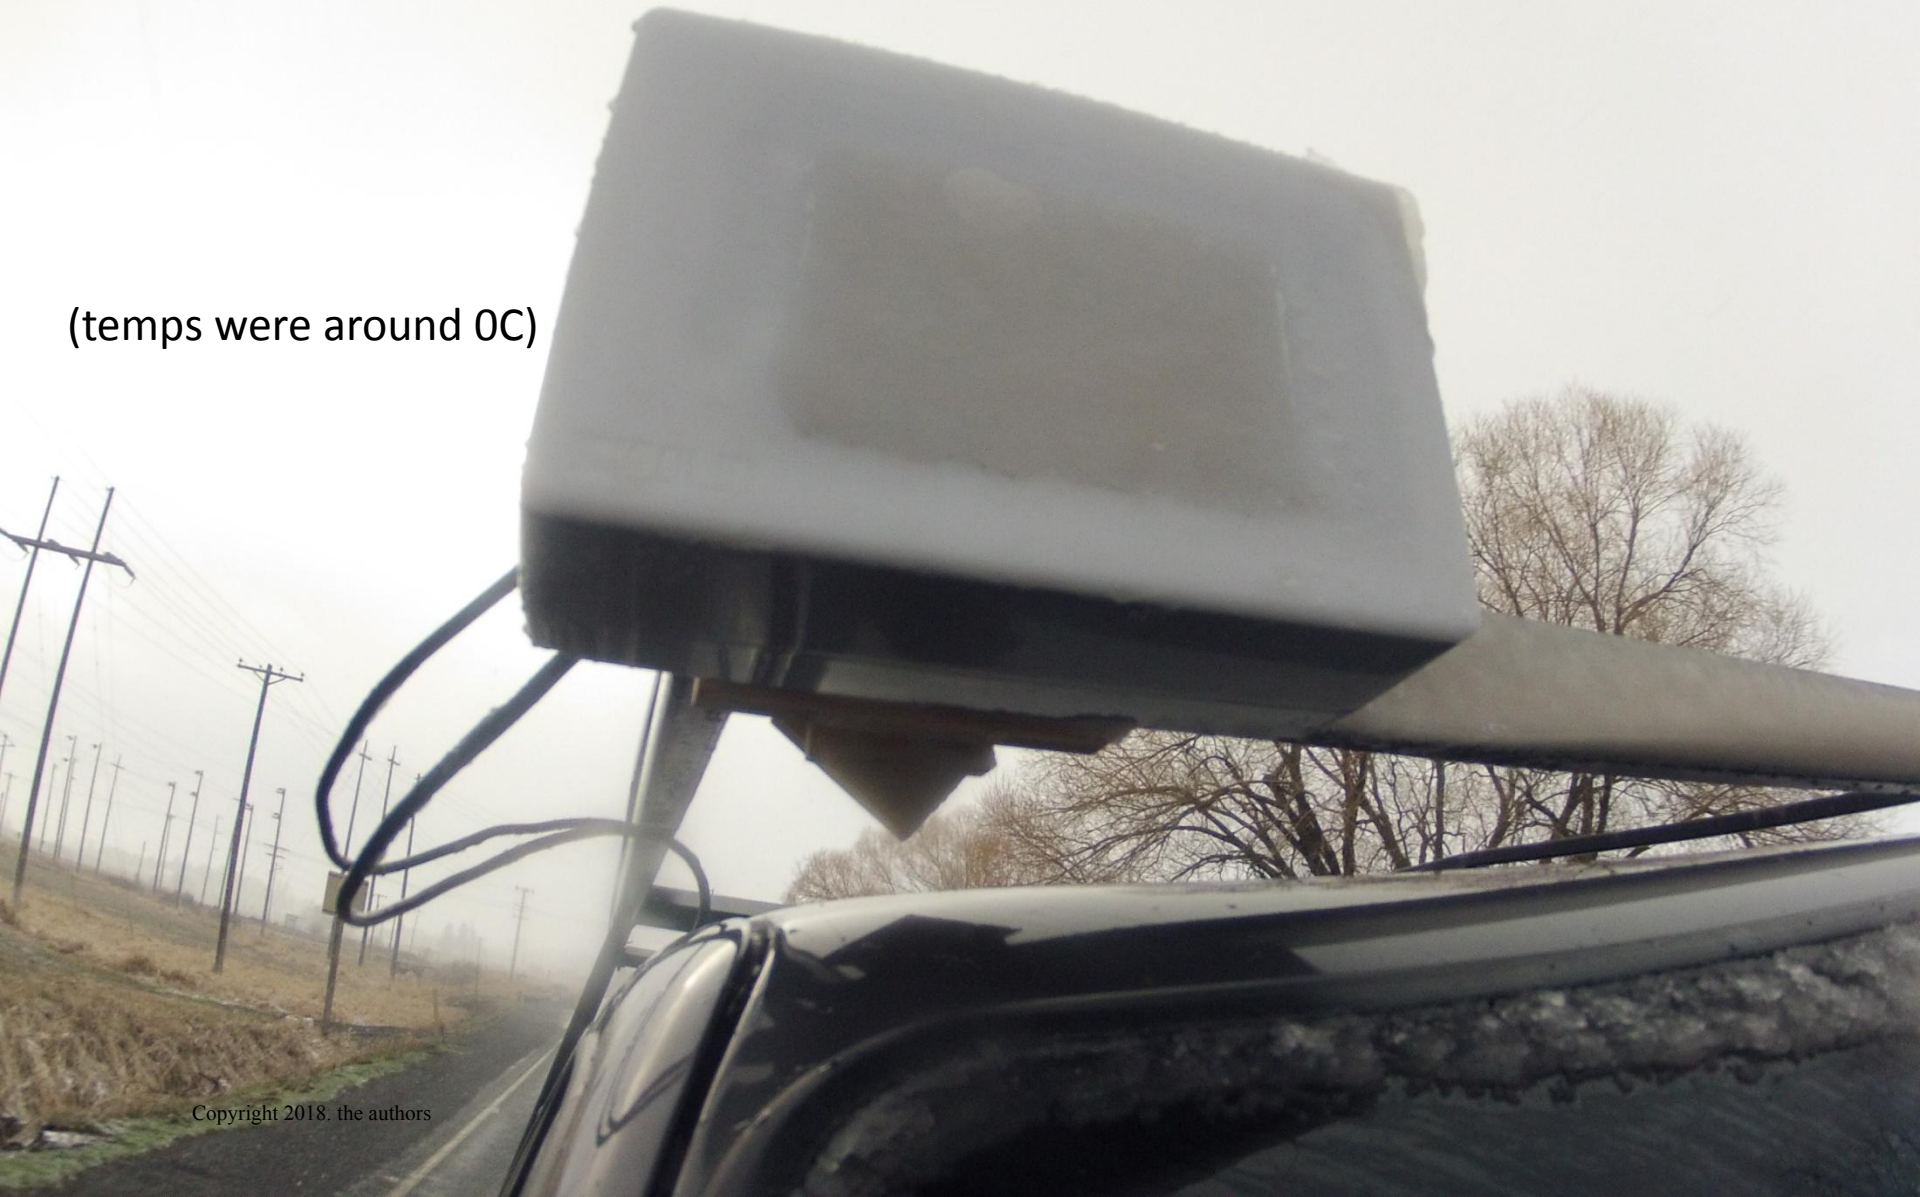
As the internal housing temp builds, the interface liquifies and the snow patch begins to descend

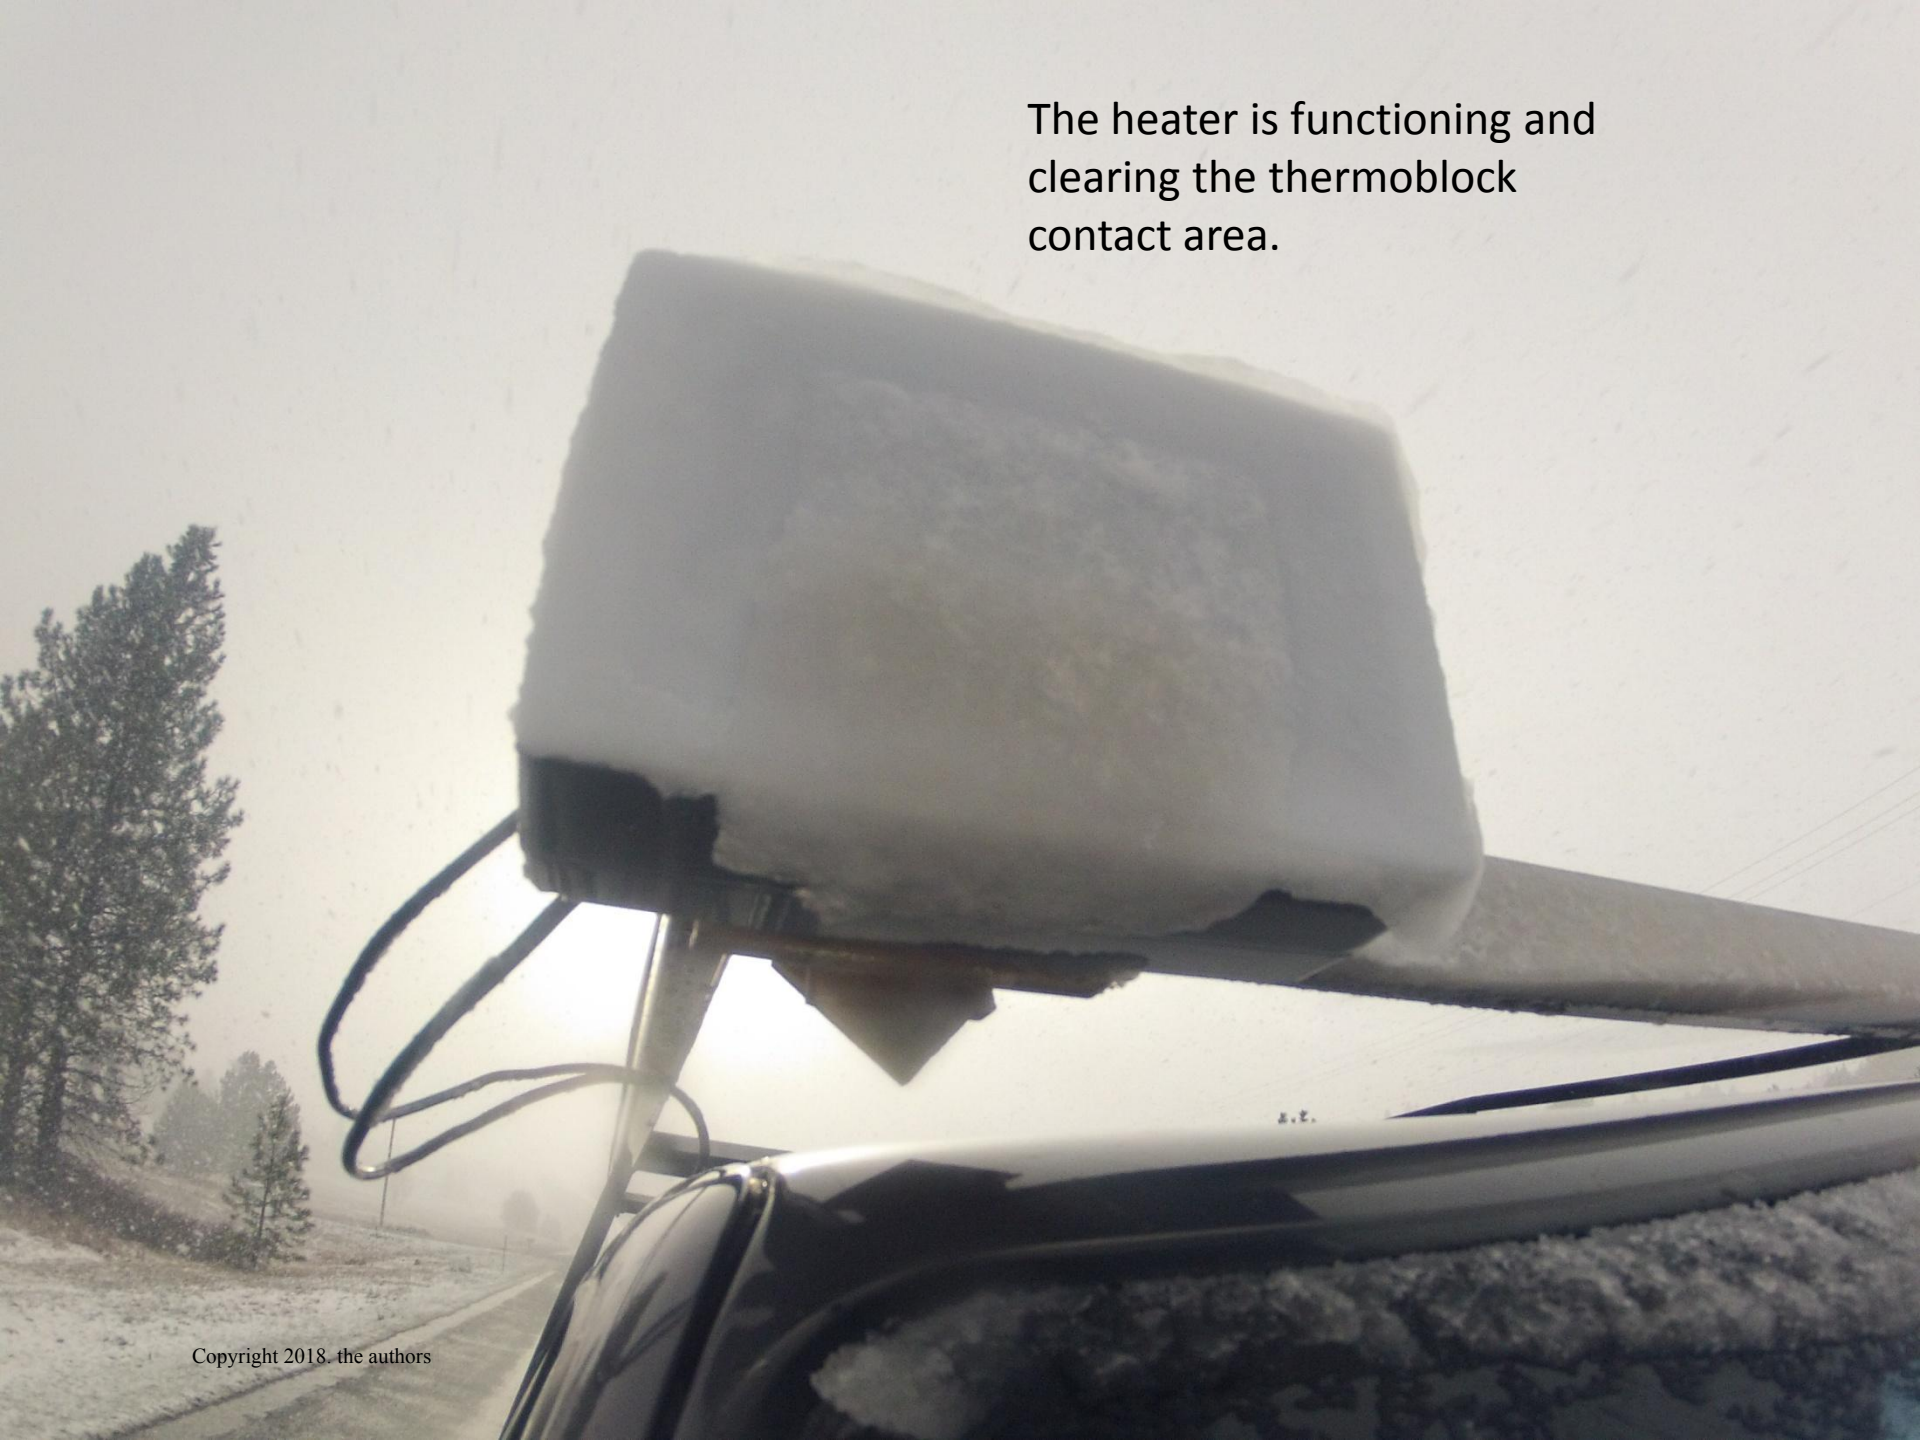
But buildup tends to “hang on” to the face and wants to create bridges.

- High moisture snow has exceptional ability to bridge the heated and unheated areas of the housing.
- Hard to generalize but icing likely starts with a “patch” in front of the radar which starts the bridging process.
- The radome material is exhibiting very low hydrophobicity and does not shed frozen material quickly.
