1. REPORT NUMBER CA20-2970	2. GOVERNMENT ASSOCIATION NUMBER N/A	3. RECIPIENT'S CATALOG NUMBER N/A
4. TITLE AND SUBTITLE Vision-Based Sensor System for Site Monitoring: Wrong-Way Driving, Phase 1		5. REPORT DATE June 5, 2020

6. PERFORMING ORGANIZATION CODE AHMCT Research Center, UC Davis
7. AUTHOR Ty A. Lasky, Kin Yen, Stephen Donecker, Wil White, Duane Bennett, Travis Swanston, and Bahram Ravani		8. PERFORMING ORGANIZATION REPORT NO. UCD-ARR-19-09-30-03

11. CONTRACT OR GRANT NUMBER IA65A0560, Task 2970
12. SPONSORING AGENCY AND ADDRESS California Department of Transportation P.O. Box 942873, MS #83 Sacramento, CA 94273-0001		13. TYPE OF REPORT AND PERIOD COVERED Final Report October 2015 – September 2019

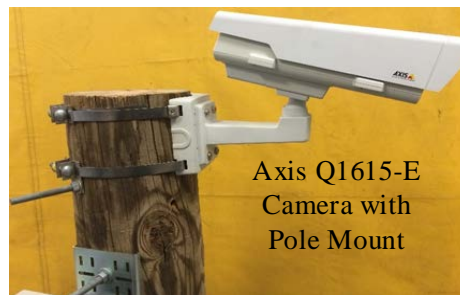
Figure 2.2: The WWD VBSM system component details

In developing the VBSM system, one objective was to maximize the use of commercial off-the-shelf (COTS) hardware and software in order to maximize its potential future use by Caltrans and other DOTs. With the minor exception of site-specific mounting hardware and a small amount of custom scripting/glue software, this goal was completely achieved. In addition, the system had to be rugged in order to survive deployment in the field for the duration of the research study. All components were selected with this in mind. However, some components did need replacement in the field as discussed in the reliability section of Chapter 3. The system block diagram is provided in Figure 2.1. The system component details are shown in Figure 2.2. An example system installation is shown in Figure 2.3.

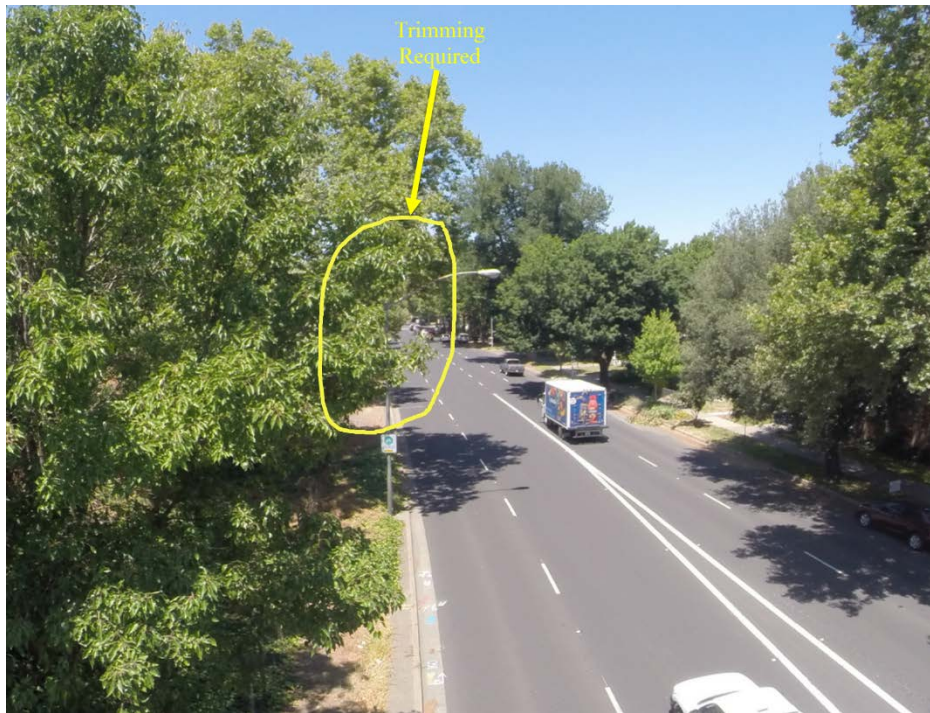
Figure 3.2: Example of tree trimming required to provide better camera FOV (US 50 WB 10th St exit)

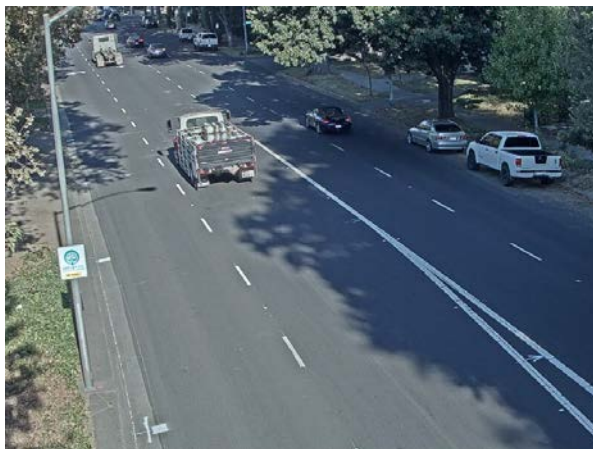
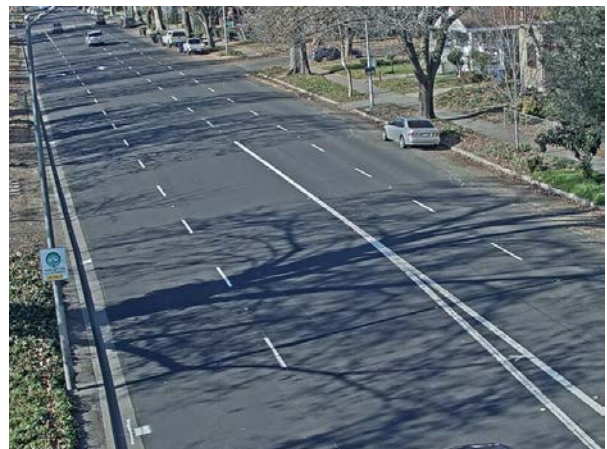
US 50 WB 10th St exit before tree trimming

US 50 WB 10th St exit after tree trimming
(12/21/2016)

Figure 3.3: US 50 WB 10th St camera view before and after tree trimming

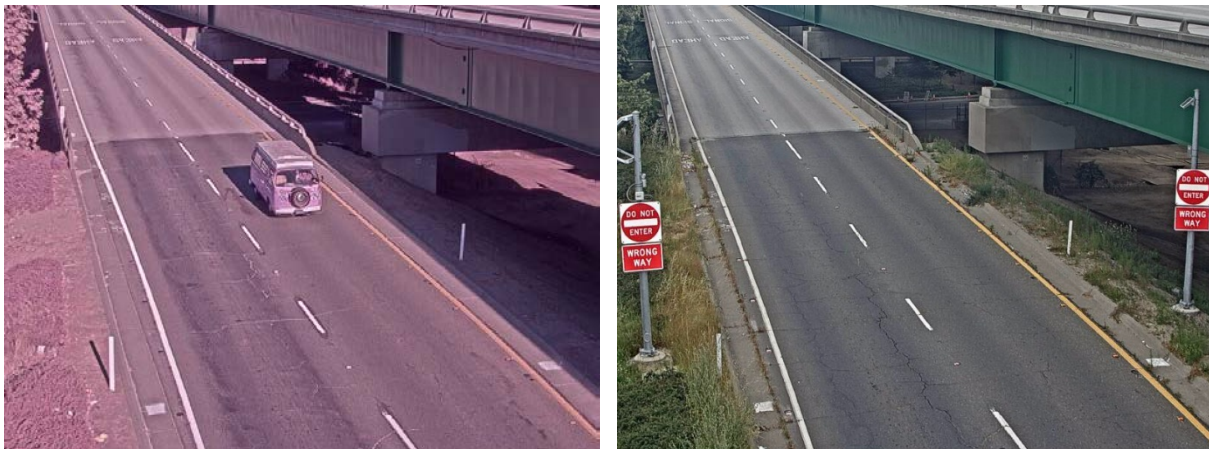
Figure 3.8: Illustration of the IR filter failure. The left image was taken before the camera replacement. The right image was taken after the camera replacement.

One Axis Q1615-E camera had internal failure which eliminated the built-in infrared (IR) filter causing a red tone in the image and video as shown in Figure 3.8. The failure occurred right after the field installation. The camera was repaired under warranty.

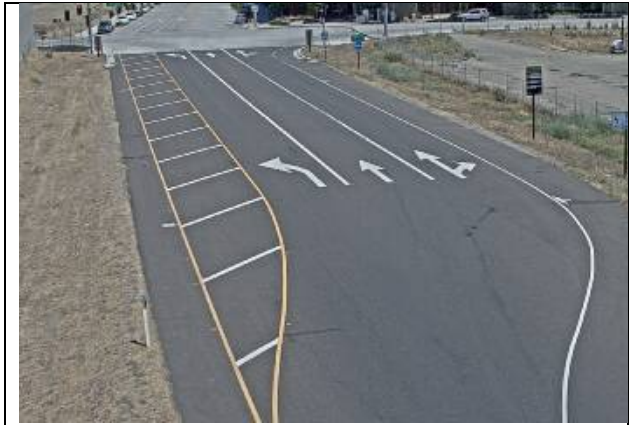
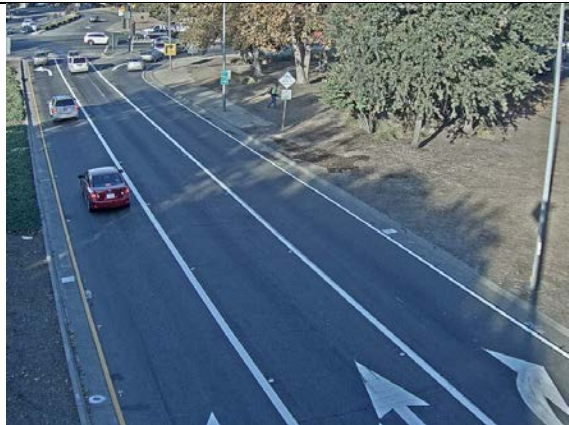
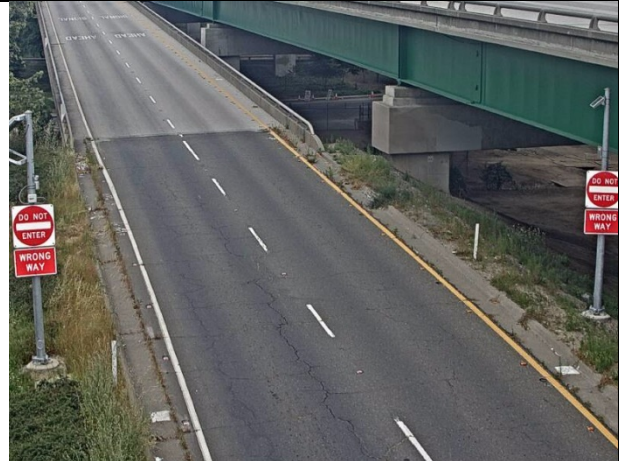
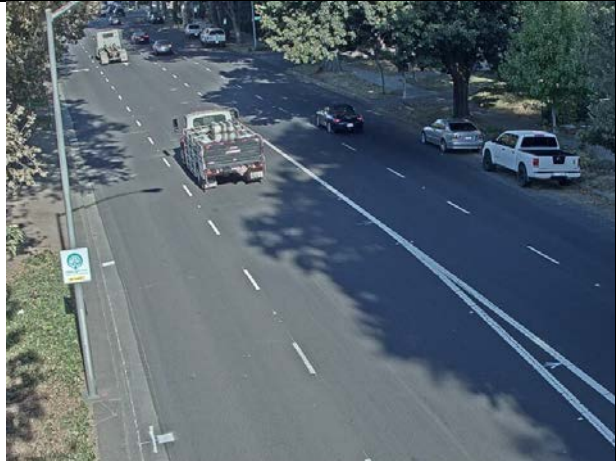
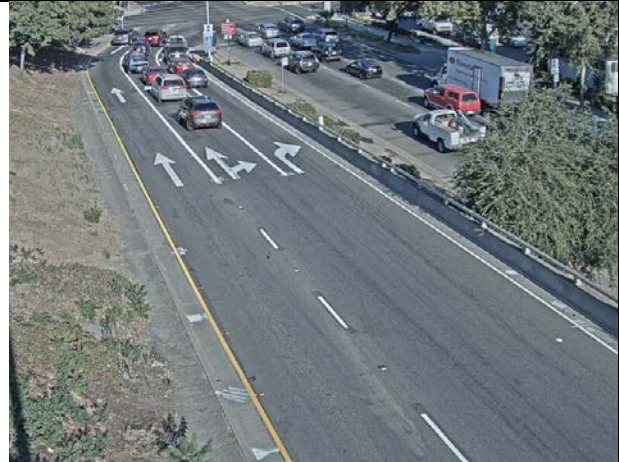
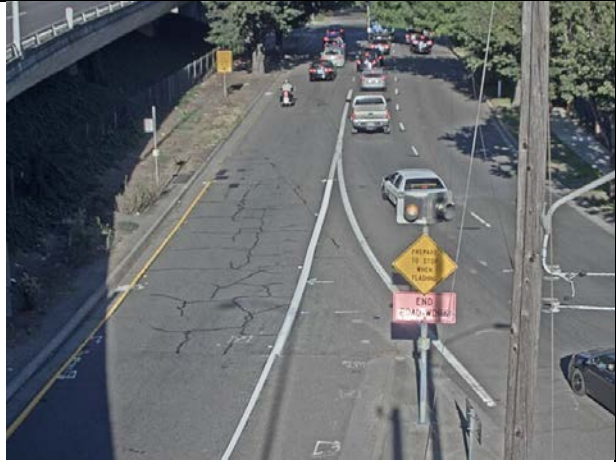
Figure 4.1: Camera view of the six mitigated Sacramento area exit ramps subject to WWD monitoring

The site monitoring results reported herein cover a 39-month period from June 5, 2016 (the date of the first site installation in Sacramento in Caltrans District 3) through August 31, 2019. Any data received outside this period is not included in the analysis. As shown in Table 1.1, the Sacramento site installations occurred from June 5, 2016 through August 21, 2016, i.e. over nearly three months, so the duration of monitoring varies a small amount by site. Both installations in San Diego were completed on December 13, 2017, resulting in a shorter monitoring duration, which may partly explain the low number of detections for these sites. Figures 4.1-4.3 provide a view of the twelve exit ramps subject to WWD monitoring. Figure 4.1 presents the Sacramento area mitigated exit ramps. Figure 4.2 presents the Sacramento area non-mitigated exit ramps. Figure 4.3 presents the San Diego area mitigated exit ramps.

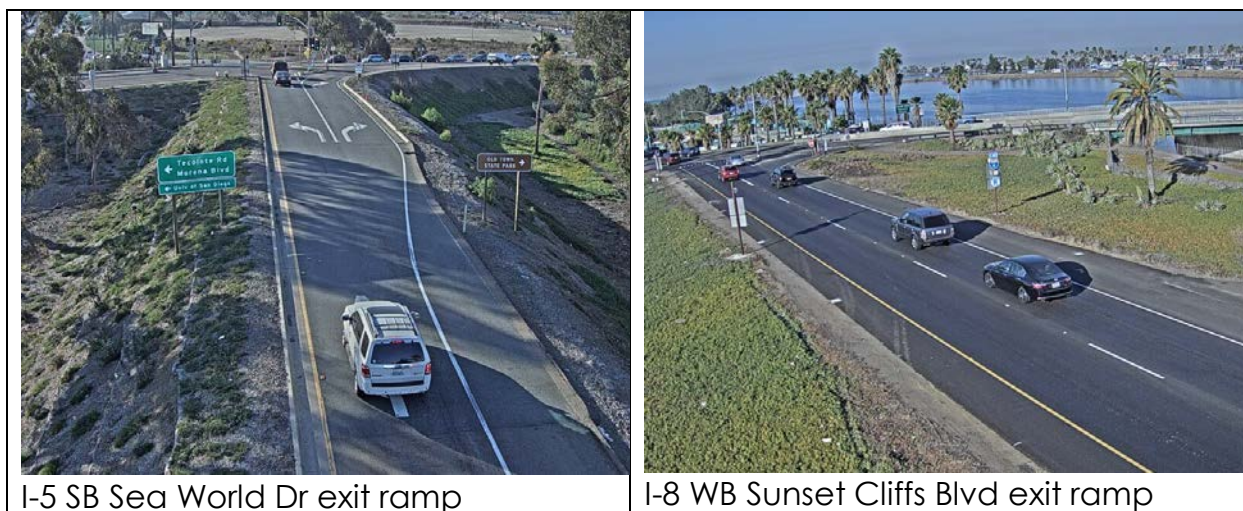
Figure 4.3: Camera view of the two mitigated San Diego area exit ramps subject to WWD monitoring

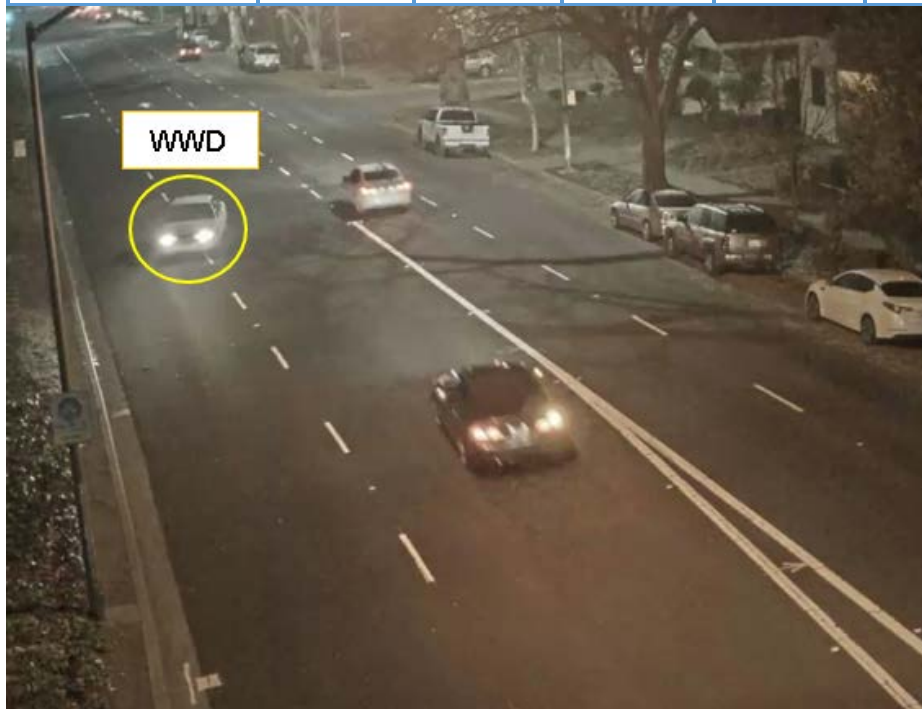
Figure 4.16: Wrong-way driver (circled in yellow) entering the exit ramp at WB US 50 at 10th Street. The driver continued onto the exit ramp despite at least five cars passing in the other (correct) direction.

- One WWD event occurred under poor visibility and rain conditions.
- In one WWD event, the driver appears to be under the influence based on the car's weaving during its approach to the exit ramp. In that case, the WWD driver passed five or more vehicles driving in the right direction and still proceeded wrong-way onto the exit ramp (see Figure 4.16).

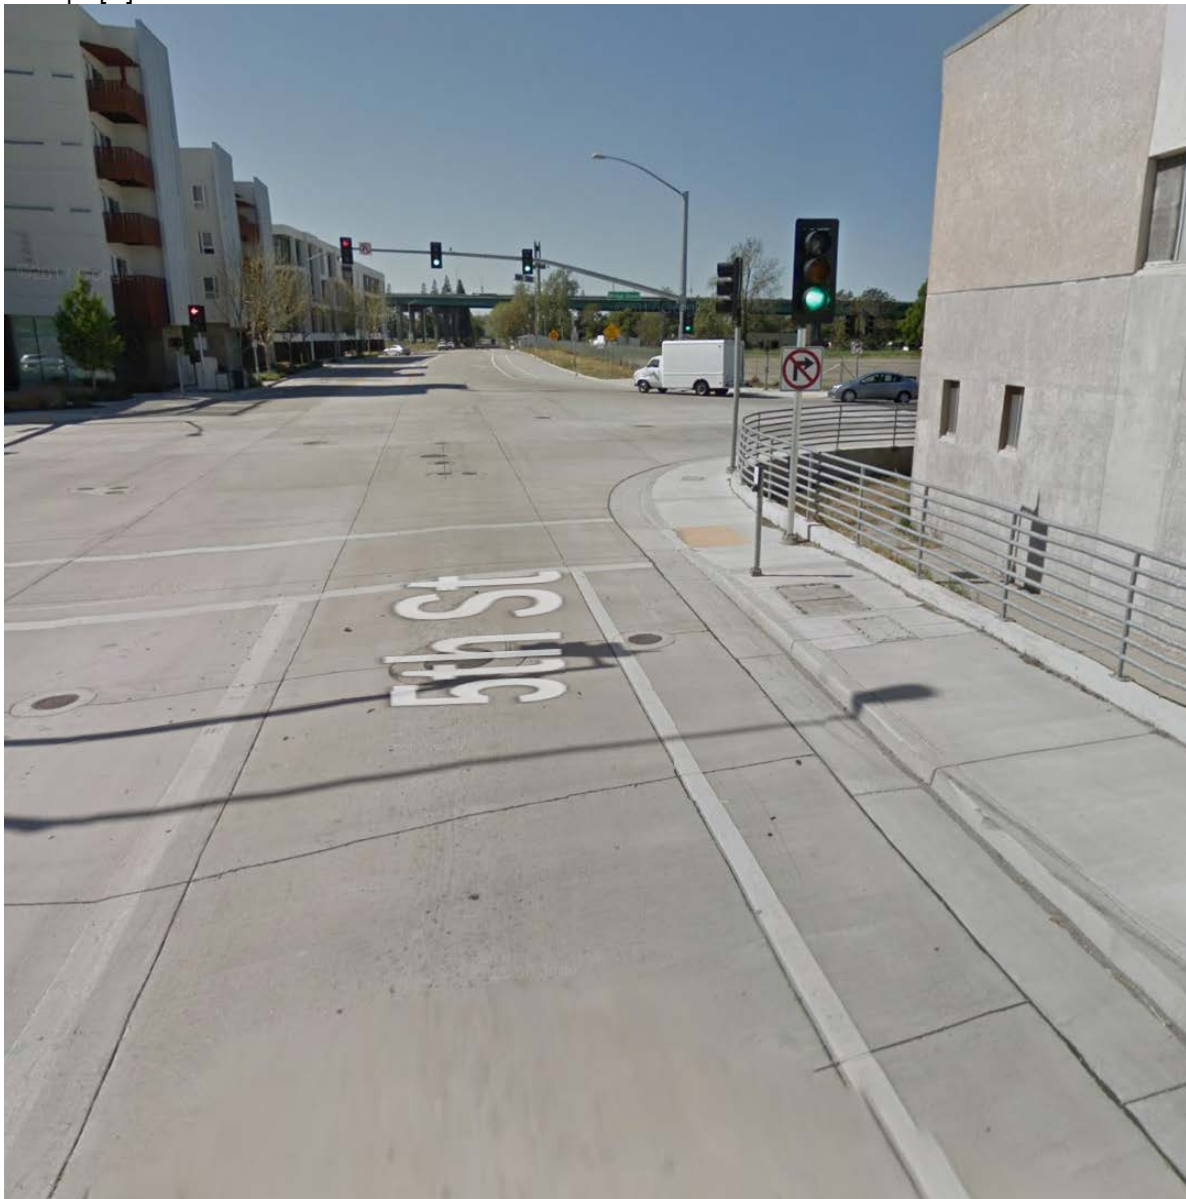
Figure 4.23: View of the approach from the north to the South River Road exit ramp. A right turn would lead to a WWD event. Image courtesy of Google Street View.

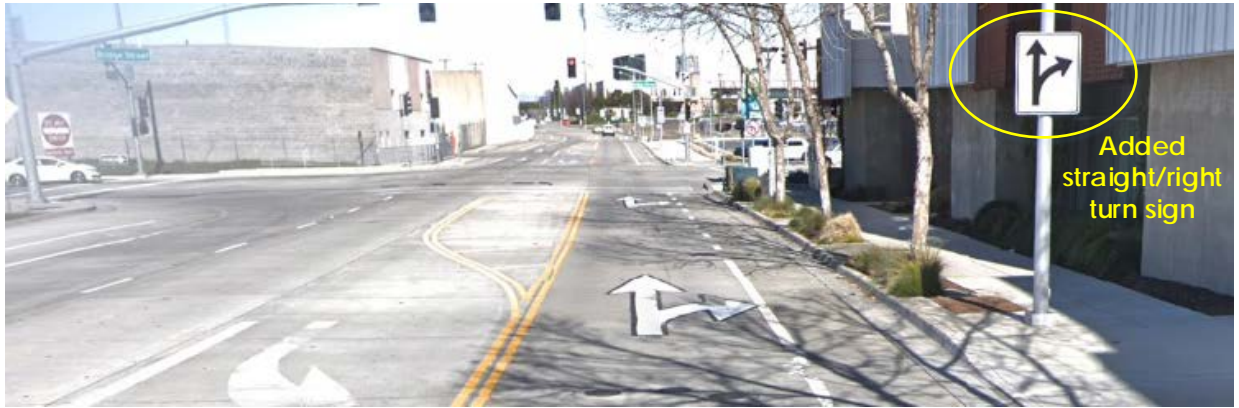
Figure 4.35: Caltrans' sign addition for northbound 5th Street on the south side of the intersection at the South River Road exit ramp. Image courtesy of Google Street View.

Following initial indications regarding the frequency of events for the South River Road exit ramp from this research, Caltrans assessed the location for possible remediation. Caltrans quickly developed a plan for sign installations, and issued a Sign Installation Order (SIO). This order included installation of two new signs on northbound 5th Street (straight/right signs, Figures 4.35 and 4.36), direction clarification sign (left turn, right turn, Figures 4.37) for westbound Bridge Street heading at the exit ramp, and, most important, four new signs on southbound 5th Street (straight/left, no right, straight, and left signs, Figures 4.38 and 4.39). These signs, particularly those on southbound 5th Street, should significantly reduce the likelihood of WWD events for this exit ramp. As with other similar exit ramps, there will still be occasional events. However, Caltrans has quickly responded to the identification of a potentially problematic exit ramp, and has provided new relevant signage to mitigate the situation. This illustrates a proactive response by Caltrans as pertinent WWD data were generated in this research. In locations where addition of mitigation signage will not be within Caltrans jurisdiction, Caltrans would need to work directly with the municipality which would have jurisdiction for the location.

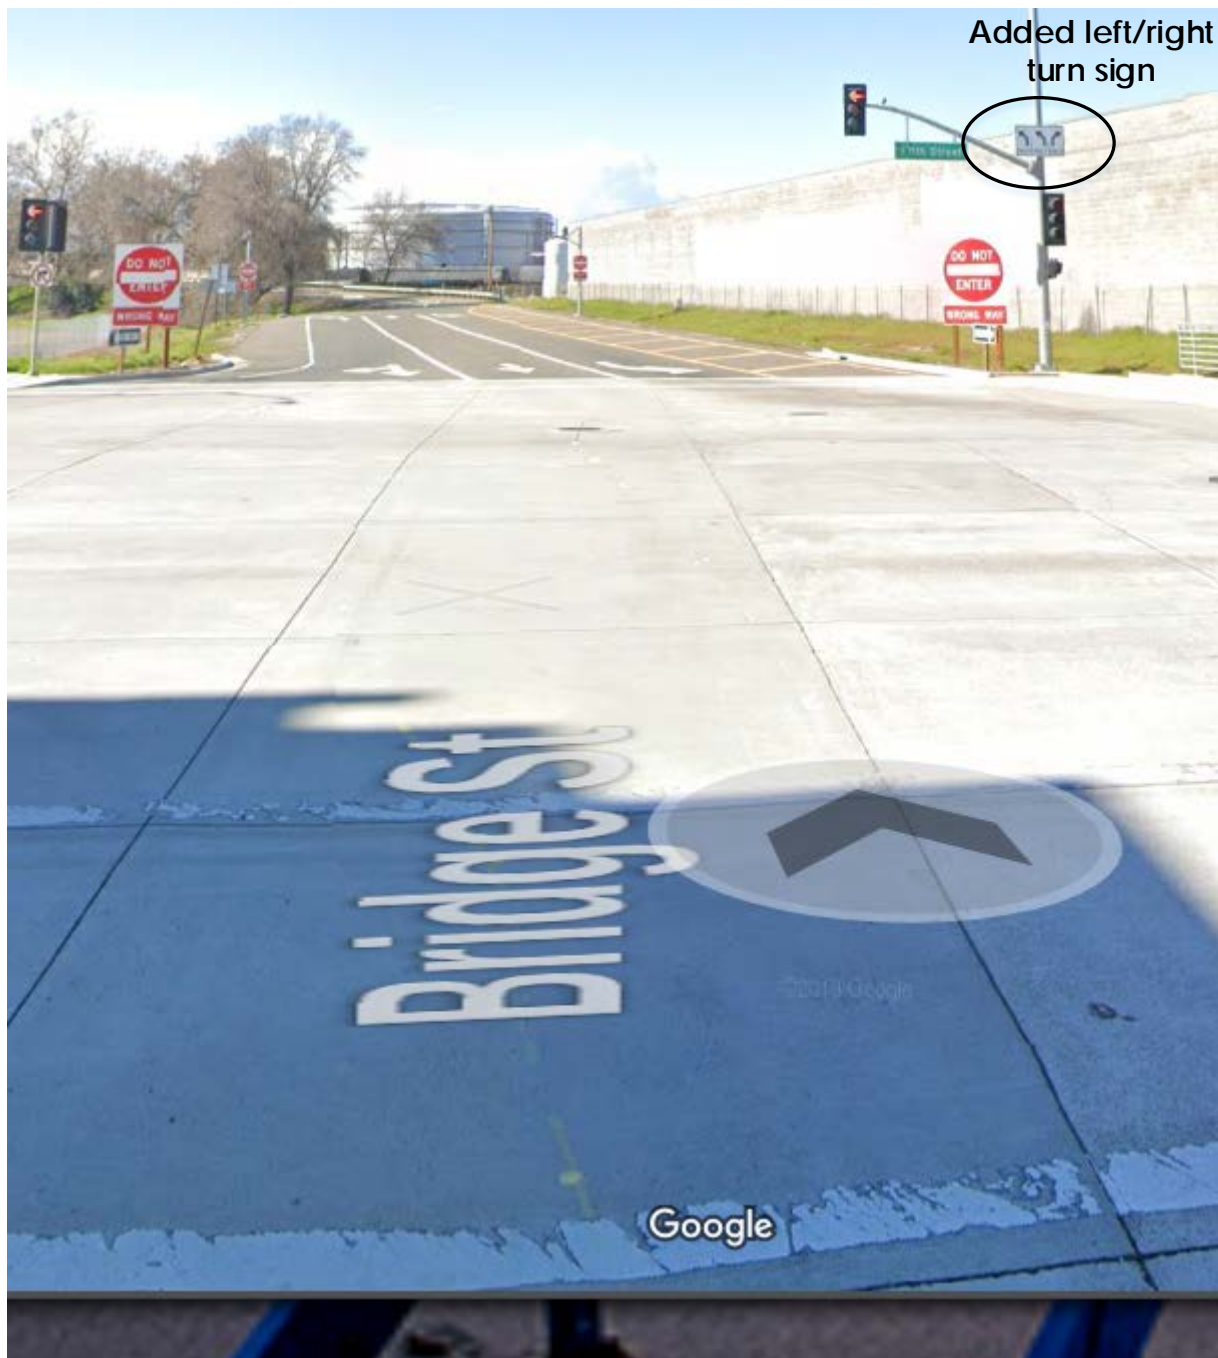
Figure 4.37: Caltrans' sign addition for westbound Bridge Street on the southwest side of the intersection at the South River Road exit ramp. Image courtesy of Google Street View.

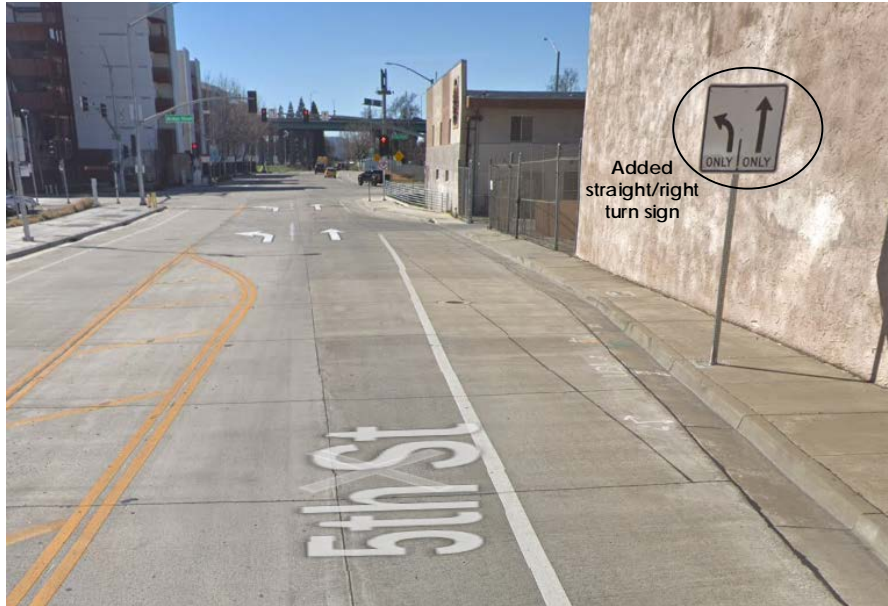
Figure 4.38: Caltrans' sign addition for southbound 5th Street on the north side of the intersection at the South River Road exit ramp. Image courtesy of Google Street View.

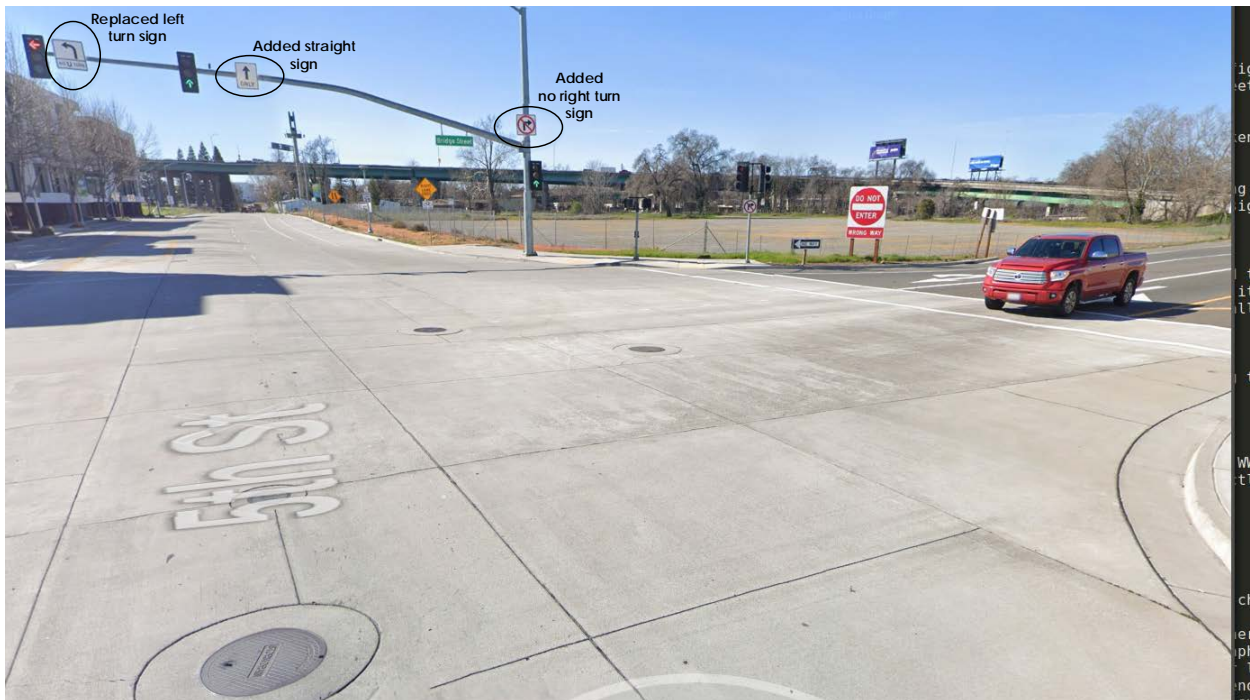
Figure 4.39: Caltrans' sign modifications and additions for southbound 5th Street on the south side of the intersection at the South River Road exit ramp. Image courtesy of Google Street View.

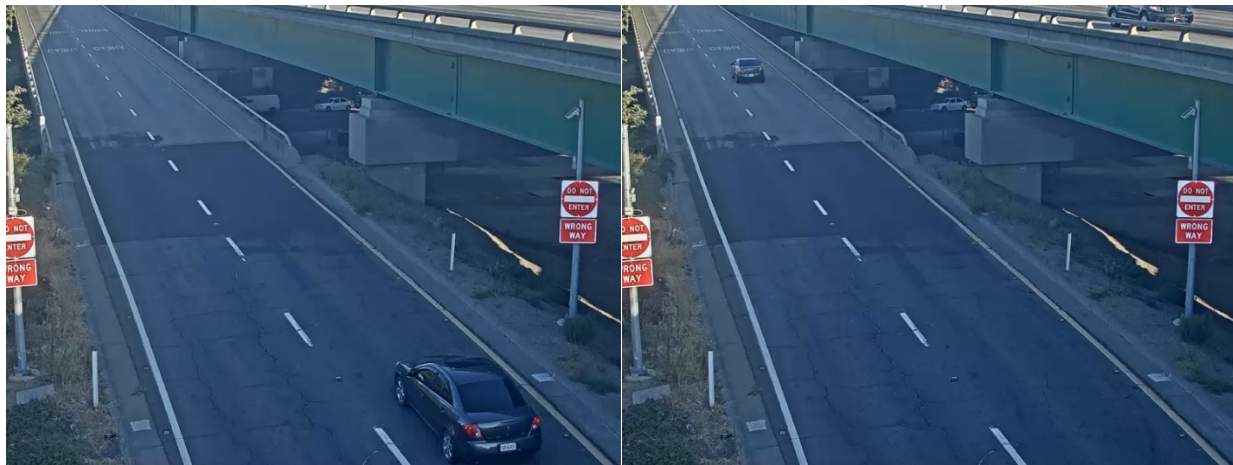
Figure 4.40: Early and late images of the vehicle entering the ramp for the WWD event of 8/18/2018 7:21 am on the 5th Street exit ramp

An early and late image of the vehicle entering the ramp for the uncorrected WWD event of 8/18/2018 7:21 am on the 5th Street exit ramp is shown in Figure 4.40. This vehicle's approach is difficult to determine due to the constrained camera location for this exit ramp. The approach could be from driving the wrong way on X Street, a one-way street. It could also be from a left turn from 5th Street or a right turn from 5th Street. Based on geometry, the right turn is the least likely option. Immediately before the WWD vehicle appeared in

the camera image, a right-way vehicle drove down the exit ramp and slowed and swerved to the right upon seeing the WWD vehicle approaching. Immediately before the WWD vehicle enters the camera image, the TAPCO flashing LED warning lights are clearly activated. The WWD vehicle moves slowly up the ramp and appears to pause at one location right after the TAPCO signs and after passing the other vehicle. However, the vehicle does proceed all the way up the ramp and does not slow down while passing the “Signal Ahead” pavement markings. Two other vehicles did emerge from the exit ramp, but the WWD vehicle did not re-emerge. Thus, this event was classified as driver-uncorrected. The researchers speculate, in this case, that the driver did realize the error, but possibly chose not to make a three-point turn on a narrow and typically busy exit ramp to correct. The actual resolution of the event beyond the three-minute video is unknown.

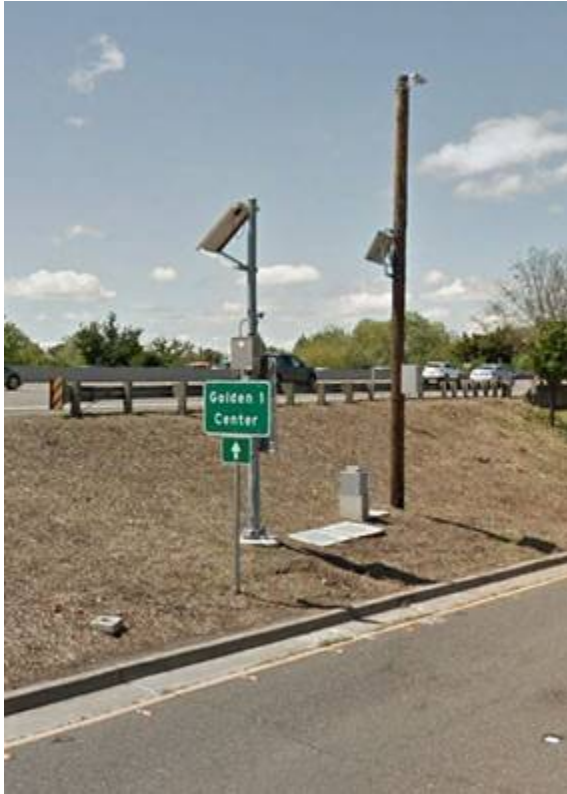
Figure 4.41: TAPCO radar sensor blocked by informational sign for the 16th Street exit ramp system. The AHMCT VBSM can be seen behind the TAPCO system.

field of view, but subsequently drive through the TAPCO zones, leading to a missed detection by the VBSM. AHMCT noted one case where a vehicle drove off-road and missed the exit ramp throat completely, but then drove through the TAPCO detection zones, on the 26th Street exit ramp. The discussion here was for the nominal AHMCT VBSM fields of view. As discussed in Chapter 3, the wooden mounting poles introduced twist, which caused the field of view for the VBSM to shift dramatically vs. the roadway. In these situations, WWD vehicles would drive up the exit ramp and would pass through what should have been the VBSM field of view, and the VBSM would not detect the vehicle due to the shifted field of view. Finally, there were some exit ramp-specific situations which reduced the normal effectiveness of either the VBSM or the TAPCO. For example, on the 16th Street exit ramp, an informational sign was installed in front of the TAPCO rear-facing radar, so it wasn't able to detect passing vehicles, and thus would not have sent any alerts to the TMC (see Figure 4.41). For future installation and maintenance of such systems, it would be essential to avoid these kinds of post-installation obstruction. A detailed breakdown of all COTS WWD events and the corresponding VBSM detection status is provided in Table 4.14.

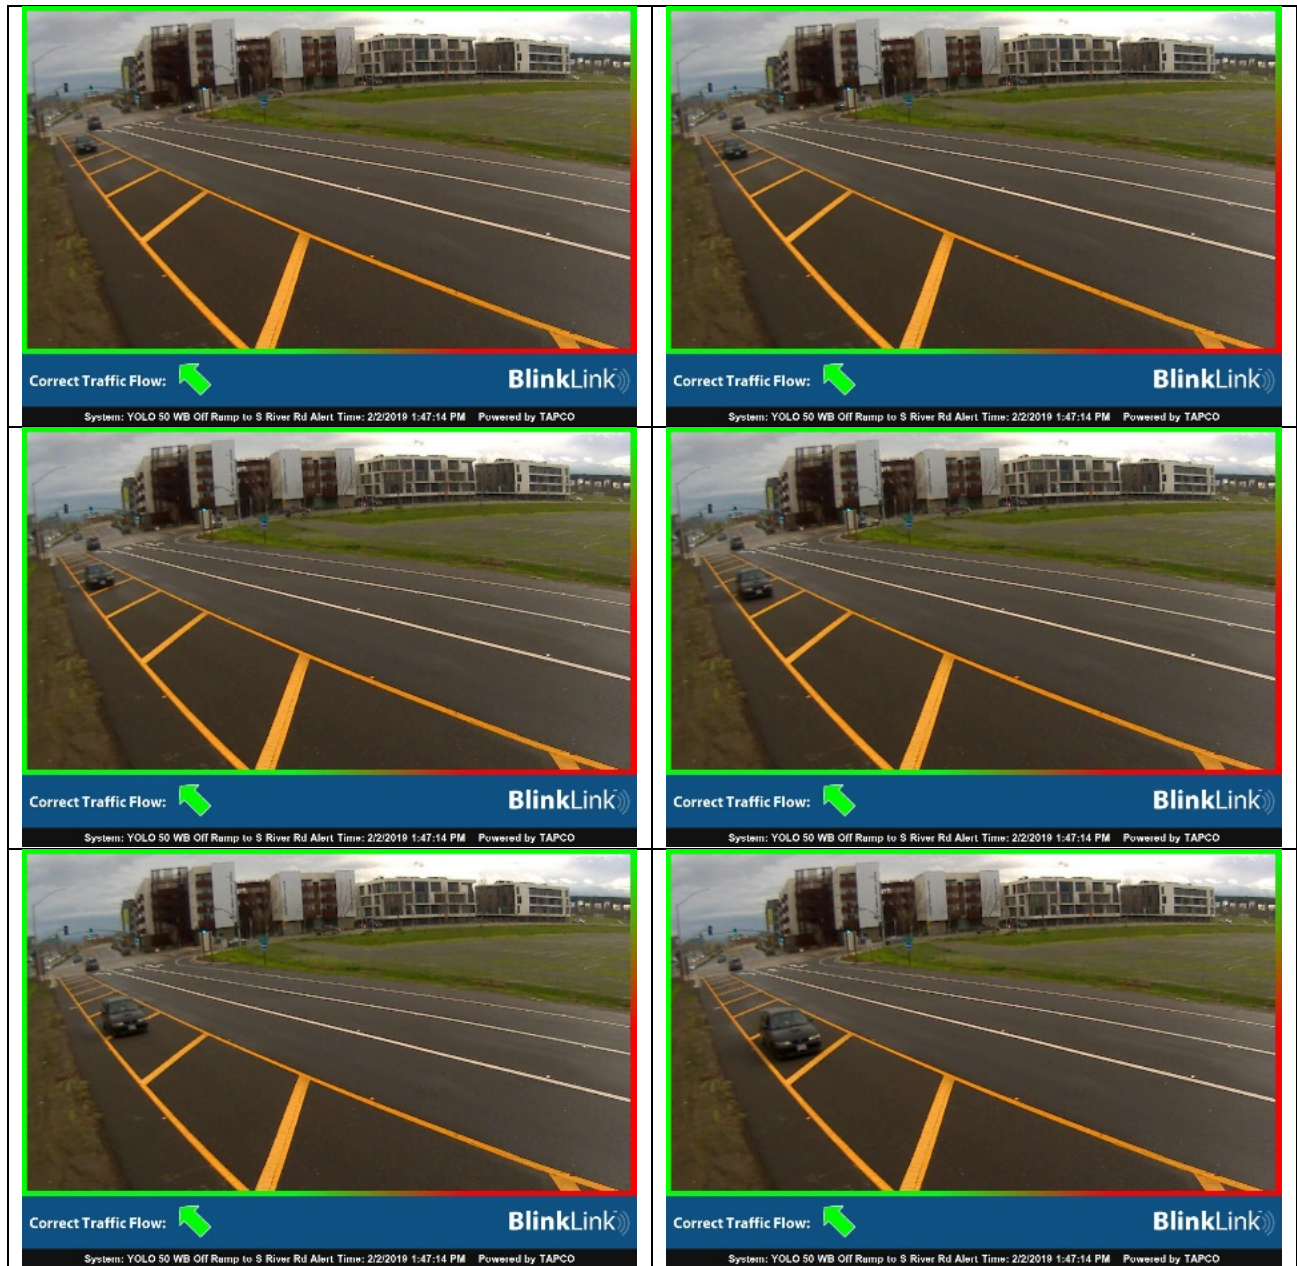
Figure 4.43: Photos (images 1 – 6 of 14) provided by TAPCO system for a typical WWD event. TAPCO provides 14-16 photos for a WWD event. Courtesy of TAPCO.

The two COTS warning systems are configured to provide one or more images in the case of a WWD alert. These images serve at least two purposes. First, a subset of the images is sent immediately to the TMC, which can help the TMC to determine whether the alert represents a genuine WWD event. This reduces the number of false responses. The images also provide an archival record of the WWD event for each issued alert. The TAPCO system provides 14-16 images for a WWD event, as shown in Figures 4.43 – 4.45, and archives these

images and other WWD event and system information on its BlinkLink site.⁵ The older generation TAPCO systems installed in Sacramento provide 14 images for a WWD event, while the newer generation TAPCO systems installed in San Diego provide 16 images for a WWD event. In the early stages of this research, TAPCO typically did not have information on whether a vehicle recovered and turned around for a given WWD event. At a certain point, TAPCO began issuing two entries for a given WWD event. In so doing, they often captured images that would indicate if a vehicle did recover and turn around. The TAPCO site includes their resolution (conclusion) for each alert. The site also includes the ability to download system activations for the previous three years' operation. This TAPCO tool was extremely valuable in the research. The research team had less opportunity and time to interact with TrafficCalm's tools. The TrafficCalm system appears to issue one photo for a given WWD event as shown in Figure 4.46. For research purposes, additional photos are needed. In addition, the researchers are not aware of a tool from TrafficCalm similar to the web site provided by TAPCO.

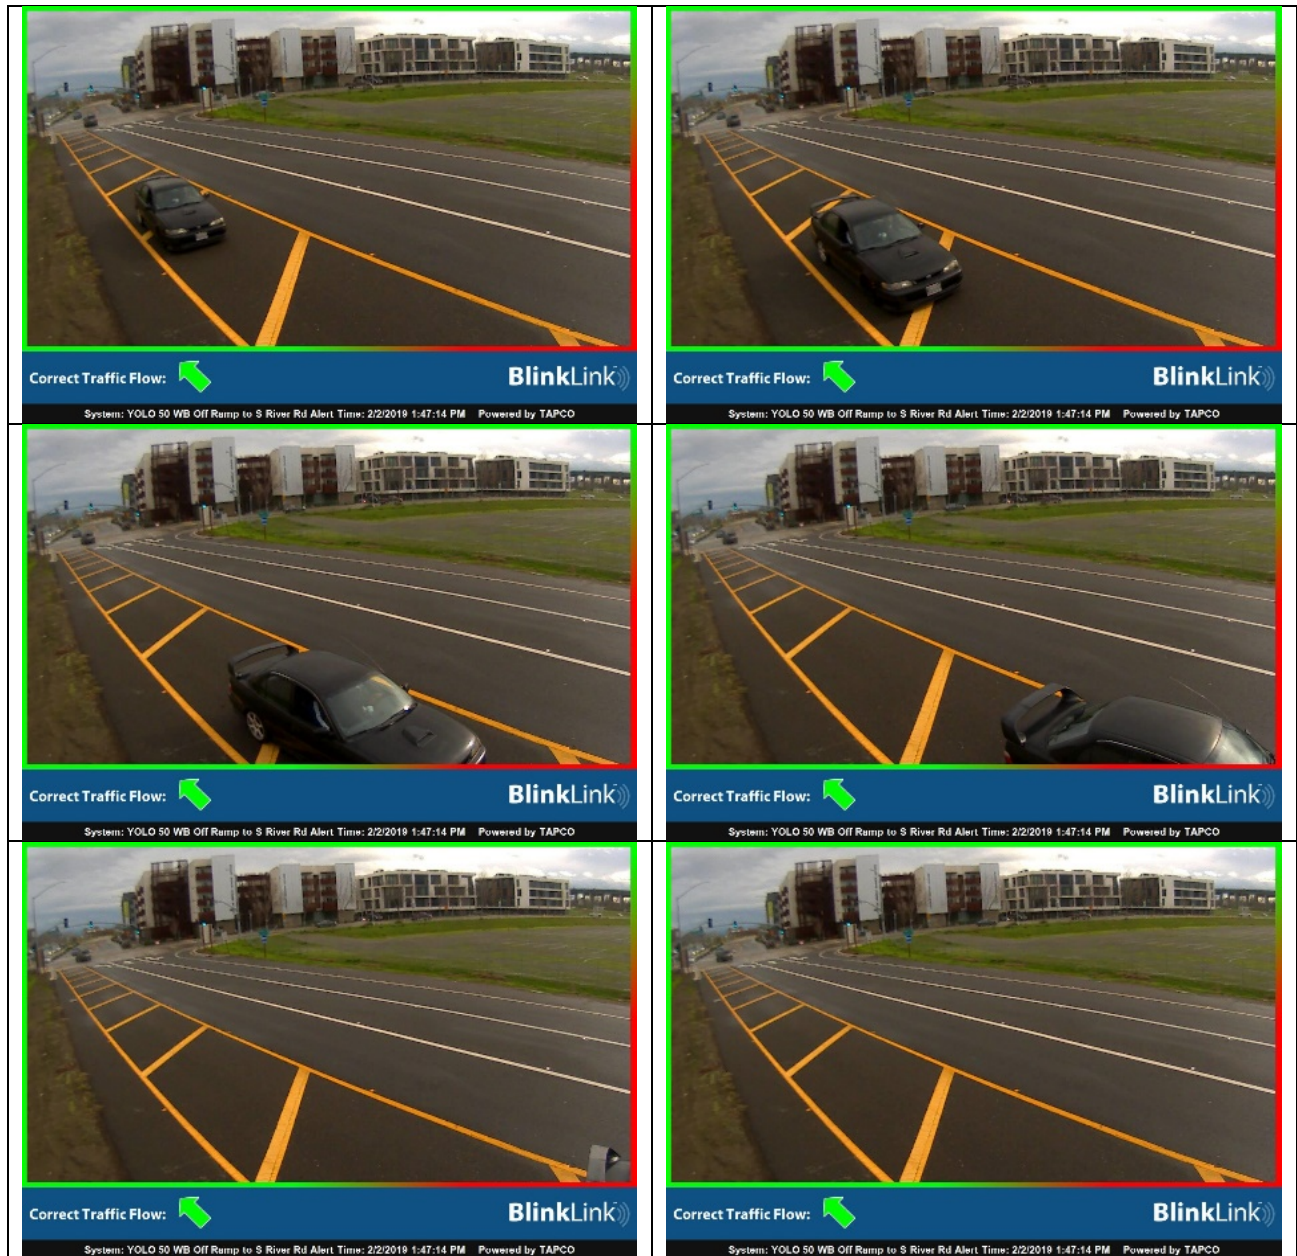
Figure 4.44: Photos (images 7 – 12 of 14) provided by TAPCO system for a typical WWD event. TAPCO provides 14-16 photos for a WWD event. Courtesy of TAPCO.

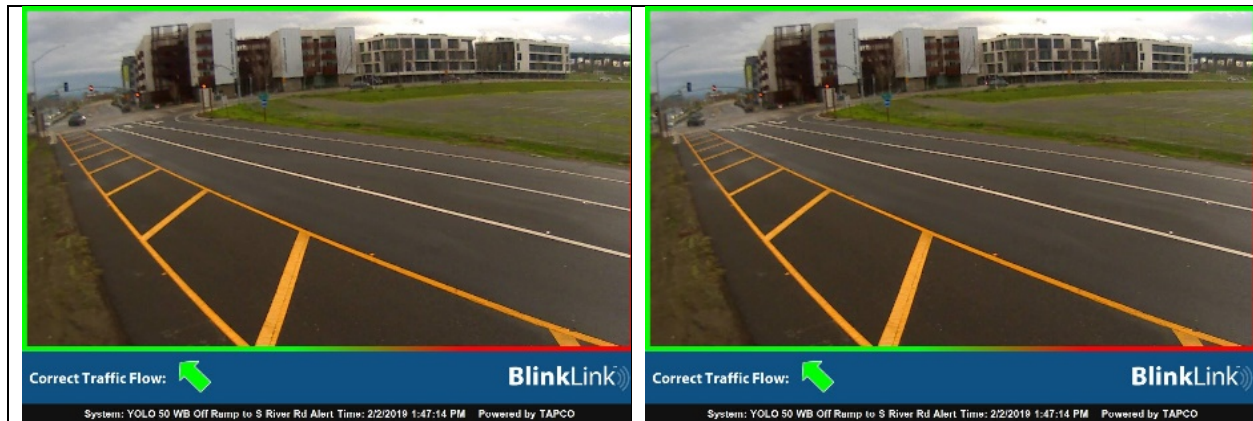
Figure 4.45: Photos (images 13 – 14 of 14) provided by TAPCO system for a typical WWD event. TAPCO provides 14-16 photos for a WWD event. Courtesy of TAPCO.

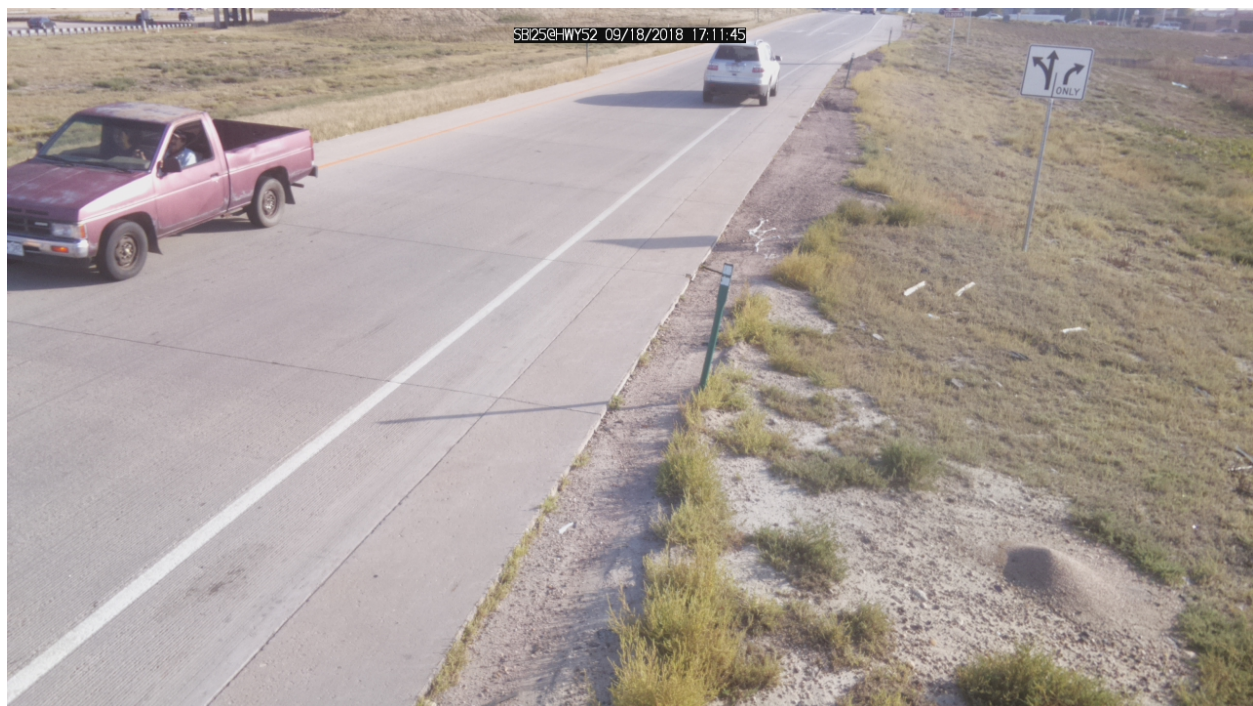
Figure 4.46: Photo provided by TrafficCalm system for a typical WWD event. TrafficCalm provides one photo for a WWD event. Courtesy of TrafficCalm.

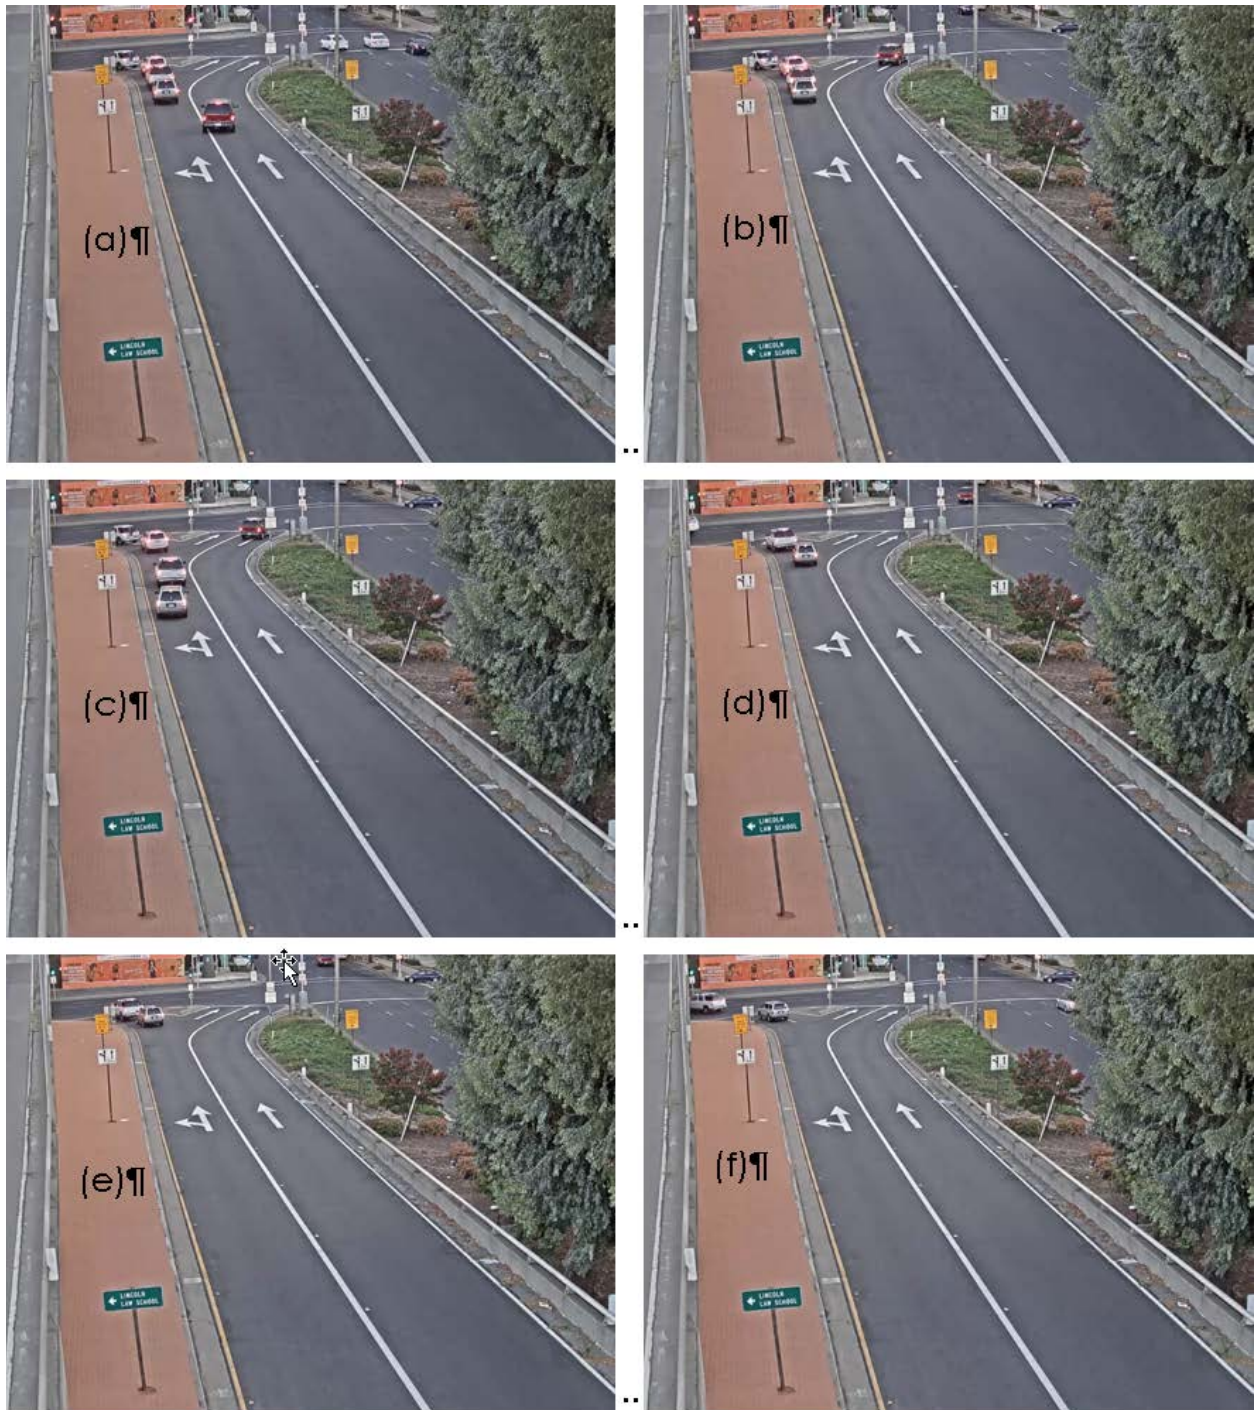
Figure A.1: Snapshots from the August 27, 2016 road rage incident on the J Street exit ramp

The incident occurred in the early evening in the summer of 2016, with well-lit conditions. Four vehicles were proceeding in the correct direction down the J Street exit ramp. The stop light to turn onto J Street was red. Two of the four vehicles stopped correctly at the intersection. The third vehicle (V3), an SUV, appears to have stopped properly as well. The fourth vehicle (V4), also an SUV, stops behind the third vehicle. V3 then backed up the exit ramp in what appears to be an attempt to impact V4. V4 then backed up the exit ramp to get away from V3. Then, the vehicles proceed to the intersection, V3 stops in an apparent attempt to keep V4 from proceeding, and finally all move through the intersection. Several snapshots of the incident are provided in Figure A.1.

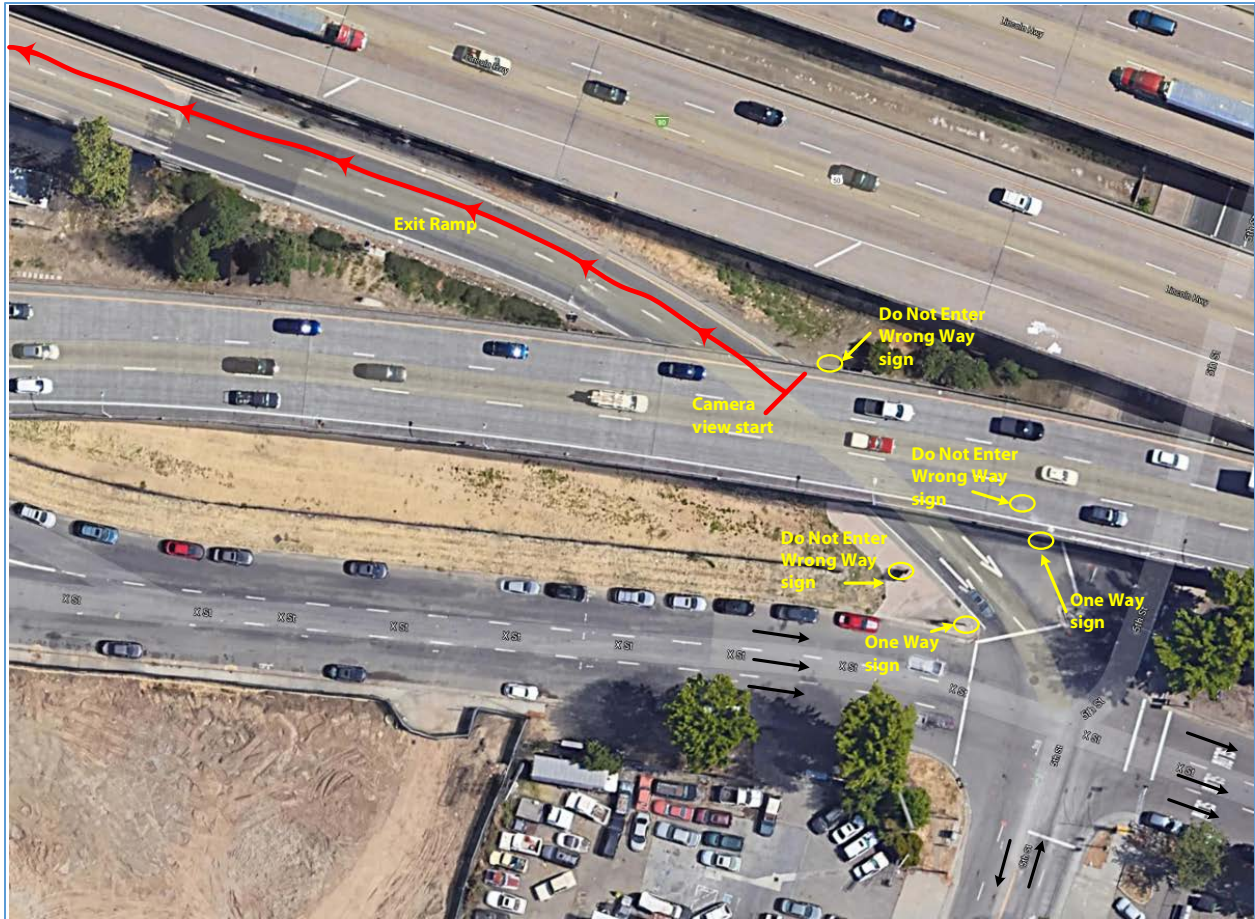
Figure A.8: Aerial view of the 8/18/2018 7:21 am WWD event on the EB 5th Street exit ramp. Approximate vehicle trajectory is shown in red. Aerial image courtesy of Google Maps.

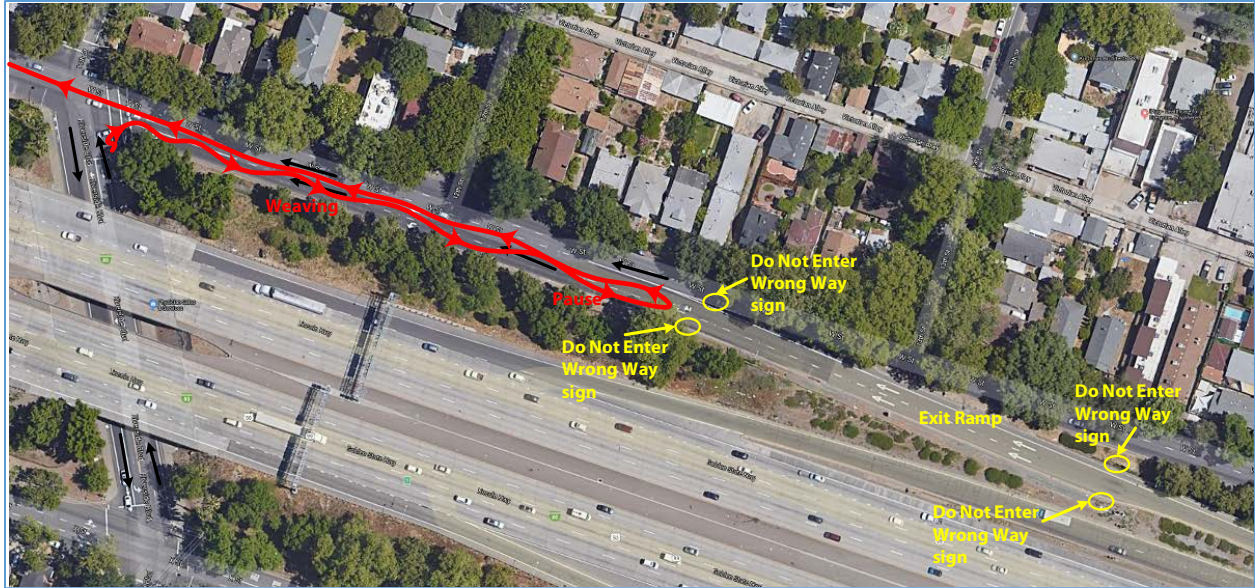
Figure A.9: Aerial view of the 12/22/2016 5:41 am WWD event on the WB 10th Street exit ramp. Approximate vehicle trajectory is shown in red. Aerial image courtesy of Google Maps.
