1. REPORT NUMBER CA20-2970	2. GOVERNMENT ASSOCIATION NUMBER N/A	3. RECIPIENT'S CATALOG NUMBER N/A
4. TITLE AND SUBTITLE Vision-Based Sensor System for Site Monitoring: Wrong-Way Driving, Phase 1		5. REPORT DATE June 5, 2020

6. PERFORMING ORGANIZATION CODE AHMCT Research Center, UC Davis
7. AUTHOR Ty A. Lasky, Kin Yen, Stephen Donecker, Wil White, Duane Bennett, Travis Swanston, and Bahram Ravani		8. PERFORMING ORGANIZATION REPORT NO. UCD-ARR-19-09-30-03

11. CONTRACT OR GRANT NUMBER IA65A0560, Task 2970
12. SPONSORING AGENCY AND ADDRESS California Department of Transportation P.O. Box 942873, MS #83 Sacramento, CA 94273-0001		13. TYPE OF REPORT AND PERIOD COVERED Final Report October 2015 – September 2019

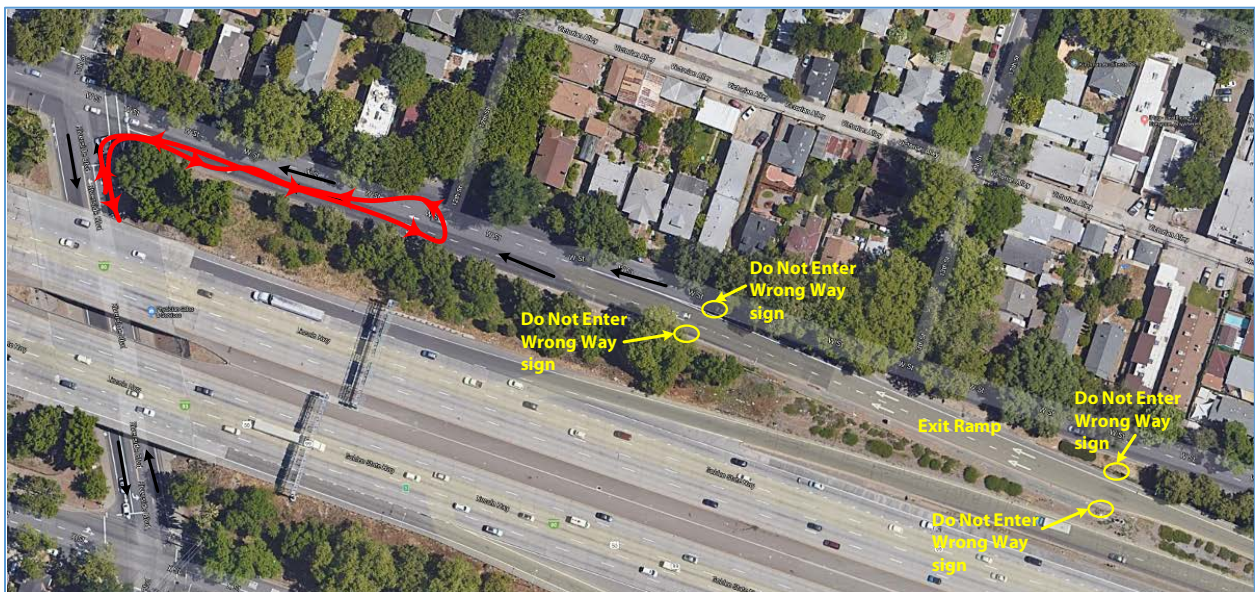
Figure A.10: Aerial view of the 5/4/2017 3:47 am WWD event on the WB 10th Street exit ramp. Approximate vehicle trajectory is shown in red. Aerial image courtesy of Google Maps.

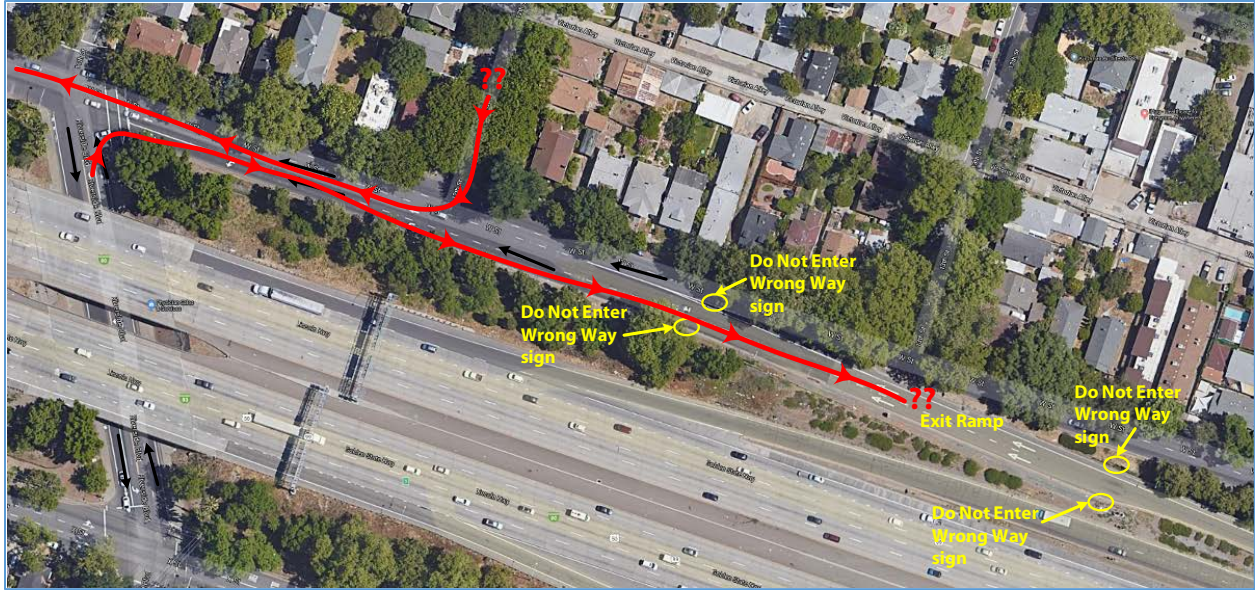
Figure A.11: Aerial view of the 5/16/2017 11:43 pm WWD event on the WB 10th Street exit ramp. Approximate vehicle trajectory is shown in red. Aerial image courtesy of Google Maps.

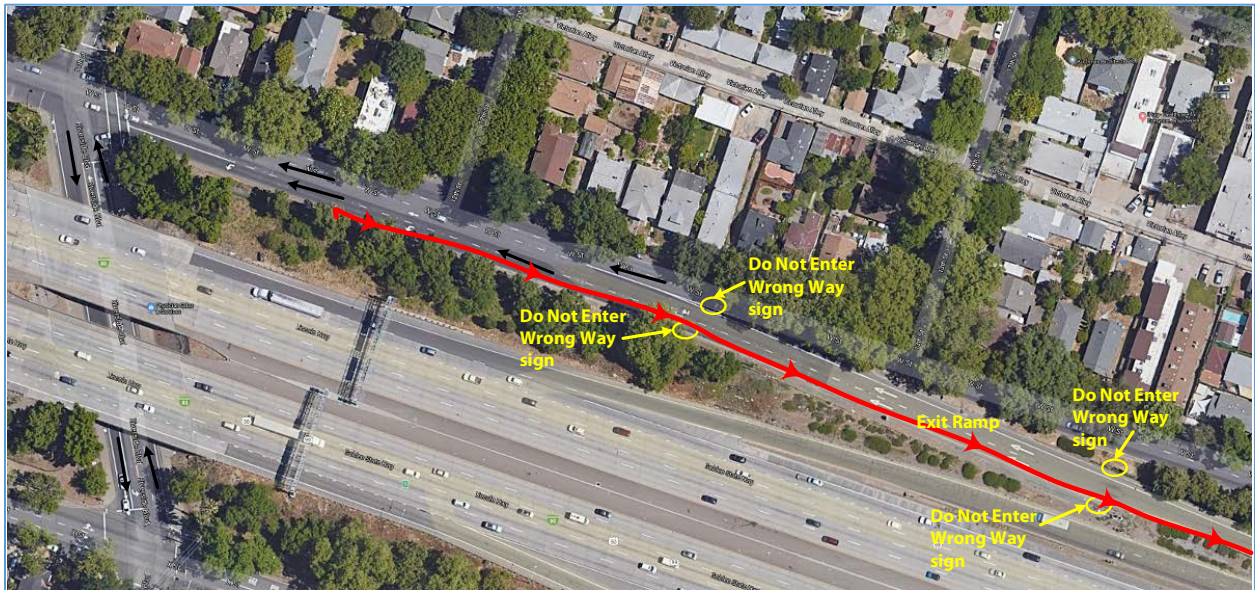
Figure A.12: Aerial view of the 2/4/2019 1:37 am WWD event on the WB 10th Street exit ramp. Approximate vehicle trajectory is shown in red. Aerial image courtesy of Google Maps.
