1. REPORT NUMBER CA24-4133	2. GOVERNMENT ASSOCIATION NUMBER N/A	3. RECIPIENT'S CATALOG NUMBER N/A
4. TITLE AND SUBTITLE Evaluation of a Portable Snow Melter for Use in Caltrans Maintenance Yards		5. REPORT DATE July 25, 2023

6. PERFORMING ORGANIZATION CODE AHMCT Research Center, UC Davis
7. AUTHOR Dave Torick, Anh P. Duong, and Ty Lasky		8. PERFORMING ORGANIZATION REPORT NO. UCD-ARR-23-07-31-01

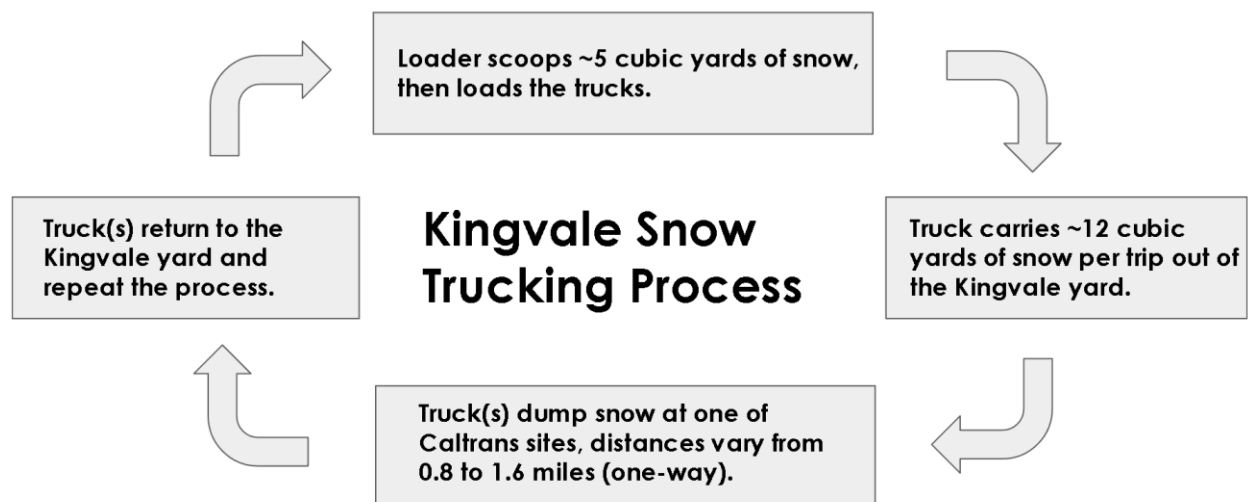
The process of trucking snow in Kingvale often involves one loader and one to five trucks, depending on staffing and weather conditions. The loader obtains approximately five cubic yards of snow per scoop. Each truck carries approximately twelve cubic yards of snow per trip. The truck operators then drive from 0.8 to 1.6 miles to dump the snow at a Caltrans snow dump site. The snow trucking process is summarized in Figure 2.1.

Figure 2.1: Kingvale snow trucking process

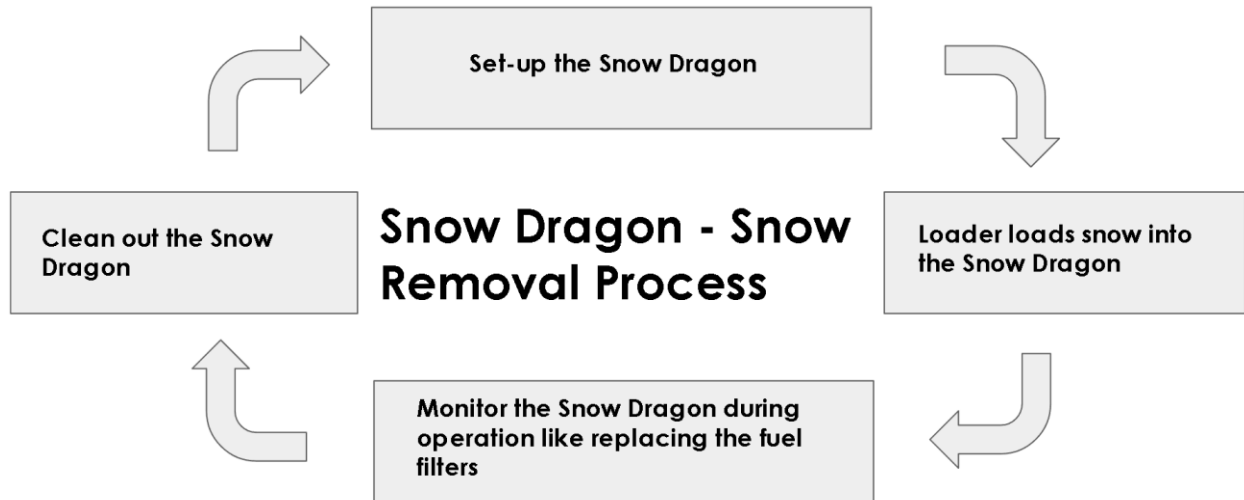
Figure 2.2: Snow removal process using the Snow Dragon

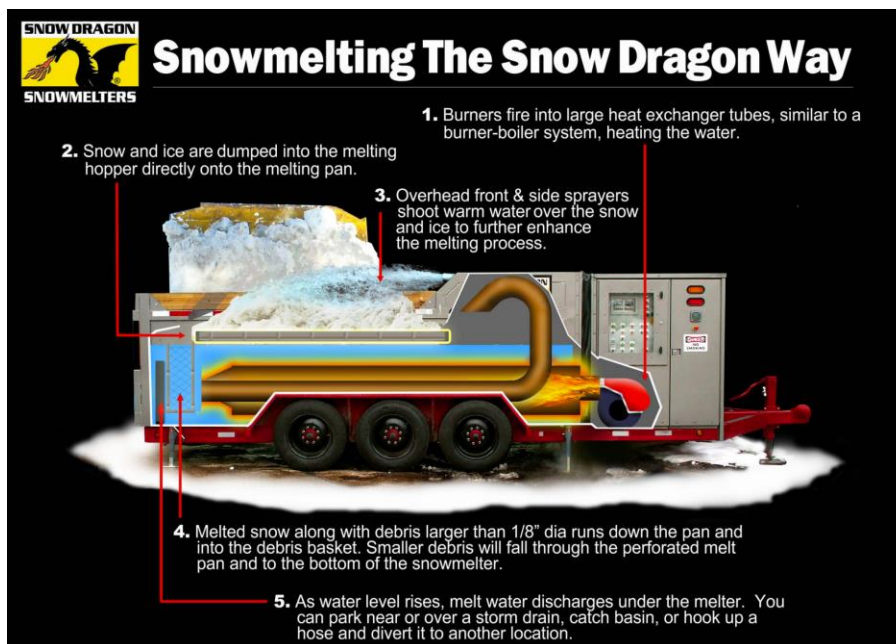
The manufacturer also created a diagram to summarize how the Snow Dragon works, as shown in Figure 2.3.

Figure 2.3: How the Snow Dragon works. Image courtesy of the Snow Dragon manufacturer.

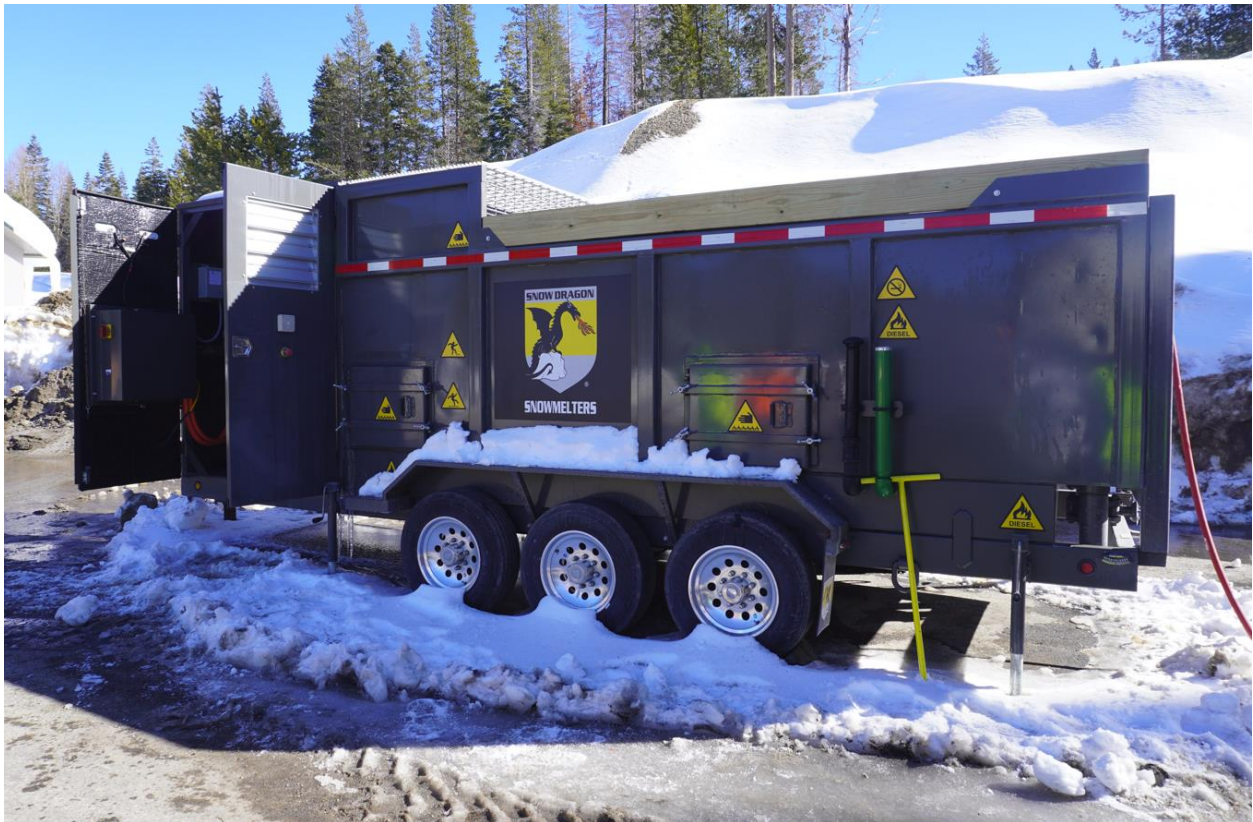
The Snow Dragon model SND900 is designed for use at malls, schools, stadium fields, and parking lots. Model SND900 measures 27' long, 8'4" wide, and 8'6" high. Figures 3.1 and 3.2 show the Snow Dragon model SND900 at the Caltrans Kingvale yard.

Figure 3.1: Left side (primary for operation) view of the Snow Dragon SND900

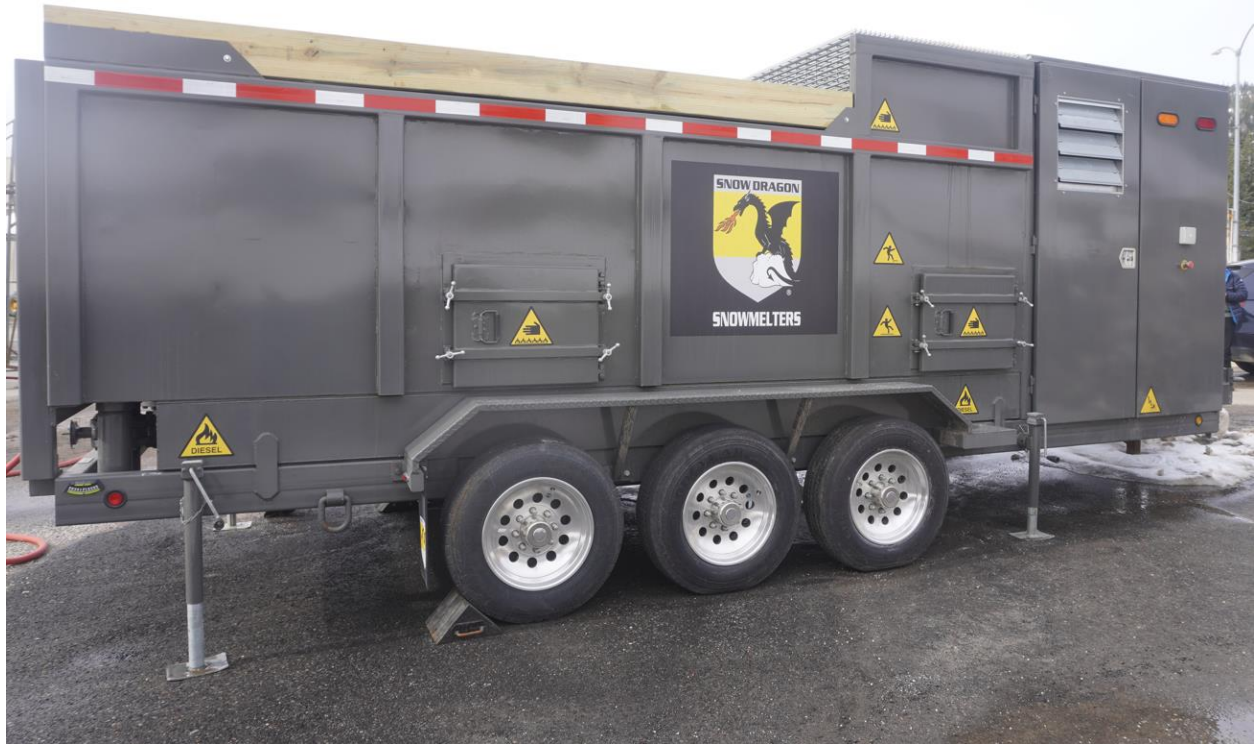
Figure 3.2: Right side view of the Snow Dragon SND900

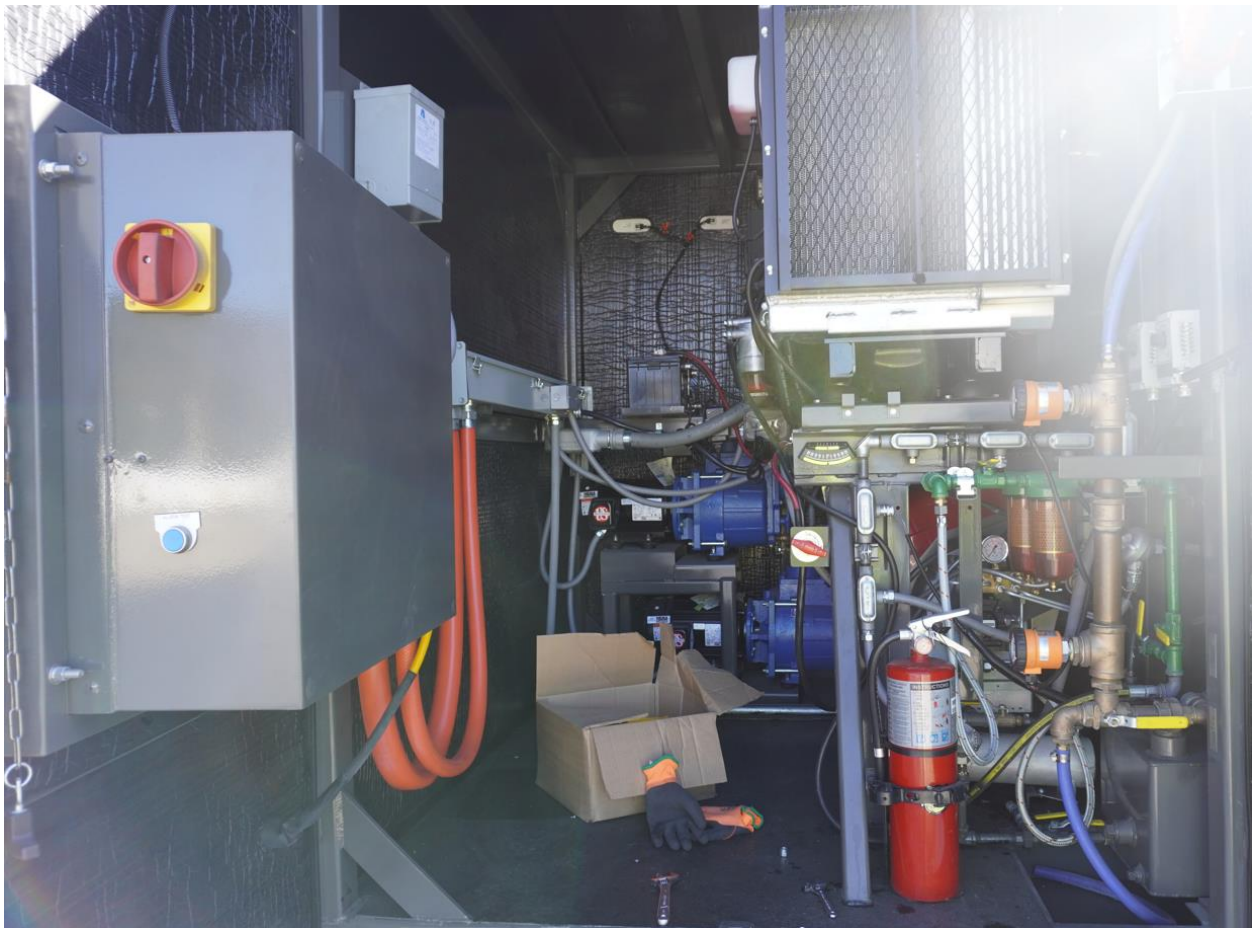
- Heated operating enclosures with lockable access door protecting equipment, including burners, water pump spray system, and generator (Figure 3.3)
- Three clean-out hatches

Figure 3.3: SND900 operating enclosure

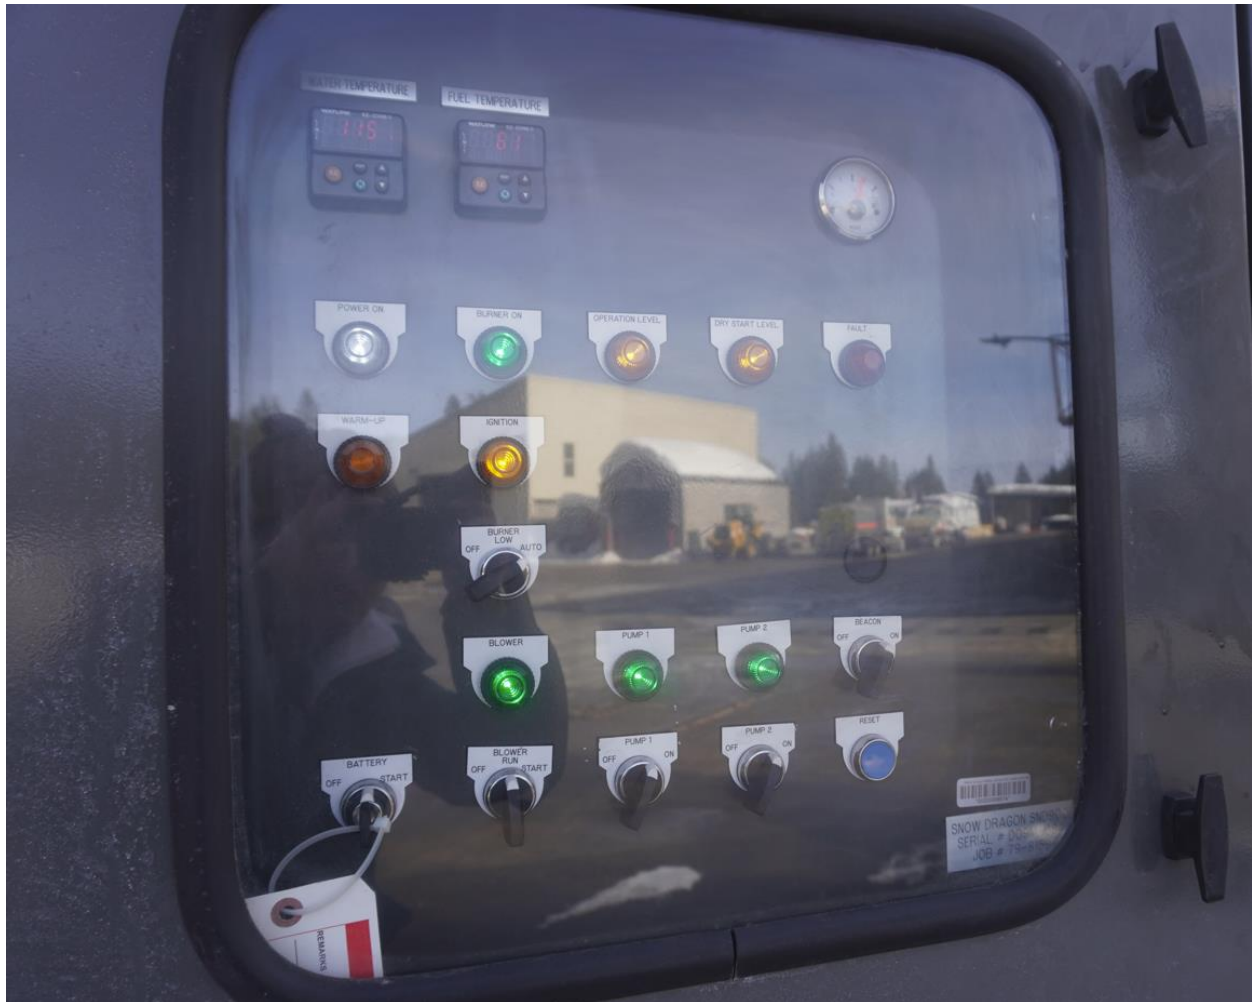
Figure 3.4: The front control panel of the SND900

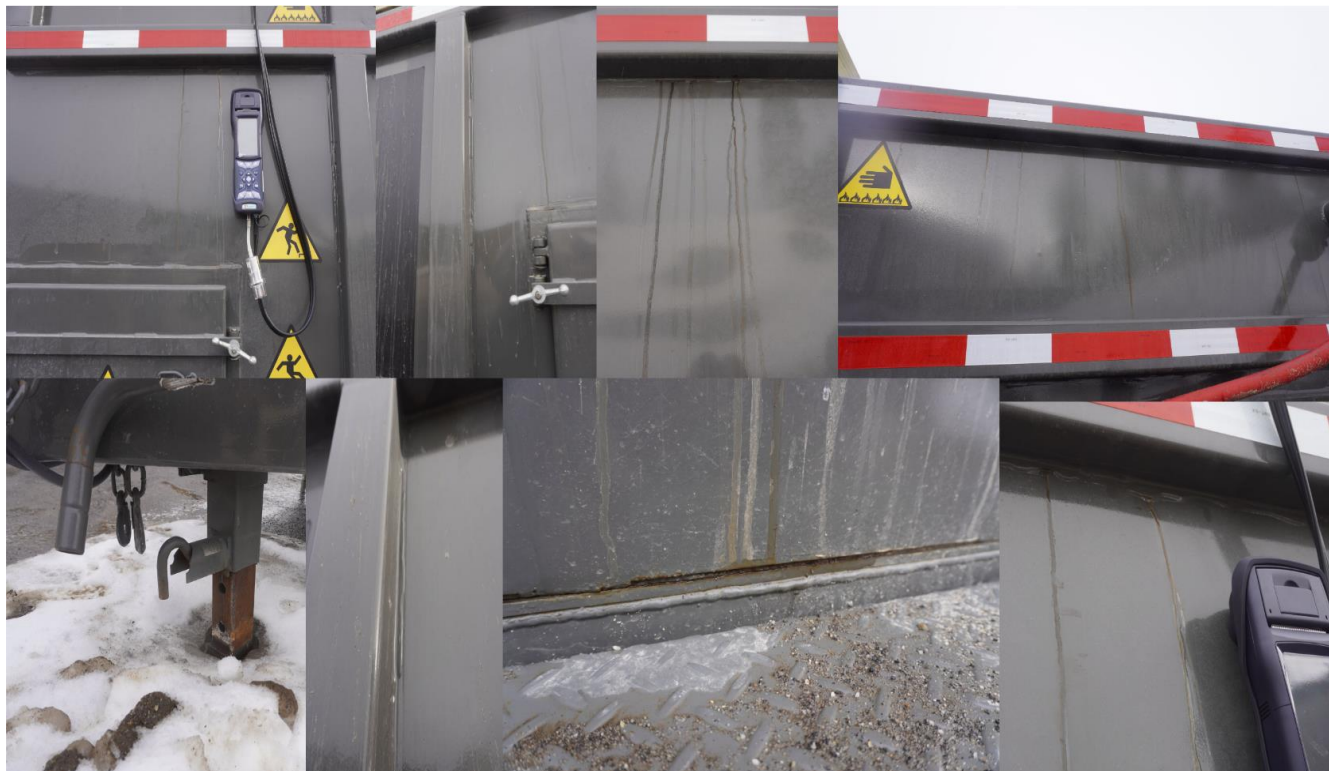
Upon inspection, there was visible rust and small water leaks on the front, back, and rear of the Snow Dragon. The locations were recorded by the AHMCT team.

Figure 4.2: Examples of rust and small water leaks on the Snow Dragon

Date (2023)	Failures	Troubleshooting Actions	Outcomes
Feb 2	Rust and water damage spots.	No solution for rust and water damage spots.	The Snow Dragon worked as expected after the oil pressure switch was replaced, thus it was ready for training. Air analyzer tests were conducted.
Feb 3	N/A	N/A	Training happened. Caltrans personnel performed test runs.
After Feb 3	N/A	N/A	The AHMCT team collected field data.

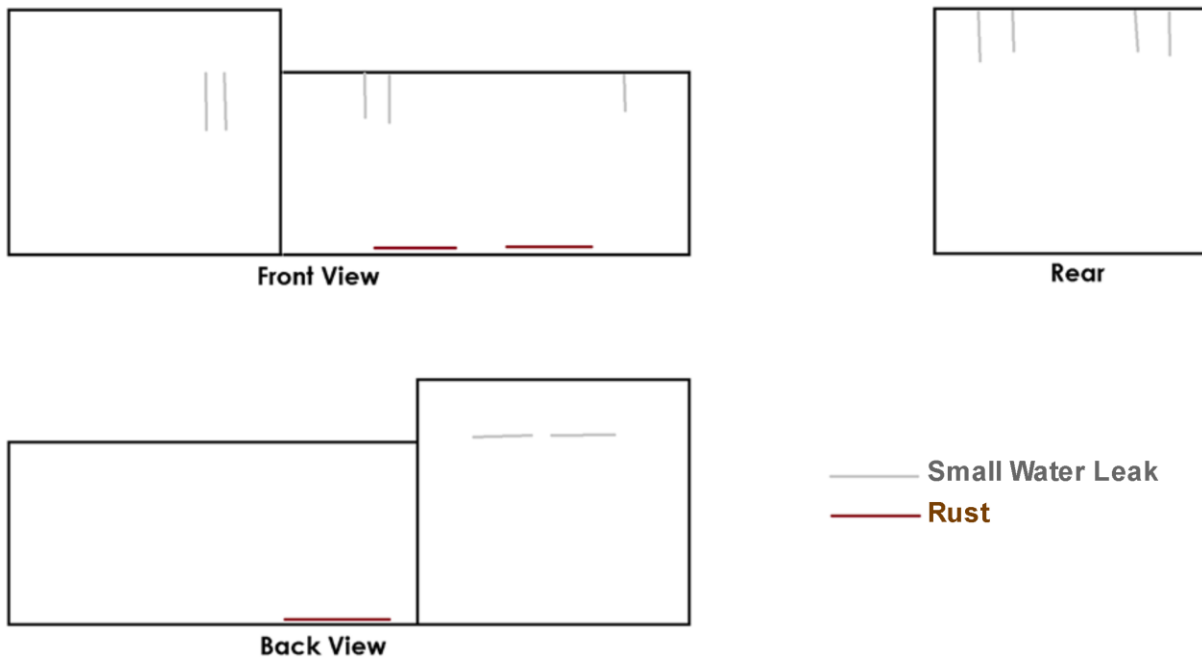
Figure 4.3: Locations where rust and small water leaks were detected on the Snow Dragon. Note that these spots only reflect problems documented on February 2.

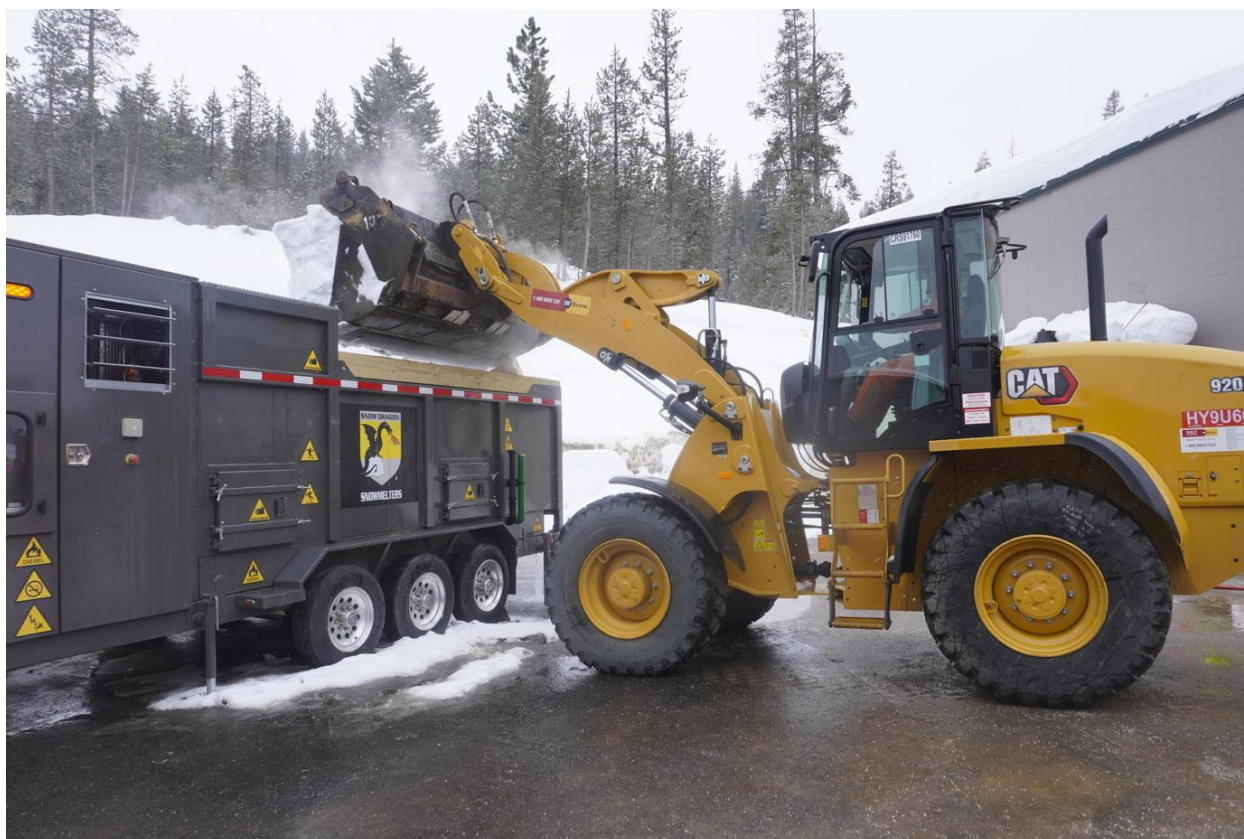
Figure 4.4: Caltrans personnel trying out the Snow Dragon for the first time using the CAT loader to add snow

Since the Snow Dragon was working as expected on February 2, the training happened at noon as scheduled on February 3. After the training, Caltrans personnel performed test runs with the Snow Dragon as shown in Figure 4.4.

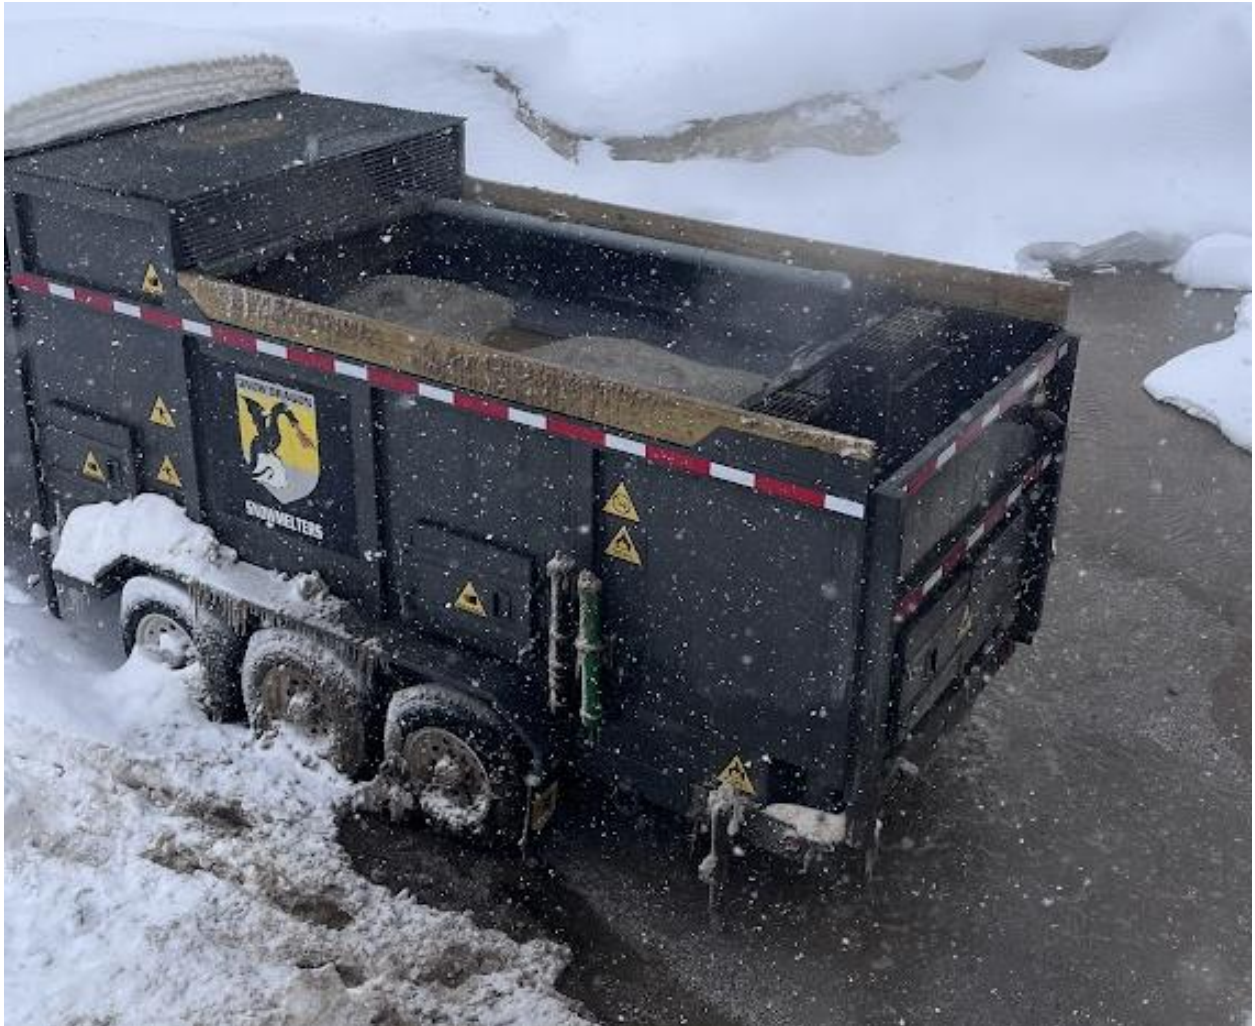
When dumping snow with more sand into the Snow Dragon, the Snow Dragon operated for 100 minutes before top and bottom clean-outs were required. The clean-outs took 45 minutes. Figures 5.2 and 5.3 depicted the conditions of the Snow Dragon after 100 minutes of operation.

Figure 5.2: The top of the Snow Dragon and its condition after melting snow with more sand for 100 minutes straight

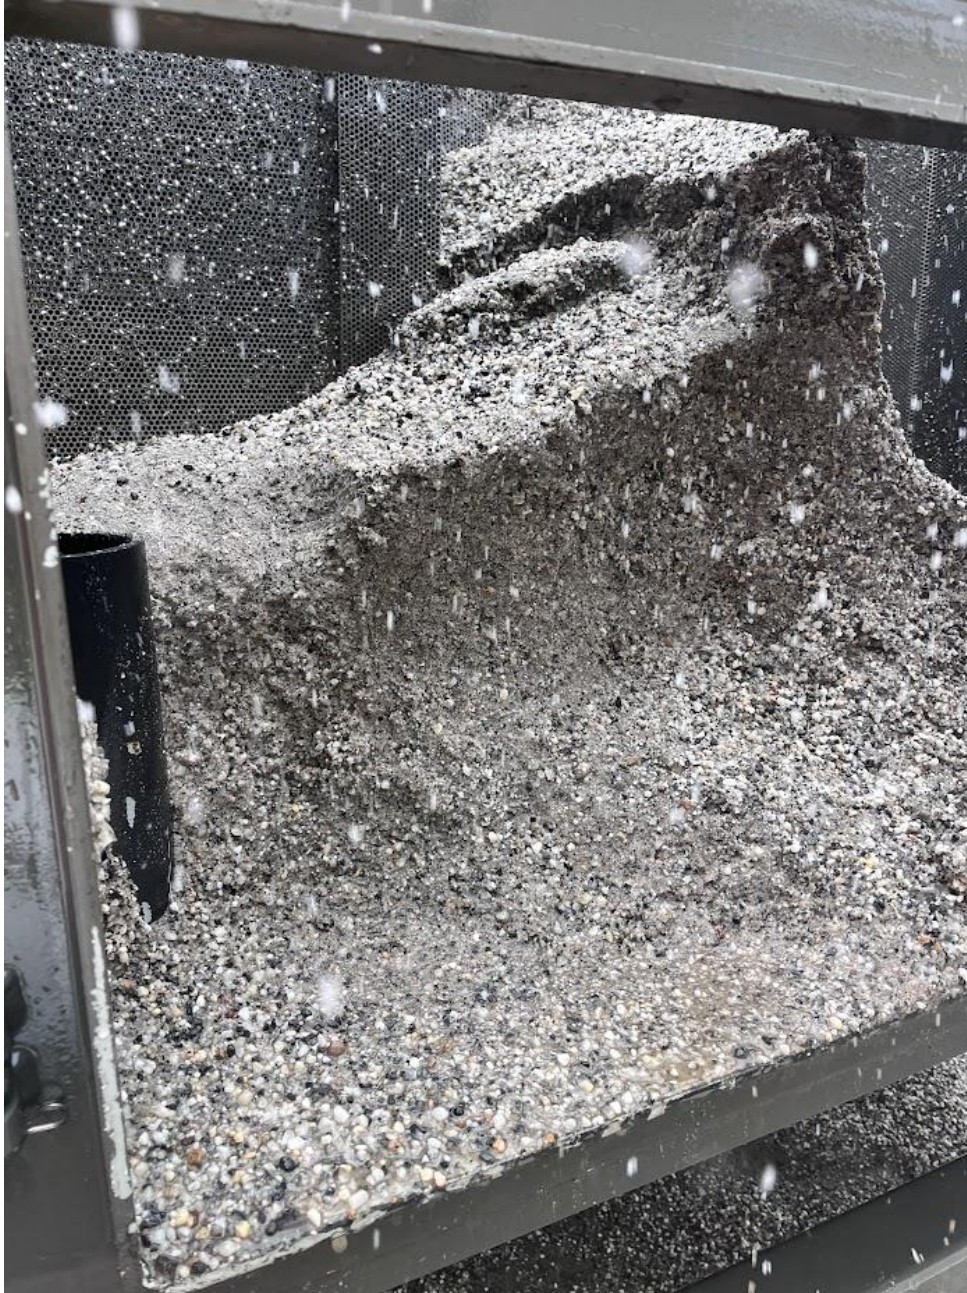
Figure 5.3: The bottom of the Snow Dragon tank and its condition after melting snow with more sand for 100 minutes straight

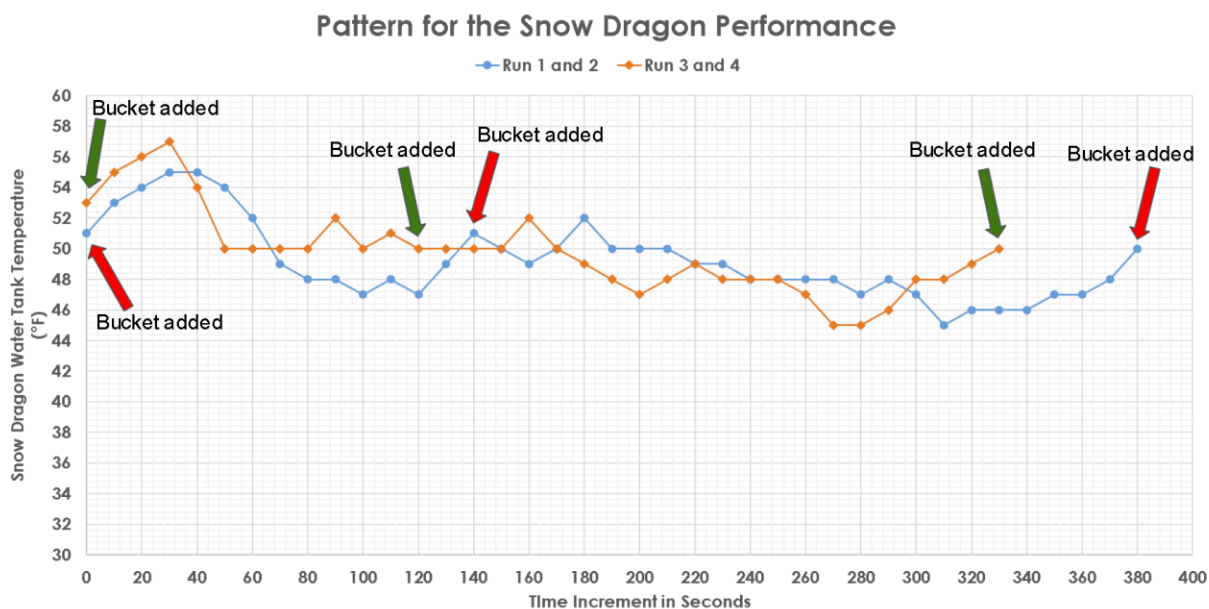
Figure 5.4: Snow Dragon performance pattern. Red arrow indicates data line “Run 1 and 2”. Green arrow indicates data line “Run 3 and 4”. “Bucket added” means a bucket was being dumped into the Snow Dragon. All test runs were for snow with less sand.

Based on Figure 5.4, one bucket generally led to a shorter recovery time, and the next bucket caused a longer recovery time. For “Run 1 and 2”, it took 140 seconds (2 minutes 20 seconds) for the first bucket to be dumped. For the second bucket to be dumped, it took 240 seconds (4 minutes). For “Run 3 and 4”, it took 120 seconds (2 minutes) for the first bucket to be dumped. For the second bucket to be dumped, it took 210 seconds (3 minutes 30 seconds). **The pattern showed that after the first bucket was dumped, the recovery time before the second bucket could be dumped was approximately 4 minutes. In other**

During field testing, the AHMCT team observed that the best approaches to optimize the Snow Dragon performance is to **maintain the Snow Dragon water temperature at around 50°F. This temperature allows the Snow Dragon to melt the most amount of snow buckets.** For instance, the operator can dump the snow bucket any time the Snow Dragon water temperature is equal to or above 50°F. When the Snow Dragon water temperature drops below 50°F, the operator should wait approximately two to four minutes for the Snow Dragon to recover the 50°F threshold.

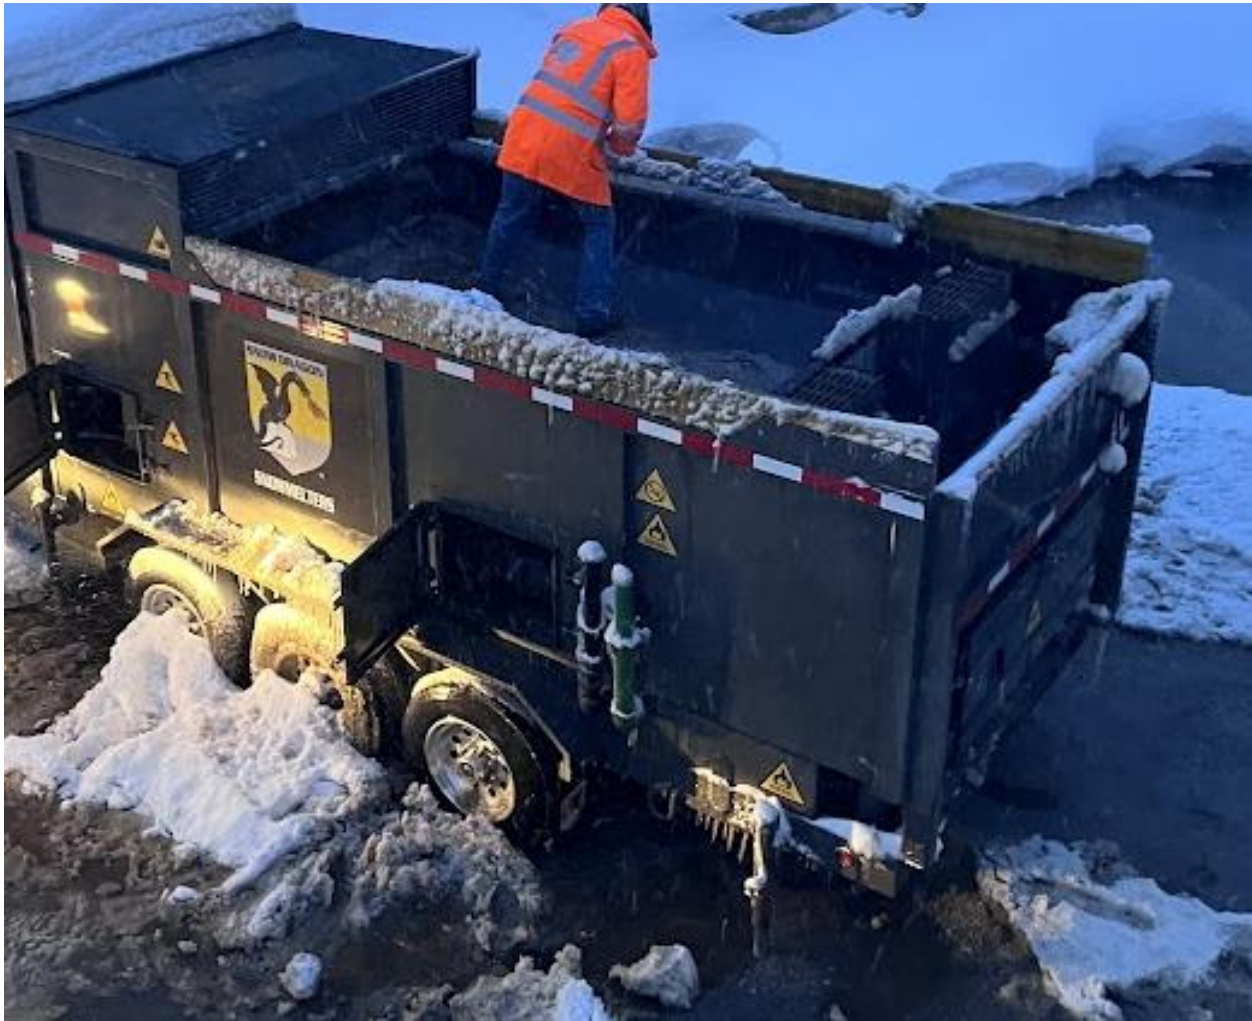
When dumping snow with less sand into the Snow Dragon, the machine operated for 205 minutes before top and bottom clean-outs were required. The clean-outs took 30 minutes. Figures 5.5 and 5.6 depict the conditions of the Snow Dragon after the 205-minute operation.

Figure 5.5: The top of the Snow Dragon and its condition after melting snow with less sand for 205 minutes

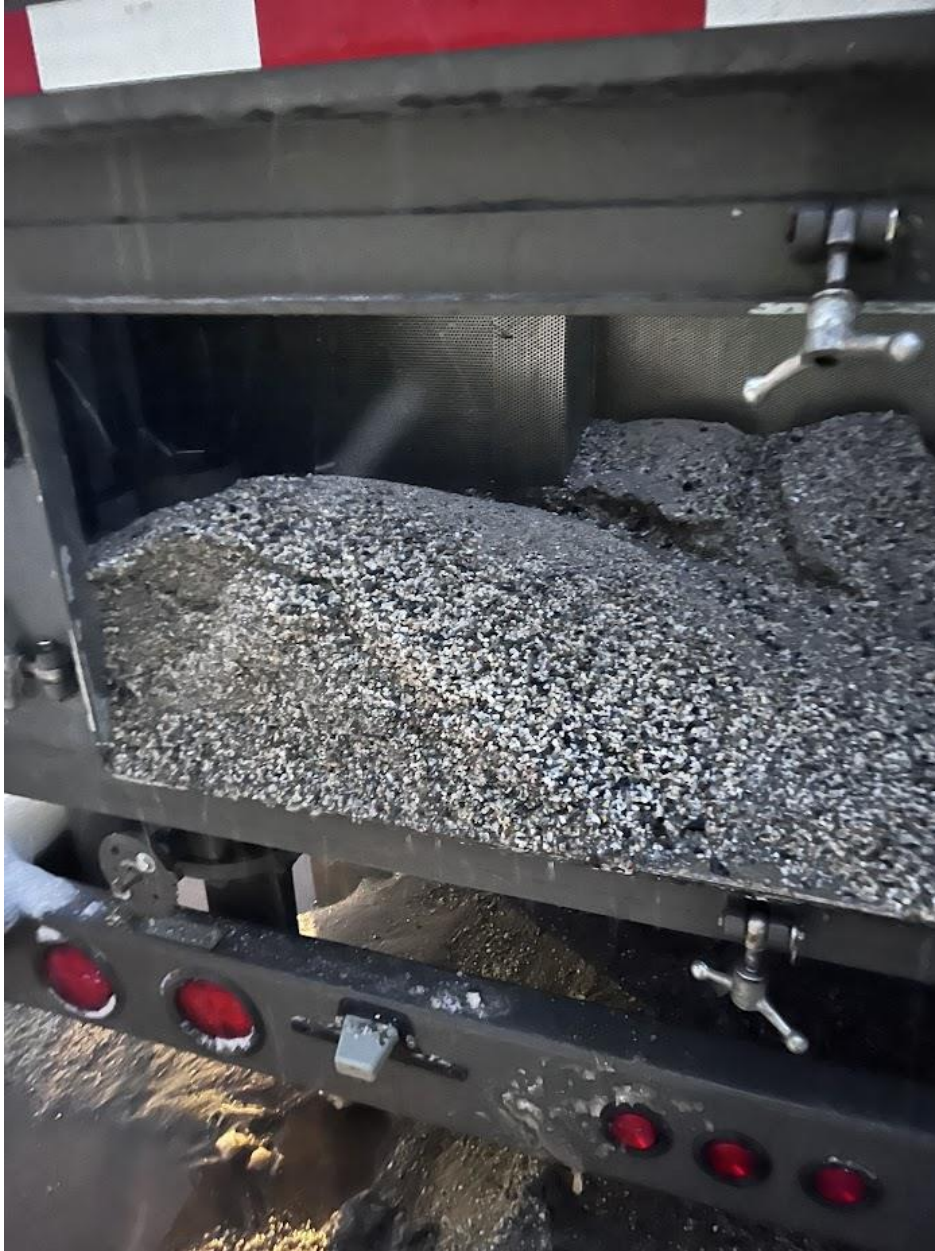
Figure 5.6: The bottom of the Snow Dragon and its condition after melting snow with less sand for 205 minutes

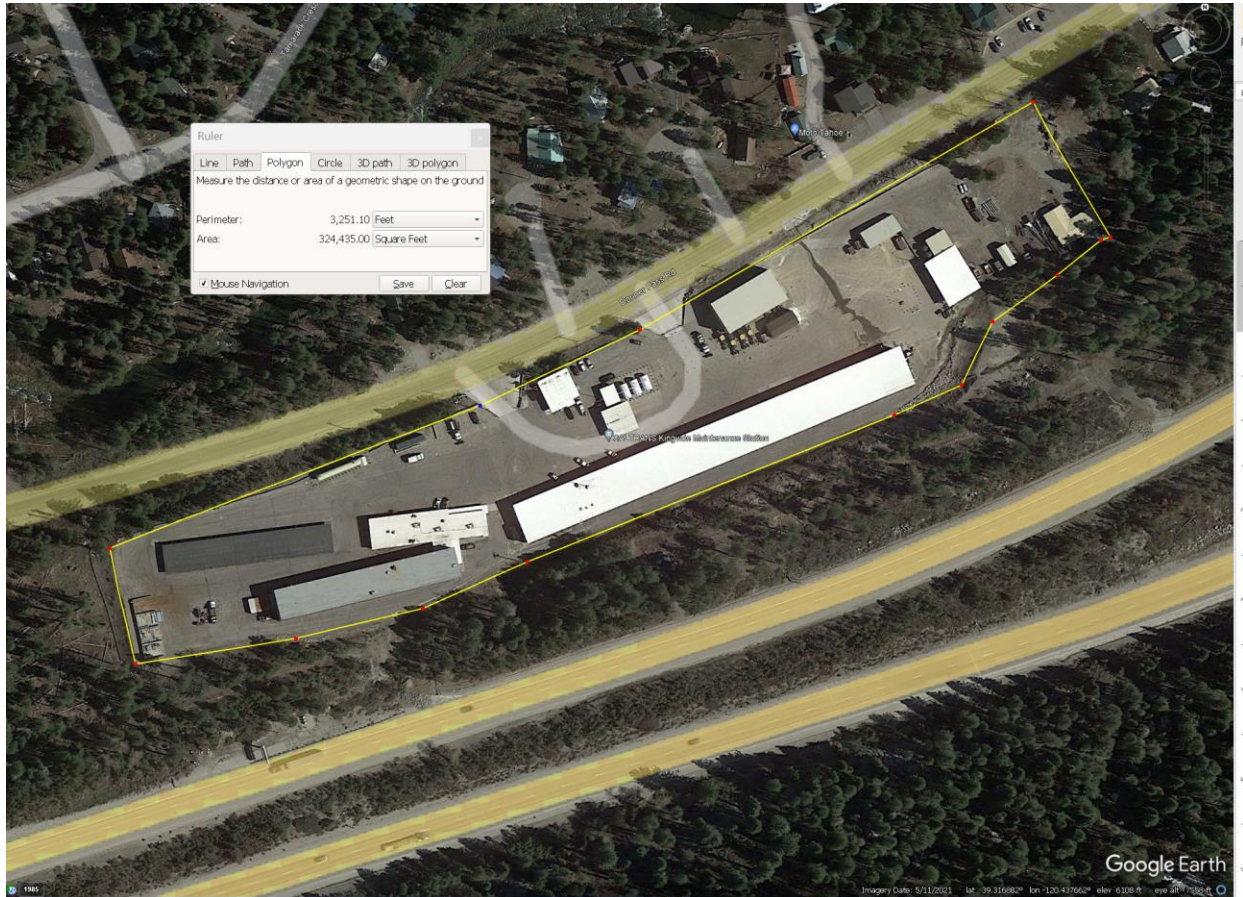
The cost to truck a cubic yard of snow can be calculated based on the amount of precipitation and area of coverage. The Kingvale yard perimeter and area were estimate by using Google Earth measuring tool. The estimated perimeter was 3,251 feet, and the estimated area was 324,435 square feet including buildings, as shown in Figure 6.1, which corresponds to an estimated perimeter of 1,084 yards and estimated area of 36,048 square yards including buildings.

Figure 6.1: Kingvale yard outlined by a yellow line. The estimated perimeter is 3,251 feet. The estimated area is 324,435 square feet including buildings. Image courtesy of Google Earth.

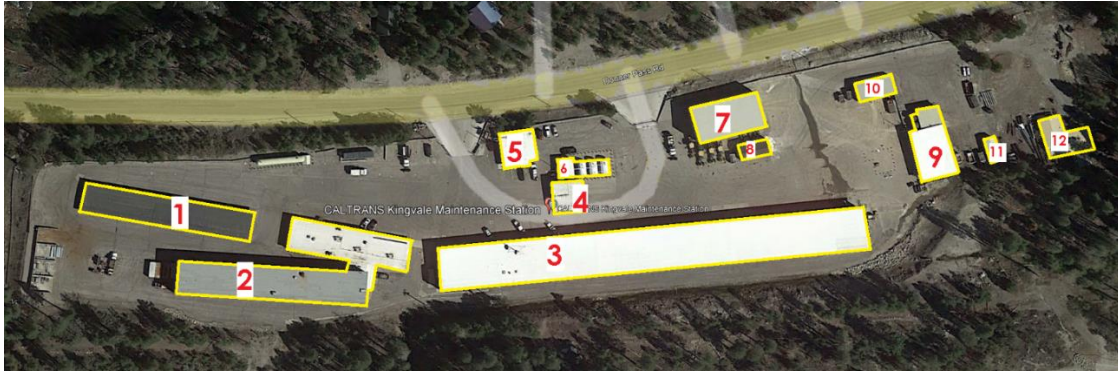
The estimated area that needs snow trucking excludes buildings. In the Kingvale yard, there are 12 main buildings as shown in Figure 6.2. The building measurement values and the estimated Kingvale area value excluding buildings are listed in Table 6.2.

Figure 6.2: Buildings to be removed from estimated area for snow trucking.
Image courtesy of Google Earth.
