**APPLICATION OF FIBER OPTIC COMMUNICATIONS
AND
OPTICAL SENSOR CONCEPTS TO GLOBAL
STRATEGY FOR BRIDGE INSPECTION**

AHMCT Research Report
UCD-ARR-93-09-22-01

Final Report of Contract
RTA-32J804

September 22, 1993

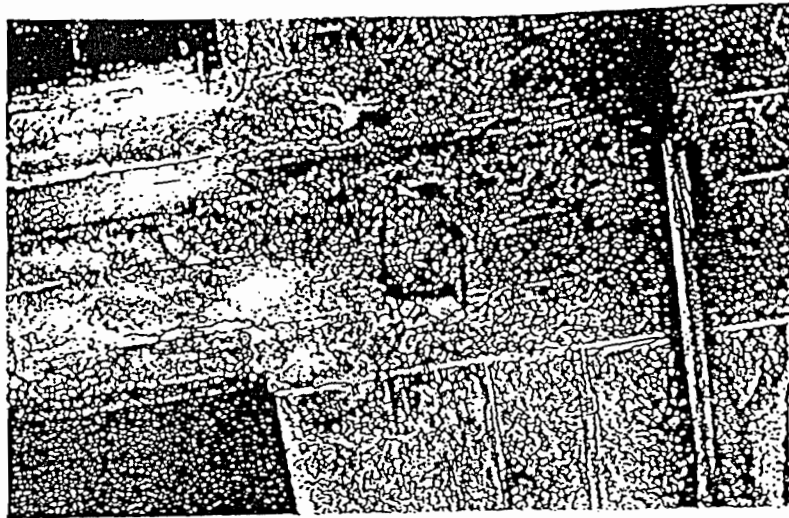
Figure 10. Concrete spalling in the region of hinges (bottom view)

- Spalling due to corrosion of the reinforcement especially in the region of hinges and construction joints(Figures 10, and 11);
- Deformation, blisters and cracks in the carriage way surface.
- Damage in the region of the hinges due to leaking expansion joints;
- Damage in the concrete bridge coping due to road salt attack;
- The bridge deck concrete can be penetrated to a depth of several centimeters by chlorides in the region of the defective bridge sealing;
- Color alterations of beams and slabs.

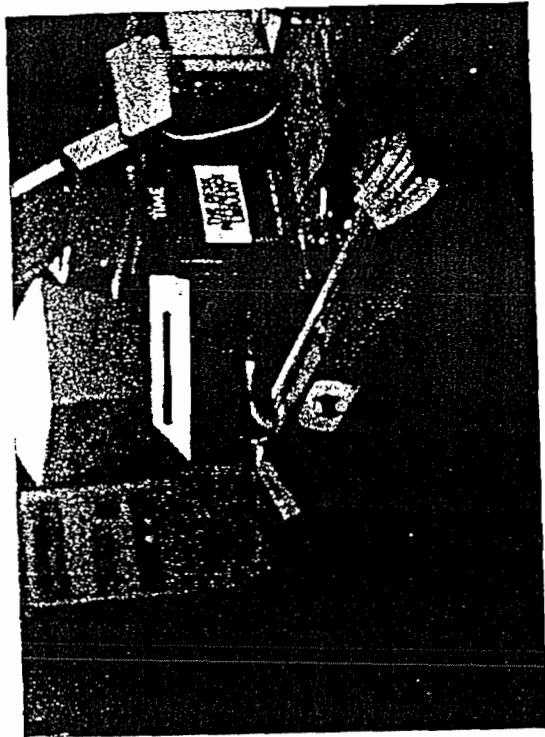
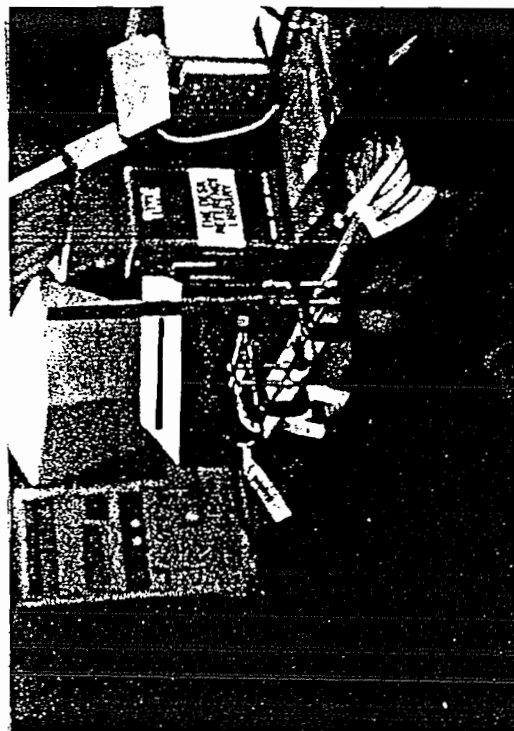
Figure 31. Photograph of the OUTF of PLANE BENDING Fiber Optic Feasibility Demonstration Sensor.
