**Assessment of Graffiti Removal Practices and Initial  
Development of a Tool for Removing Graffiti from  
Retroreflective Signs**

**Report Number: CA09-1955**

**Final Report of Contract: 65A0275, Task ID: 1955**

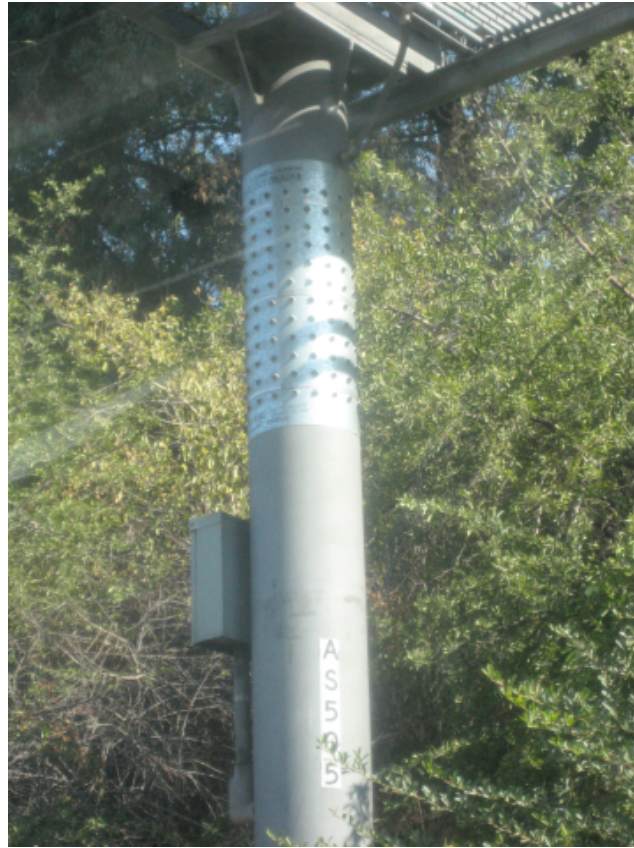
**Figure 1-1: "Cheese Grater" Barrier**

Success has also been reported by moving surfaces out of reach. For example, signs on surface streets that see high pedestrian traffic are tagged quite often. Moving these signs higher than the currently required seven feet greatly reduces the amount of graffiti present on them, simply because taggers cannot reach them as easily [20].

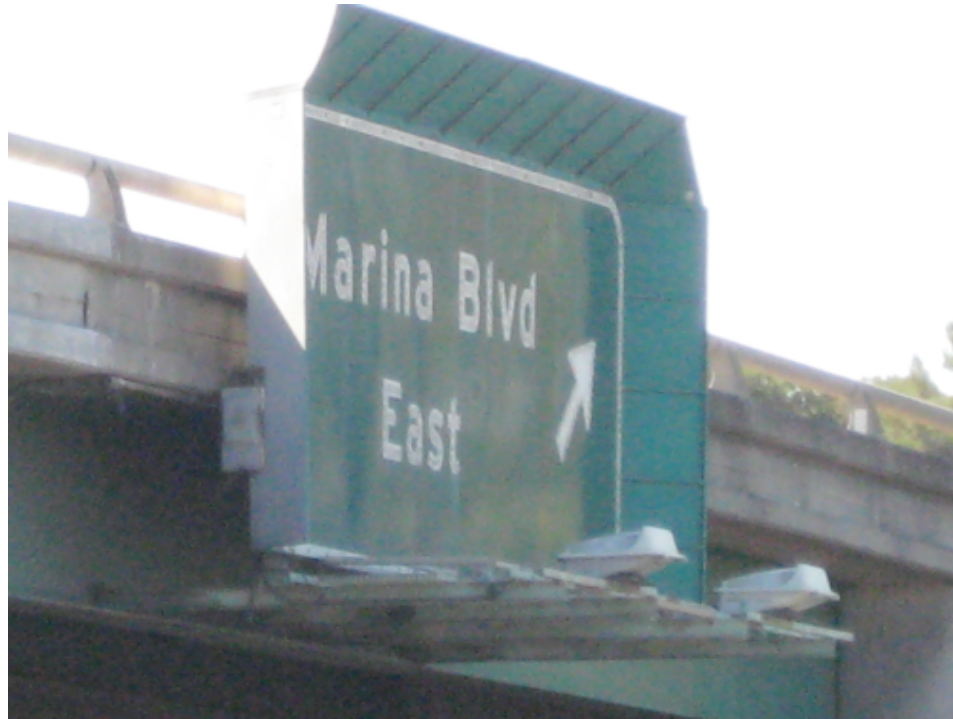
**Figure 1-2: "Cobra Shield" Barrier**

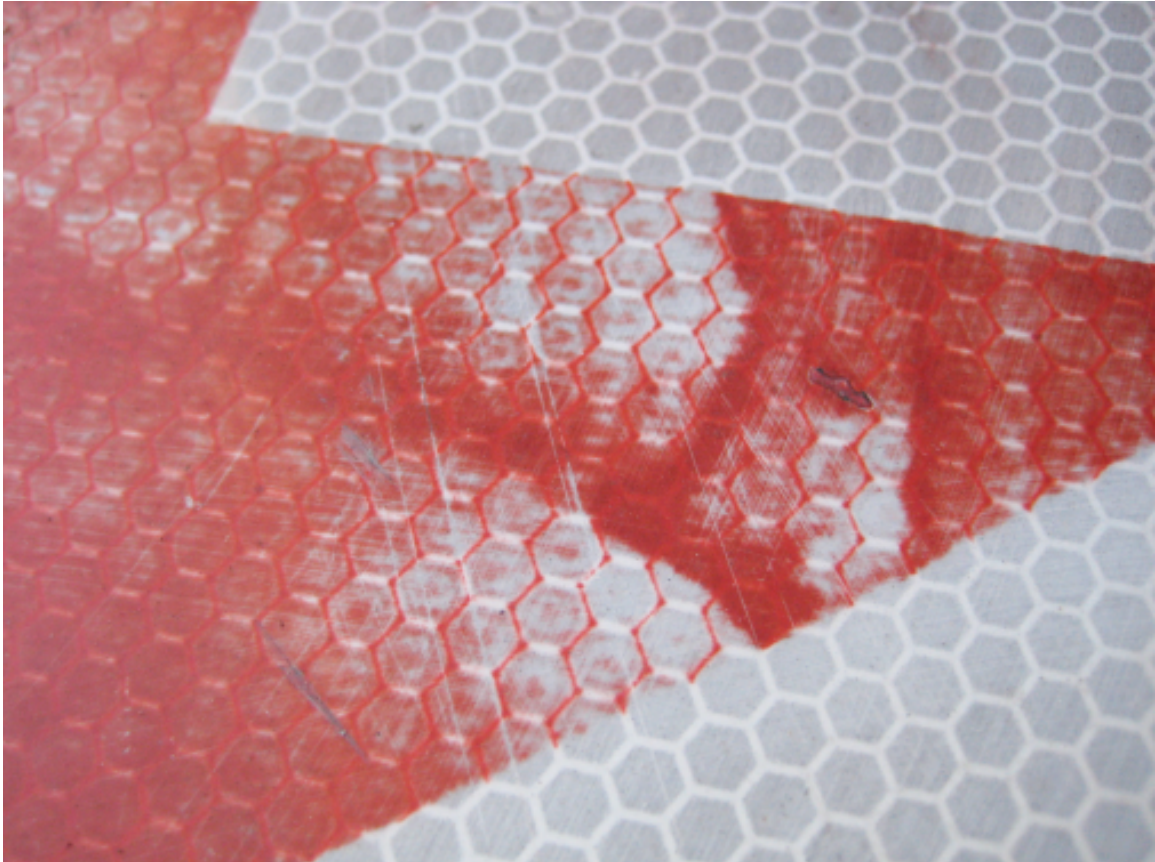
**Figure 1-3: Encapsulated glass bead film**

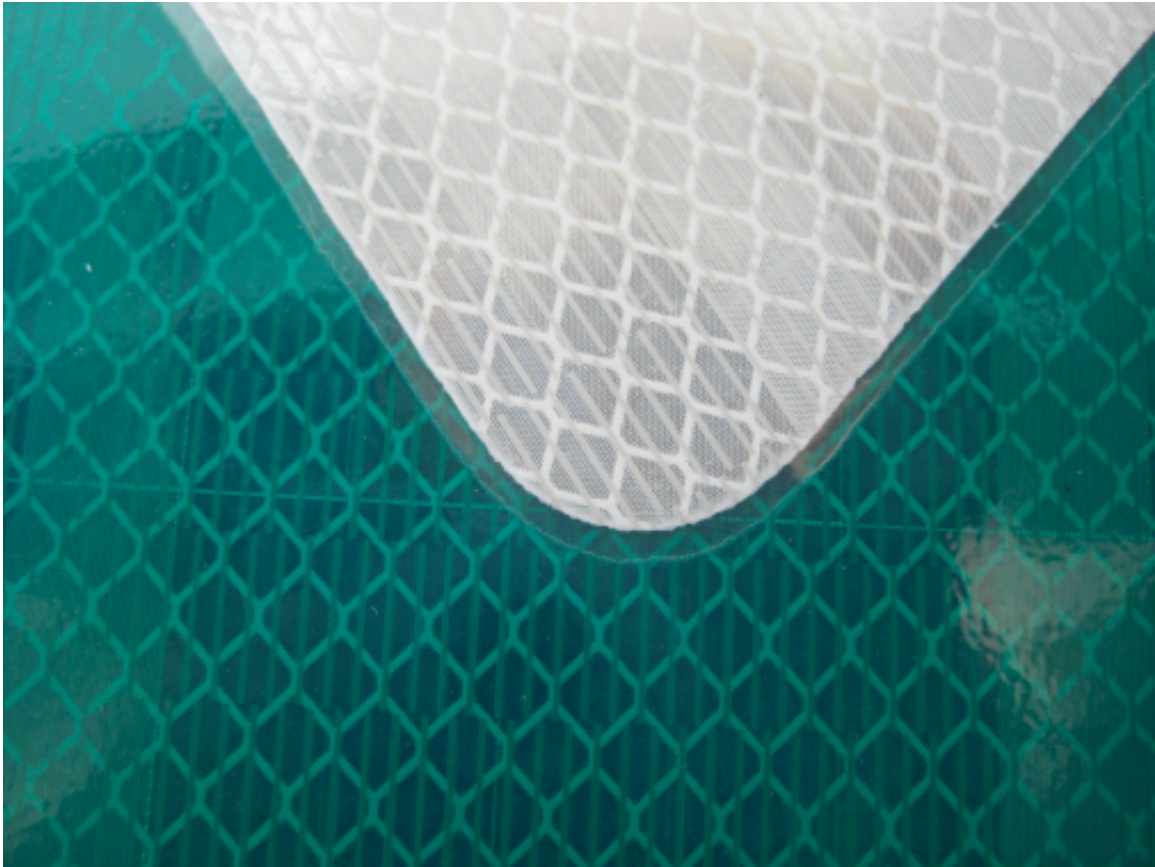
**Figure 1-4: Microprismatic film, different layers of lettering and background**

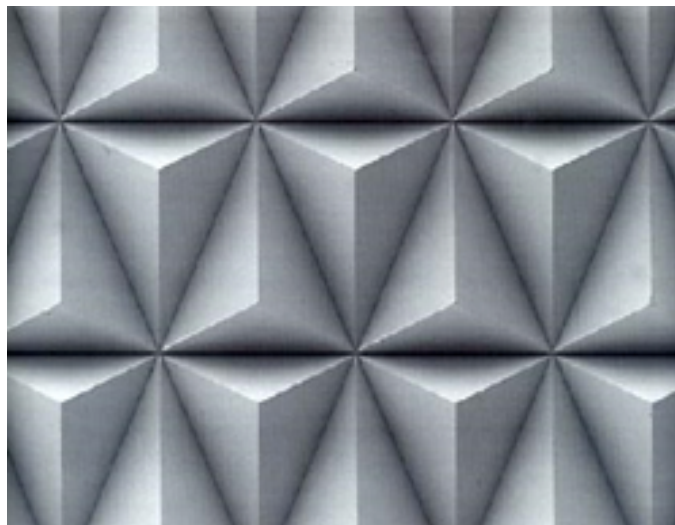
**Figure 1-5: Close-up of microprismatic film**

efficiently than the glass bead types, however they are more susceptible to damage from excess pressure deforming the structure.

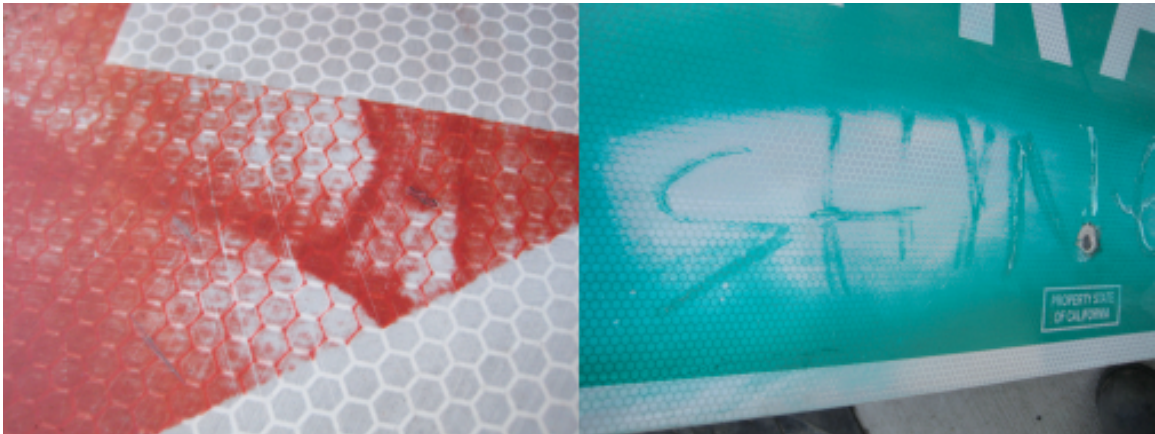
**Figure 1-6: Damage to graphics from abrasion and chemicals**

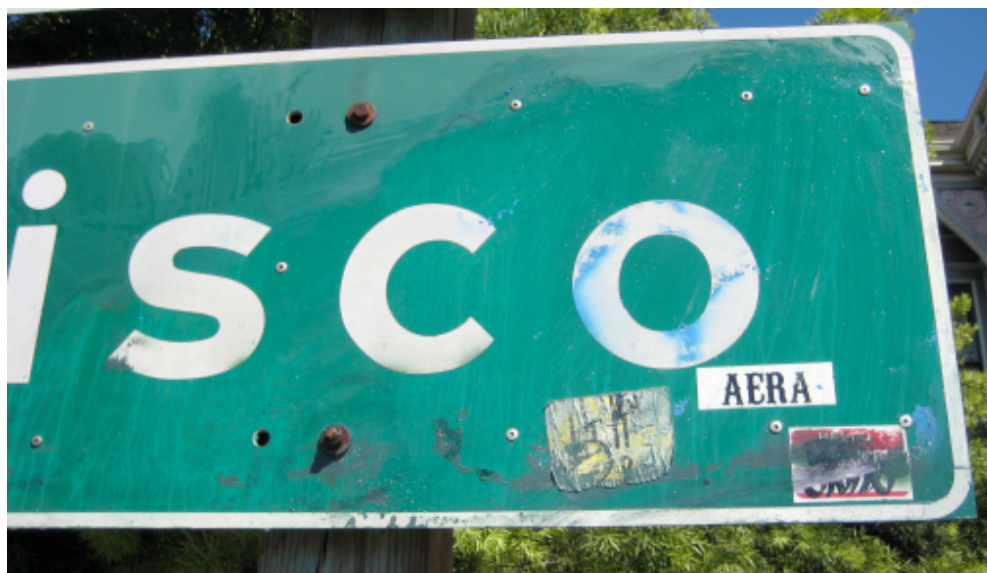
**Figure 1-7: Older sign with non-reflective decals**

Much older reflective signs have the background color painted on and the lettering in non-reflective decals (Figure 1-7), and some have small round prismatic reflectors embedded in raised lettering (Figure 1-8).

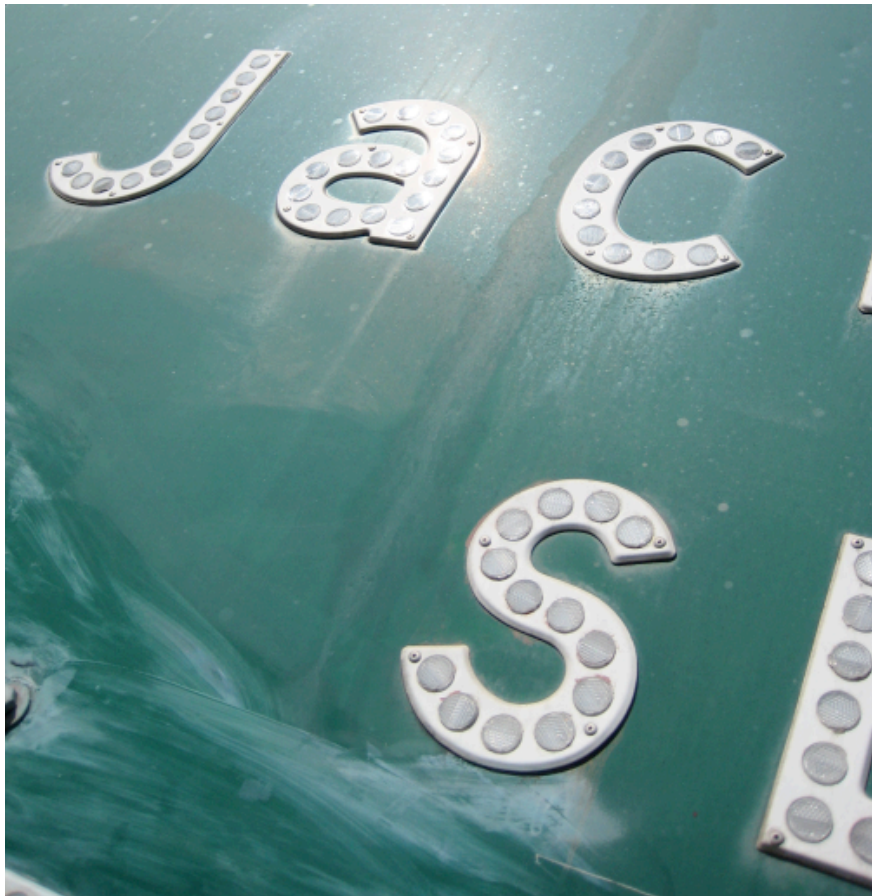
**Figure 1-8: Older sign with reflectors in raised lettering**

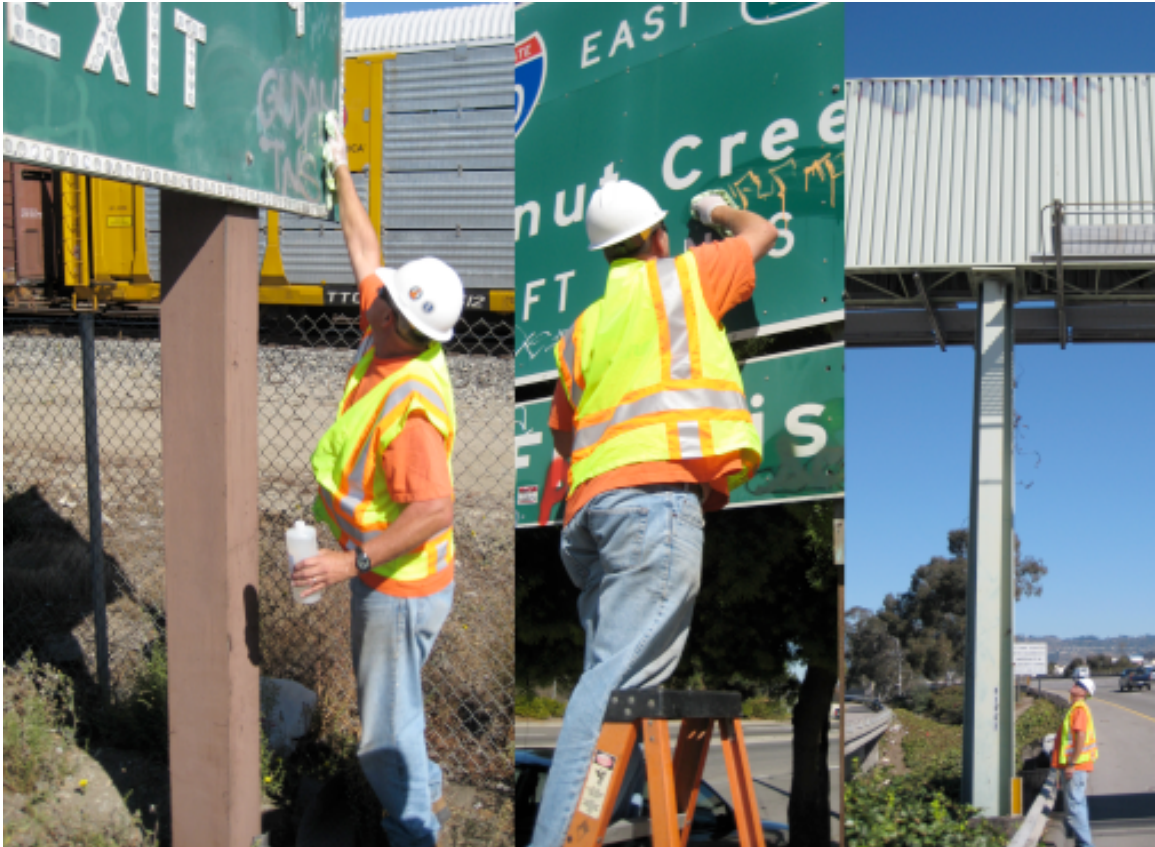
**Figure 1-9: Methods of cleaning signs; far right requires a personnel lift**

Signs are often placed at or above head level, requiring maintenance personnel either to clean with their arm stretched over their head, which is uncomfortable; up on a ladder, which can be hazardous, especially on uneven ground; or in a personnel lift, which can impede the flow of traffic if lane closures are required (Figure 1-9). The signs are cleaned using a chemical applied by hand and wiped off with a rag, and any drips must be captured by an absorbent cloth laid out on the ground, in accordance with environmental regulations. The chemical, once applied, must be allowed to sit for a minute or so to take effect and begin softening the paint, then it is scrubbed around and wiped off, hopefully taking the graffiti with it. Sometimes several applications are needed, and a common complaint is that the chemicals work too slowly. Because the process takes a while to perform, and there are sometimes several signs in the area which require cleaning, the aim of cleaning the sign is not necessarily to get it clean, but to get it legible. Often this means that the graffiti on the sign is not completely removed but merely significantly reduced. Finally, because damage to the sign shows up as a reduction in retroreflectivity, and because the signs are cleaned during the day when one cannot tell if the reflectivity to the sign is damaged, it is difficult for a worker to know immediately if damage has occurred.

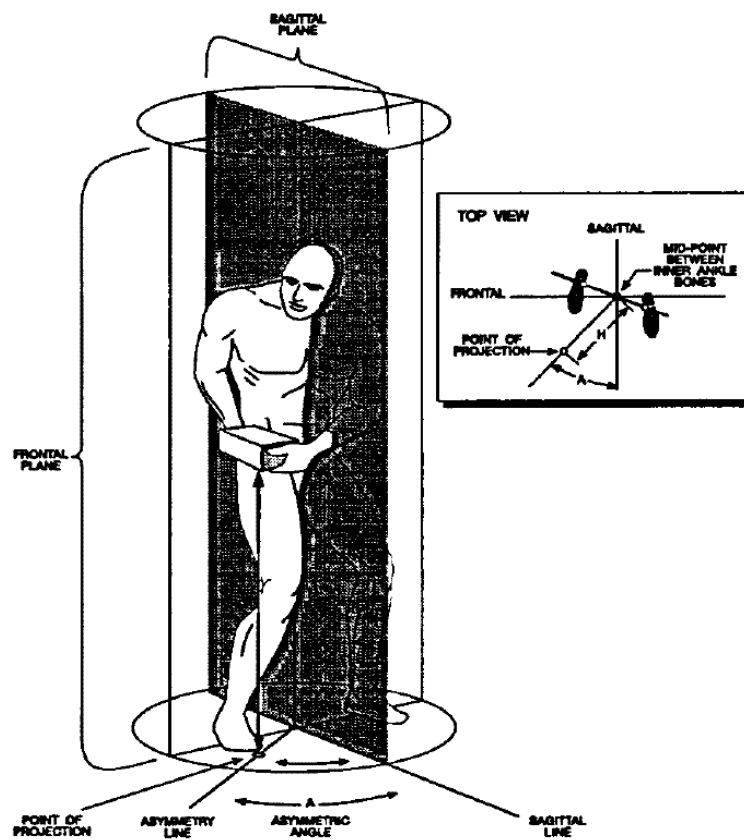
Figure 2-1: Determination of asymmetry angle [25]

- AM = Asymmetric Multiplier,  $1-(0.0032A)$ , where A is the angle between the asymmetry line and the mid-sagittal line. This is basically a measure of how much a worker must twist when picking up the item. Figure 2-1 shows how this angle is determined.
- FM = Frequency Multiplier, derived from the frequency and duration of the lifting. Because the tool is assumed to be lifted infrequently ( $<0.2$  lifts/min) and for a short duration ( $<1$  hour), this multiplier is set at 1.
- CM = Coupling Multiplier, derived from the quality of hand-to-item coupling, or how easy it is to grasp the object. This multiplier will be set at 1, since it is assumed that the tool will be designed such that it is easy to lift (e.g. using straps or handles)

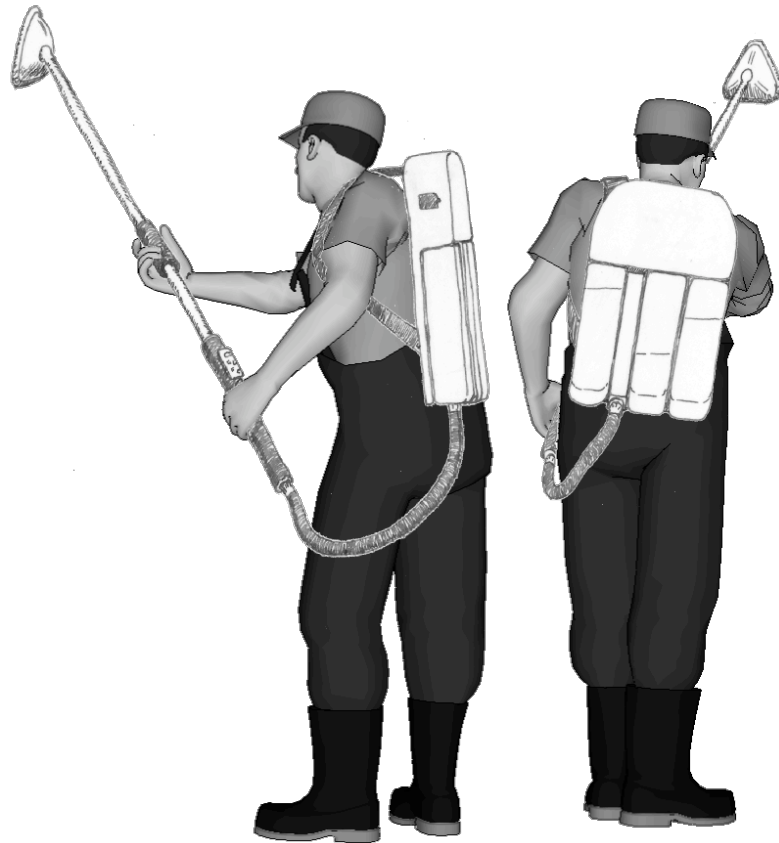
**Figure 2-2: Conceptual sketch of sign cleaning tool**

solvent would be applied by a powered pump and recovered into a tank by a vacuum. A conceptual sketch is shown in Figure 2-2.

It should be noted that this is only an initial design proposal and will need to be developed further. For instance, the power requirements for extended operation of the vacuum system may be larger than can be feasibly supplied by battery, or the telescoping wand may increase the cost and complexity of the tool such that a static wand is a better choice. In any case, these concepts (and possibly others) should be further investigated, screened, scored and ranked, and the best one chosen.

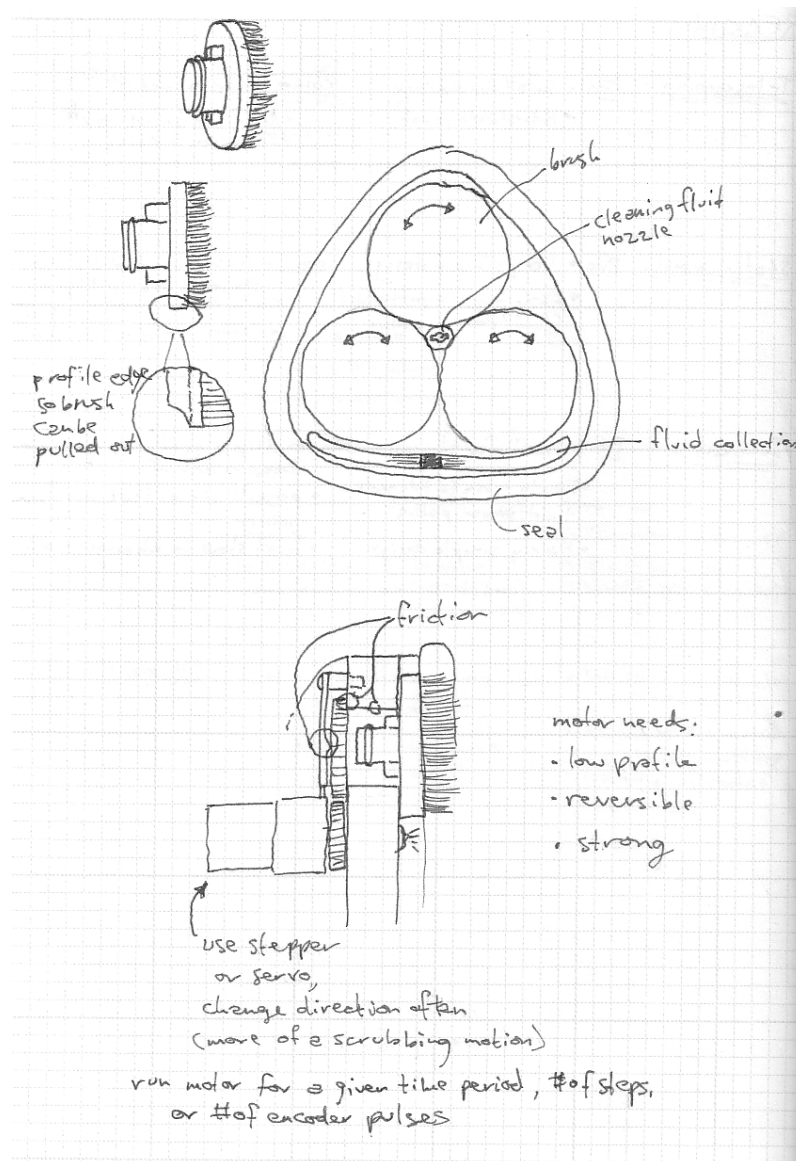
**Figure 3-1: Conceptual sketch of end effector**

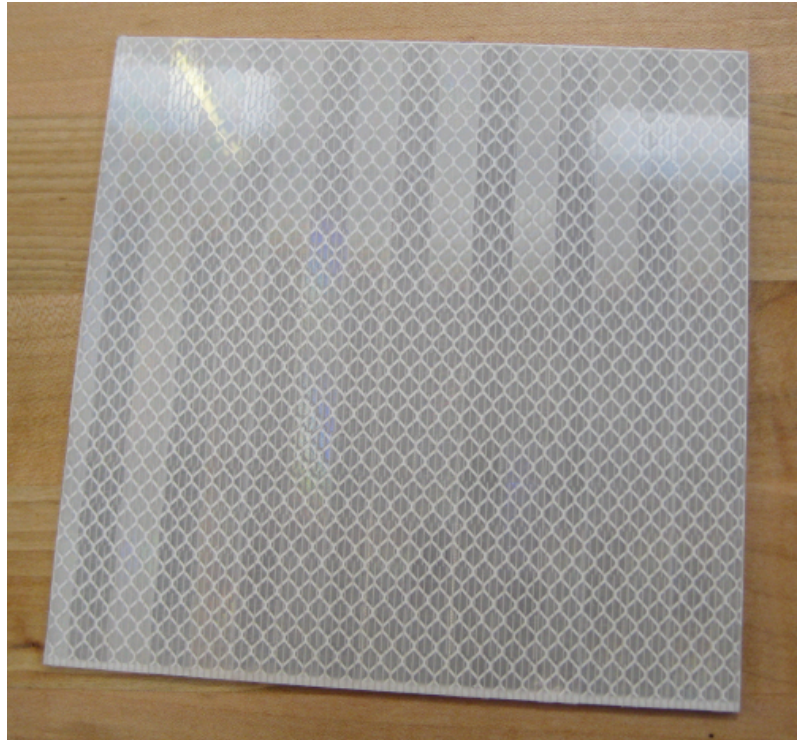
**Figure 3-2: Typical sign sample used in test**

The samples under test were 15.24 cm (6 in) square panels of 6061-T6 aluminum coated with plain white 3M Series 3930 High Intensity Prismatic retroreflective sheeting (Figure 3-2). Half of the sign samples also had an additional coating of 3M 1160 Premium Protective Overlay Film (anti-graffiti coating). These materials were chosen because they are the most commonly used by Caltrans in road signage, and also because the prismatic film is the most susceptible to pressure damage from improper cleaning. White signs, as opposed to another color, were chosen due to price considerations and the fact that only reductions in  $R_A$  relative to a new sign are being measured.

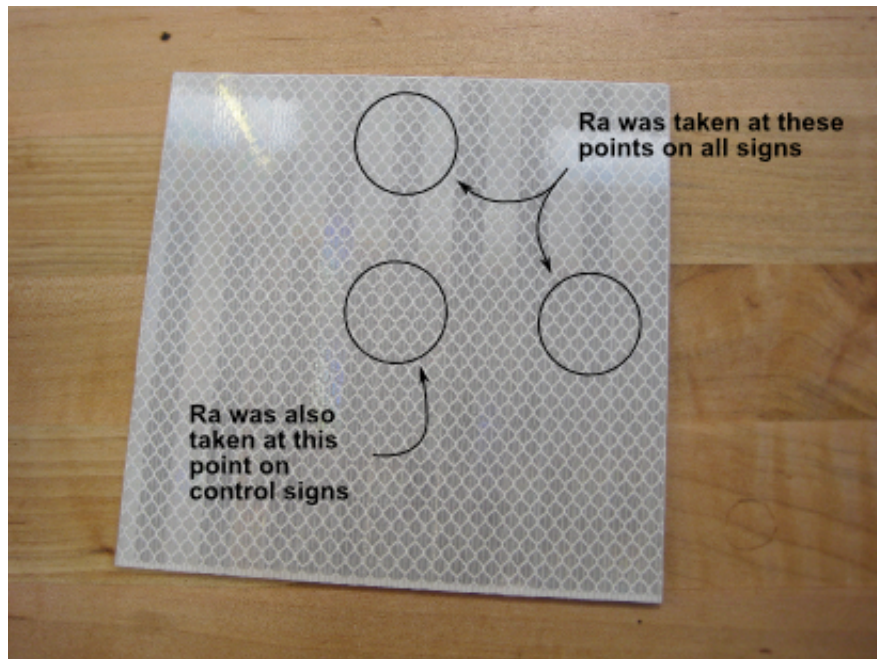
**Figure 3-3: Location of test areas on sign samples**

In order to compare the degradation of the sign, a set of new, untouched sign samples were used as a control. Five samples of each type of sign were taken randomly from the batch of signs used in the tests. Their  $R_A$  was taken in three spots on each one, for a total of six measurements per sign: one in the center of the sign, one at the center of the top edge, and one at the center of the right-hand edge (Figure 3-3). These readings were averaged together for each sign, and then the five values for each sign were averaged together to provide one control  $R_A$  value for each type of sign (with 1160, and without 1160). The results can be seen in Table 3-2. The control values were taken only once.

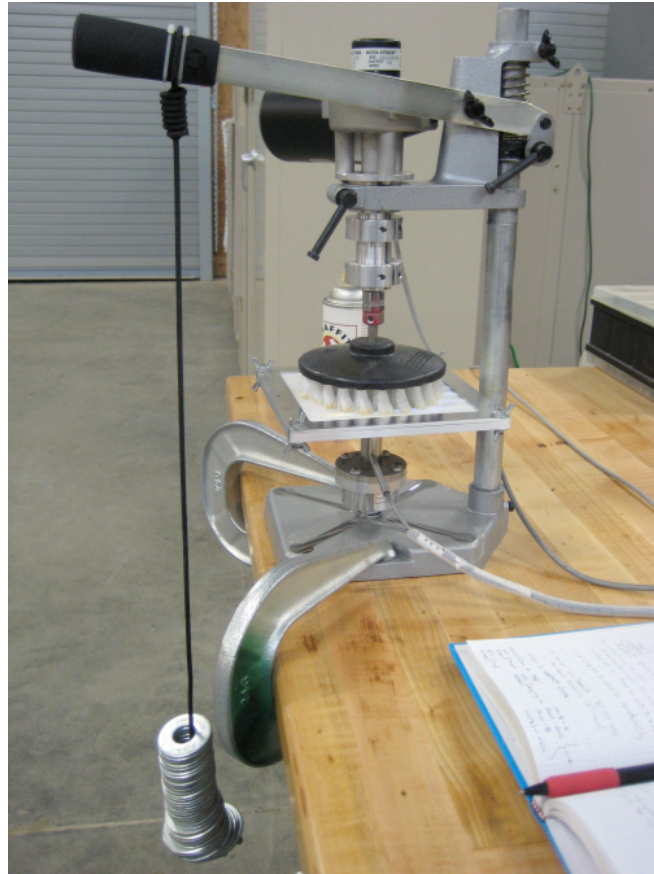
**Figure 3-4: Test fixture in use**

Figure 3-4 shows the test fixture in use.

The motor used in the test fixture was a reversible 12 VDC 100 rpm 24.9 W (1/30 hp) gearmotor, which could generate 2.26 N-m (20 in-lbs) of torque and pull 6 amps continuously at no-load conditions. This motor was chosen based on basic calculations of the interface between the brush and sign. The coefficient of friction (COF) data that most closely represented the brush-sign interface was that for polystyrene sliding on polystyrene, for which the static COF is 0.5 (kinetic unavailable) [30]. Since the static COF is generally higher than the kinetic COF and since the sign surface was to have cleaner applied to it which would act as a lubricant, this value was taken as the worst-case scenario and used in the motor-size calculations for the test stand. Because the test fixture uses flexible bristle brushes, it was assumed that axial loads would result in

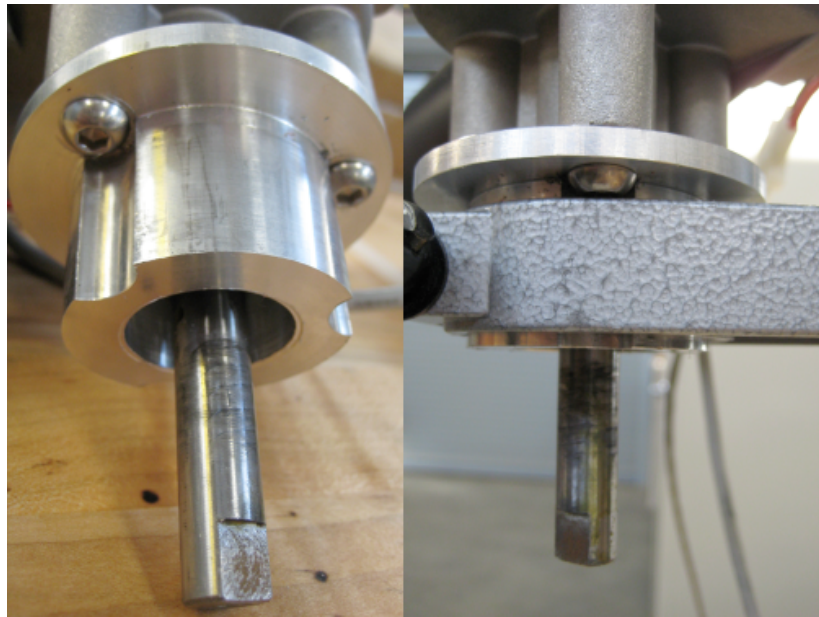
**Figure 3-5: Flange motor mount. Left: bolted to motor. Right: clamped in stand.**

In order to fit the motor into the carriage of the test stand, a flange mount was machined from aluminum (Figure 3-5). This flange attached to the motor mounting holes on the motor and clamped into the collar of the carriage. It also had a hole bored

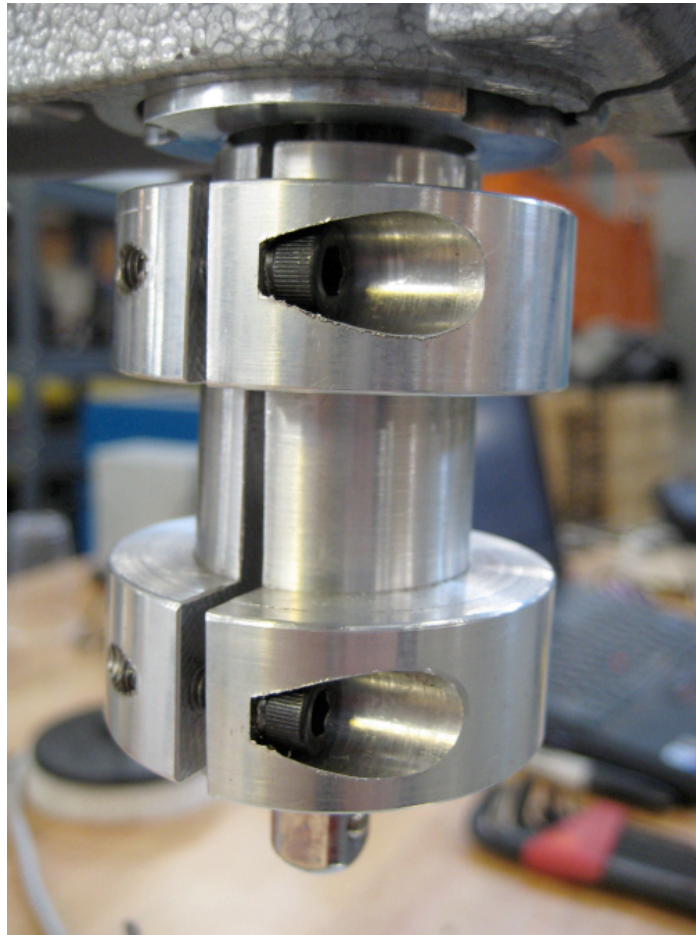
**Figure 3-6: Coupling from shaft to brush**

lengthwise through its center which allowed passage of the motor shaft. The shaft was in turn coupled to the brush by a rigid aluminum two-piece clamp-on shaft coupling, which was turned down a bit on a lathe in order to reduce the inertial load it presented to the motor (Figure 3-6).

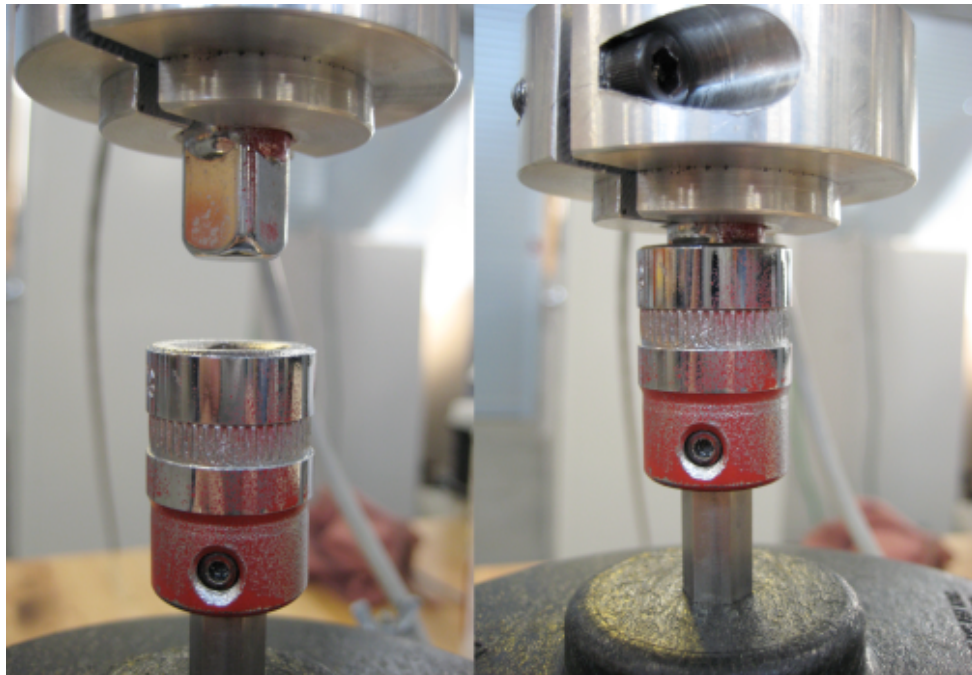
**Figure 3-7: Brush connection to clamp-on coupler**

Because a few different types of brushes would be tested, it was advantageous to be able to rapidly change the brushes, as well as move them out of the way so that sign samples could be loaded and unloaded from the test bed. This was achieved by inserting a 1/4" to 3/8" socket driver adapter into the coupling, such that the 3/8" side stuck out of the bottom. Then, a 3/8" drive 5/16" hex bit socket, with the bit removed and the brush's

drive shaft in its place, was attached to that, such that the brush could be rapidly moved or changed (Figure 3-7).

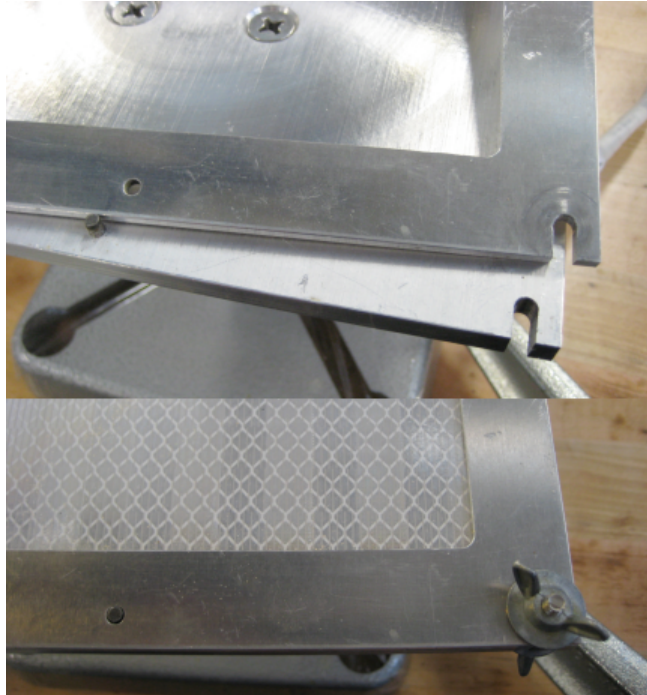
**Figure 3-8: Detail of test bed showing frame attachment method**

The bed on which the sign samples were tested was comprised of a flat plate on which the samples were placed, and a frame that covered the sign along its edges and held it immobile for the test. This frame was attached to the plate by four dowel pins (which prevented rotational motion and allowed quick registration of the frame to the plate) and four wingnut and machine screw combinations (which provided clamping force on the sign) in slots along the upper and lower edges of the frame and plate. Slots were used rather than holes so that the signs could be quickly and easily changed; the wingnut and machine screw combinations needed only to be loosened slightly in order to be removed and the sign sample changed, rather than having to completely disassemble any hardware (Figure 3-8). The flat plate was rigidly attached to a flange-to-flange mount torque sensor, which in turn was rigidly attached to a load sensor, which in turn was rigidly

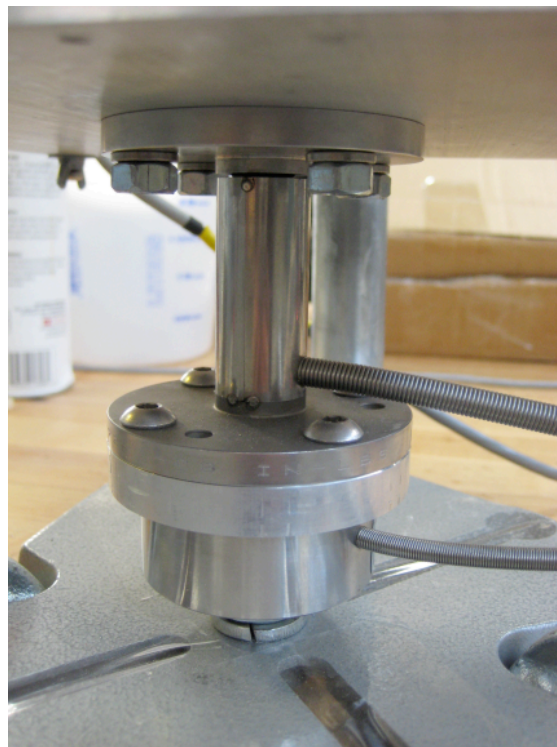
**Figure 3-9: Torque cell and load cell affixed between test bed and stand**

attached to the bed of the Makita fixture (Figure 3-9), and the entire test stand was rigidly clamped to a table.

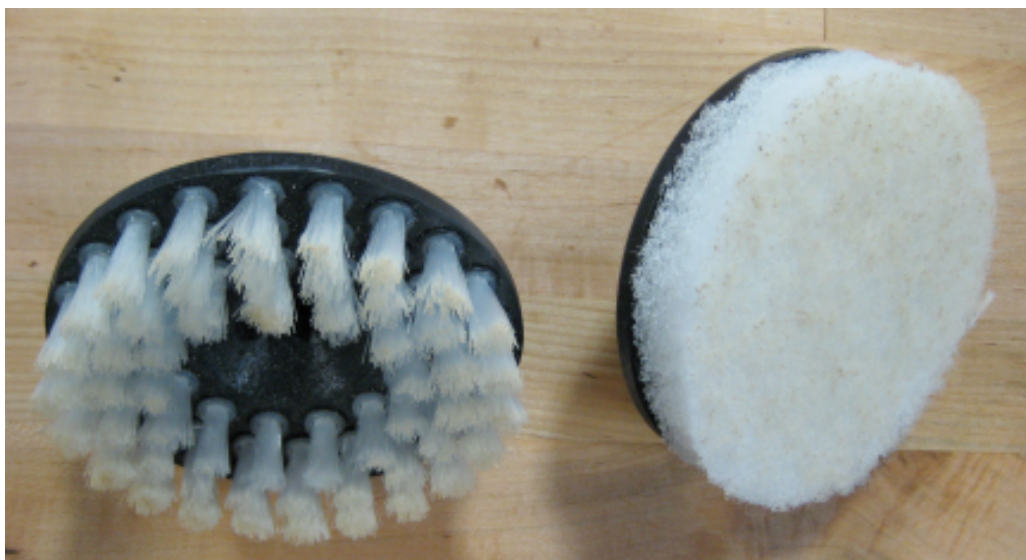
**Figure 3-10: Brushes used in tests. Left: Polypropylene; Right: Scouring Pad**

Two different types of brushes were used for the first test, both manufactured by the same company (Tucel Industries, Inc.) and attached to the test fixture the same way. One was a polypropylene bristle brush (Figure 3-10, left), with bristles about 2.54 cm (1 in) in length, an inner diameter of about 6.35-7.62 cm (2.5-3 in), and an outer diameter of 12.7-13.3 cm (5-5.25 in), depending on the amount that the bristles spread out due to the load. The other was a scouring pad (Figure 3-10, right) made of an unknown material with a diameter of 12.7 cm (5 in). The pad itself was replaceable, and attached to the base by small hooks, much like hook-and-loop fasteners (Figure 3-11). These materials were chosen because of the contrast in the way each behaved when moving across the sign. When the brushes changed direction, the bristles underwent a large amount of bending while their tips remained stationary. This caused a spike in the force being applied to the sign by the brush, which subsided once the bristles began their sliding motion in the opposite direction. If a sign were to be subject to pressure damage, it is possible that a significant amount would happen at that point.

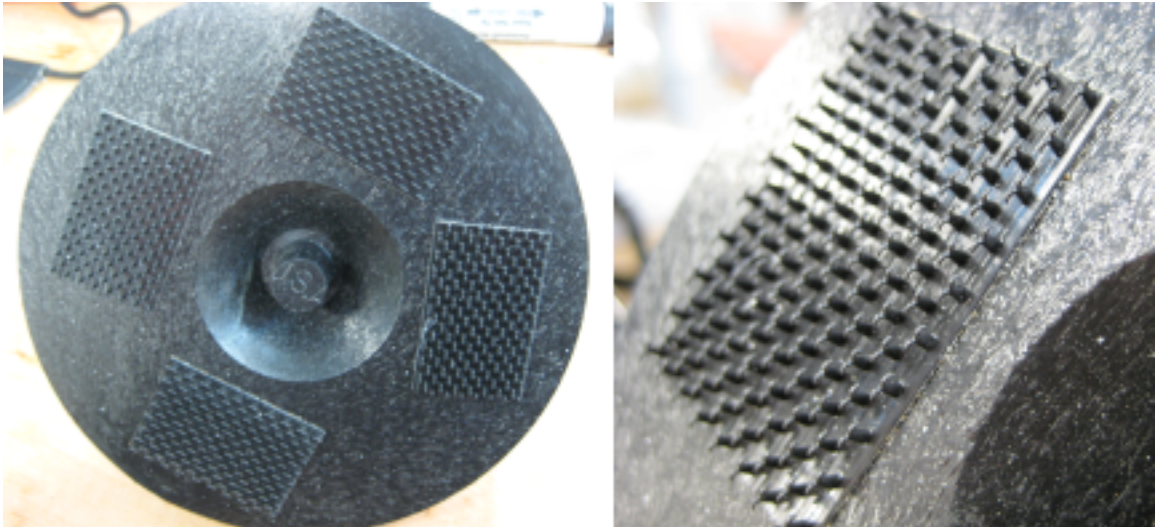
**Figure 3-11: Hook-and-loop attachment for scouring pad**

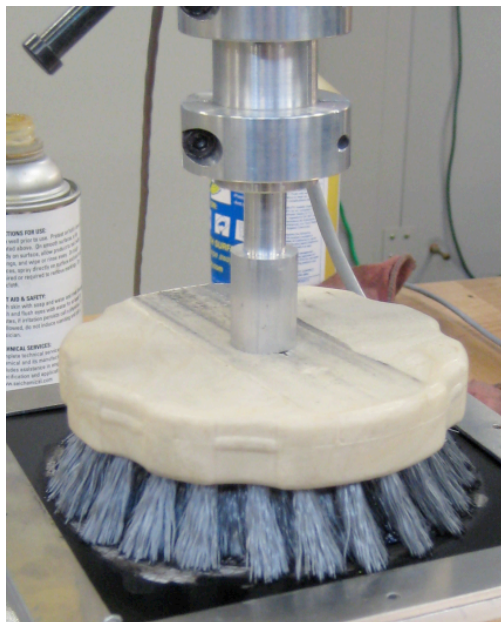
**Figure 3-12: Polystyrene brush**

For the second and third tests, a polystyrene brush manufactured by Grainger, Inc. was used (Figure 3-12). This brush had an outer diameter of 13.3 cm (5.25 in) and an inner diameter of 3.81 cm (1.5 in) with 2.54 cm (1 in) bristles, and had a 0.95 cm (3/8 in) shaft that fit into the shaft coupling. This brush's bristles were softer than those of the polypropylene brush, but were still resistant to chemical damage.

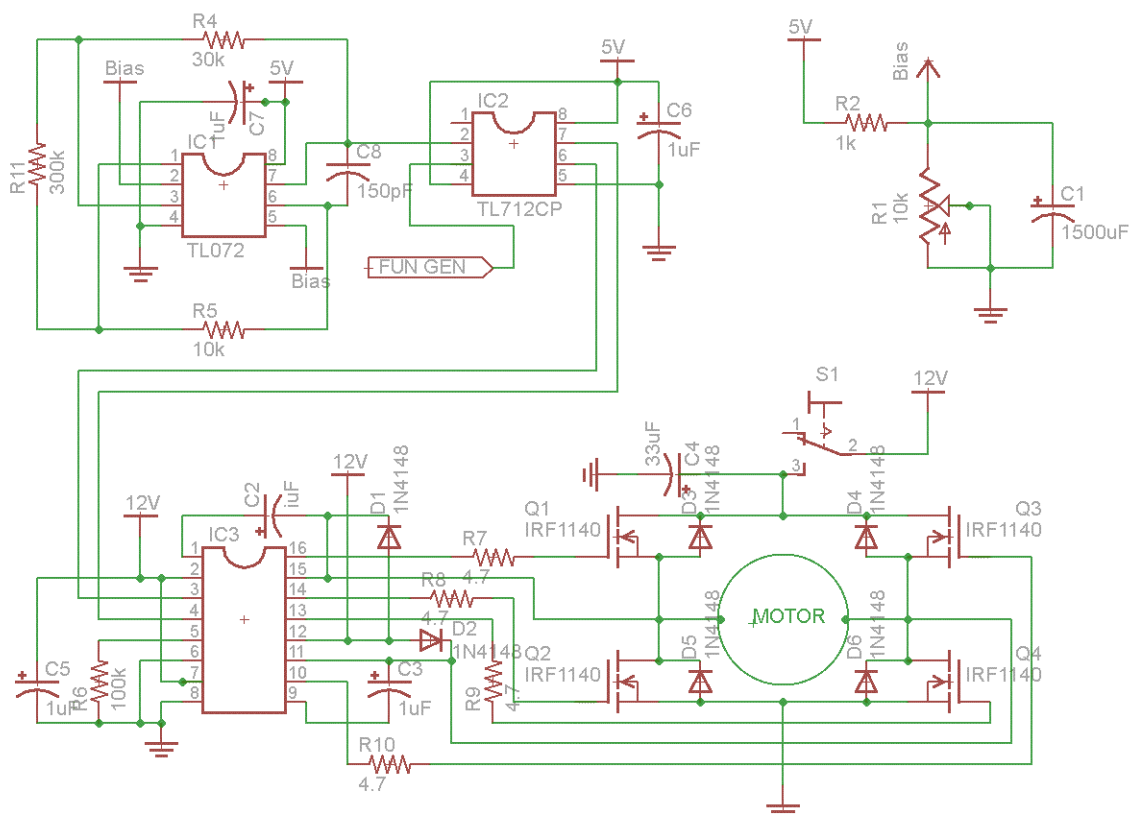
**Figure 3-13: Class D PWM driver schematic**

To obtain the motion, a variable frequency and amplitude signal was generated by the LabVIEW VI and sent through the digital acquisition card (DAQ) to a class D amplifier (schematic shown in Figure 3-13), which generated an amplified pulse-width modulated (PWM) signal, which was then sent to the motor. Two speeds were used for the test: ~30 rpm, and ~65 rpm, on average, for the low and high values. Neither of these was completely exact due to the changing loads that were presented to the motor from the brush type and the axial force.

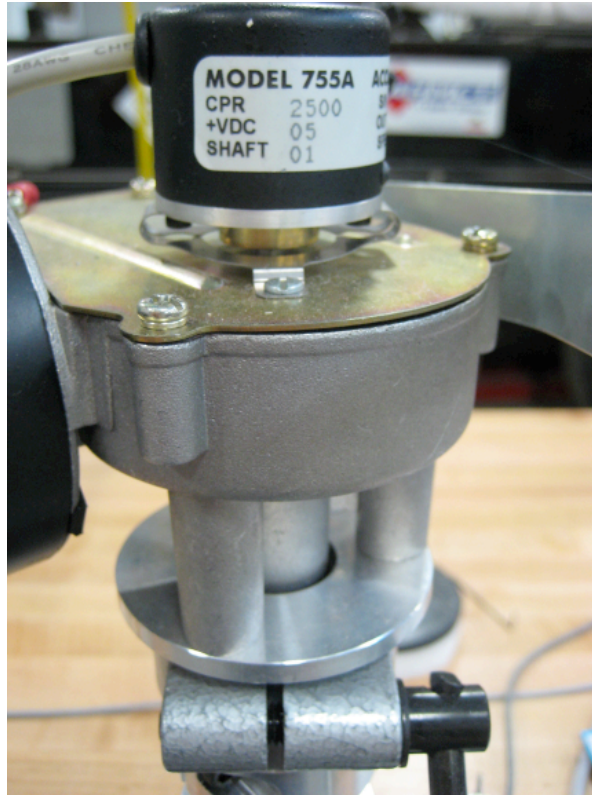
**Figure 3-14: Encoder attached to back of motor**

The rotational rate was measured by a Accu-coder 755A incremental rotary encoder with an output of 2500 pulses per revolution (Figure 3-14). This encoder was attached to the output shaft of the motor by physically altering the motor's stock construction. This involved cutting a hole in the backplate of the worm gear box and adding a shaft extension that stuck out of the hole. The encoder was then attached to this shaft extension, and the body of the encoder was rigidly attached to the backplate of the worm gear box. The output of the encoder was routed to a National Instruments USB-6229 16-bit DAQ card for input to the VI.

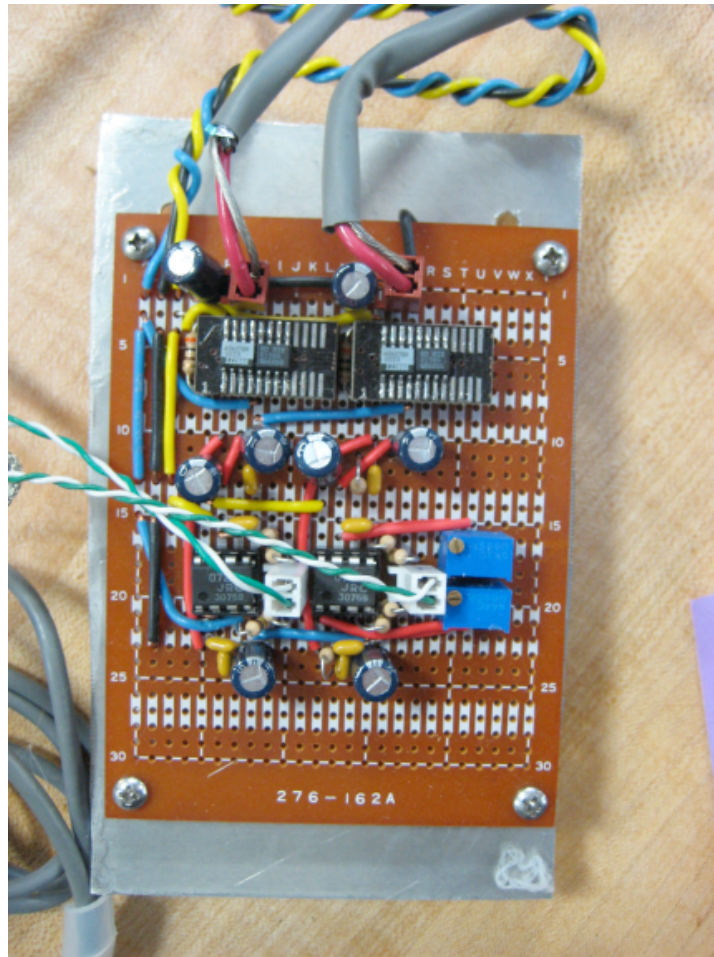
**Figure 3-15: Filtration and amplification circuit for instrumentation**

Both the torque and load sensor outputs required filtration and amplification before being digitized by the DAQ card. Filtration was accomplished using a Sallen-Key topology, which creates an active 2<sup>nd</sup> order low-pass Butterworth filter, with the cut-off frequency set at 50 Hz in order to filter out any high-frequency noise. Due to having such a low-level output, the filter for the load cell also incorporated a gain stage of 2. The filtered signals were then sent to an instrumentation amplifier, where they were boosted by a gain of 800 (Figure 3-15). Finally, these signals were routed to the DAQ card.

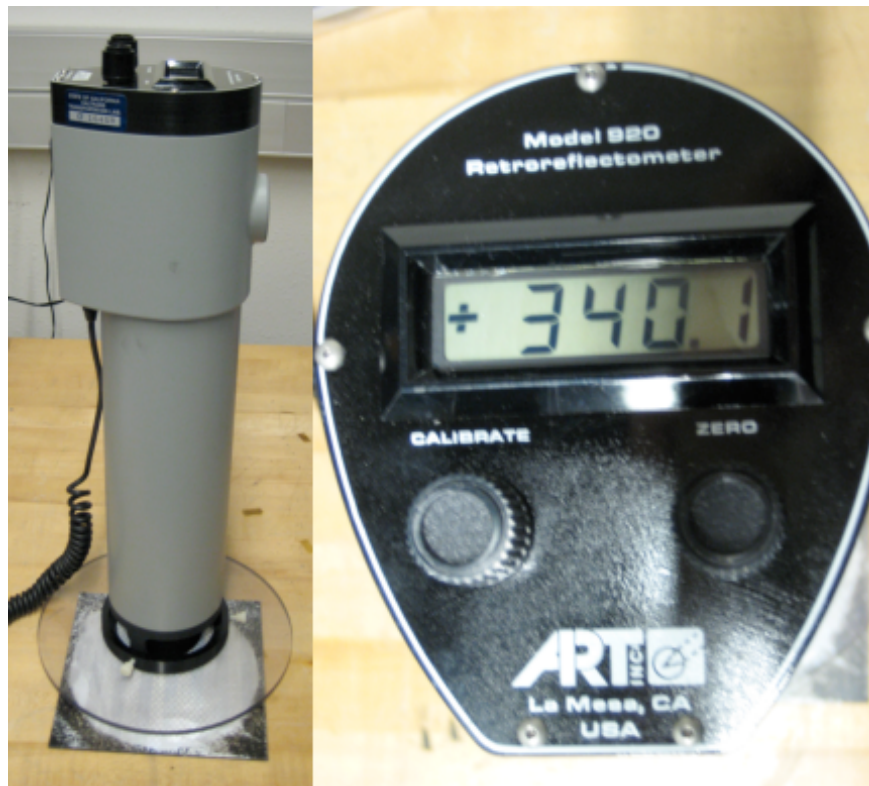
**Figure 3-16: Retroreflectometer; Detail of calibration knobs and readout**

Once all replicates of the test were run, the resulting coefficients of retroreflectivity ( $R_A$ ) were measured for each sign, to be later compared against control values. The  $R_A$  values were taken using a Model 920L field retroreflectometer manufactured by Advanced Retro Technology, Inc. First, the retroreflectometer was calibrated using two different materials of known  $R_A$ , by using the two knobs on the end of the retroreflectometer (Figure 3-16). The first material was a flat black felt surface with an  $R_A$  of zero, by which the retroreflectometer was zeroed out. The other material was a small piece of encapsulated glass bead retroreflective film with a known  $R_A$  of 308.

Once the retroreflectometer was calibrated, the  $R_A$  values of the control samples were taken. The standard method for taking the readings, as dictated by the manufacturer, was to take a measurement at roughly  $0^\circ$  orientation, another at the same spot but with the retroreflectometer rotated roughly  $90^\circ$ , and then to average these two measurements. This average value counts as one reading.

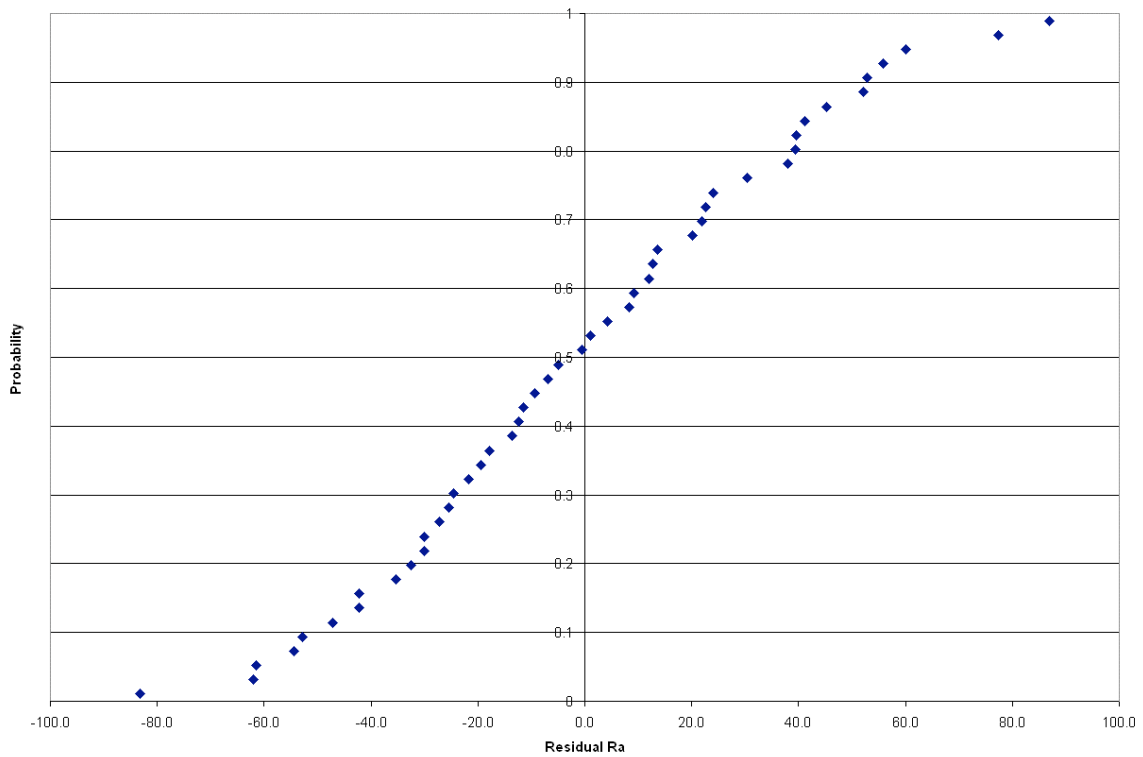
**Figure 3-17: Probability plot of residuals for  $R_A$  data**

which is the difference between the actual data point and the grand mean over all data points. Figure 3-17 shows the plot. Although the data are somewhat spread out, they appear to be normally distributed, and so the following analysis methods are most likely relevant.
