**Assessment of Graffiti Removal Practices and Initial  
Development of a Tool for Removing Graffiti from  
Retroreflective Signs**

**Report Number: CA09-1955**

**Final Report of Contract: 65A0275, Task ID: 1955**

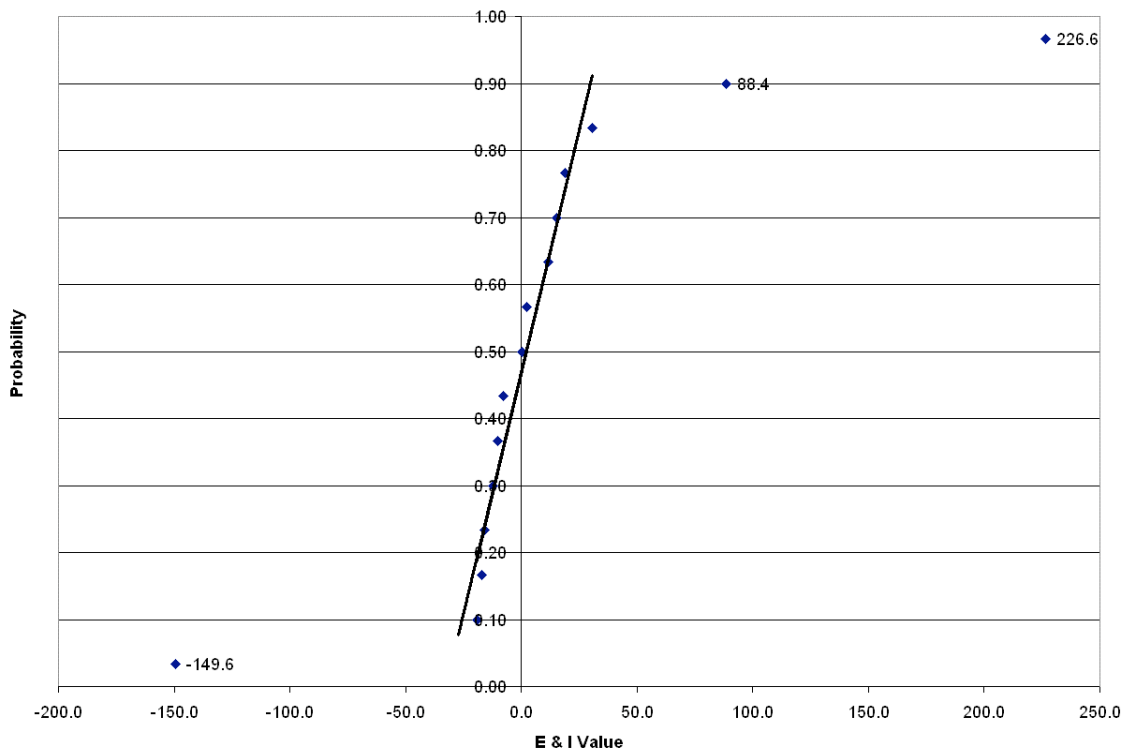
**Figure 3-18: Probability plot of ordered effects and interactions**

The effects and interactions of the factors were calculated by multiplying the average  $R_A$ 's for a given run by the signs indicated in the column of the factor of interest. Then these values were summed and divided by the divisor shown in that column. This results in the difference between the two averages of the "positive" values and the "negative" values (for more clarification on the calculations see Appendix C: Sample Statistical Calculations). For instance, to calculate the interactions between factors 1 and 2, the values in the AVG column are multiplied by the signs in the 12 column, then summed and divided by 8 (Table 3-3). The values obtained from this process are shown in Table 3-4 along with the standard error. These values were ordered and put into a normal probability plot (Figure 3-18), where it becomes apparent that the effects from 3, 4 and 34 (in bold) are likely to be significant because they lie well off the "error line" and are almost certainly not due to noise. Recall that factors 3 and 4 are the brush type and the

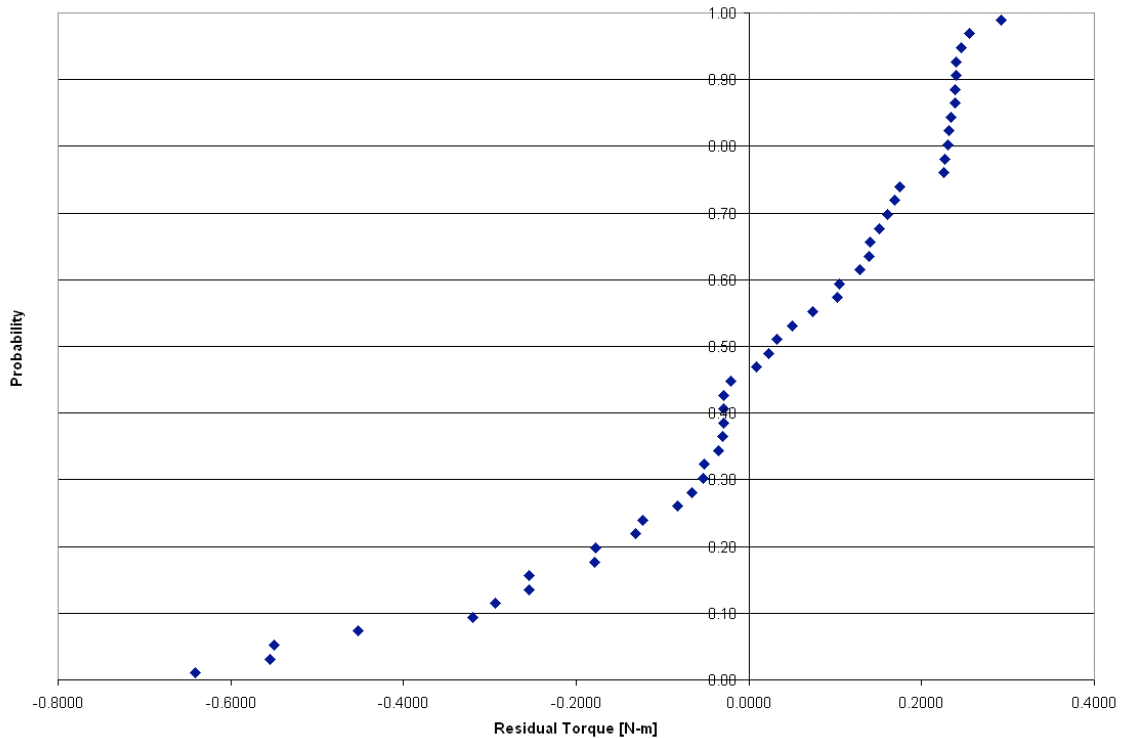
**Figure 3-19: Probability plot of torque residuals**

However, if the residuals are calculated and plotted in a fashion similar to Figure 3-17, the result is Figure 3-19. Note that the residuals do not appear to be distributed normally about the mean, which indicates that further investigation of the effects and interactions of the factors may not be accurate. However, it should be enough, looking at the raw data, to notice that the highest levels of torque appear in the runs which used the scouring pad on the 1160 film at high load (runs 14 and 16). The next highest levels of torque appear in the runs which used the scouring pad without the 1160 film at high load (runs 6 and 8). This may be enough information to suggest a motor size, given a particular brush choice and axial load.

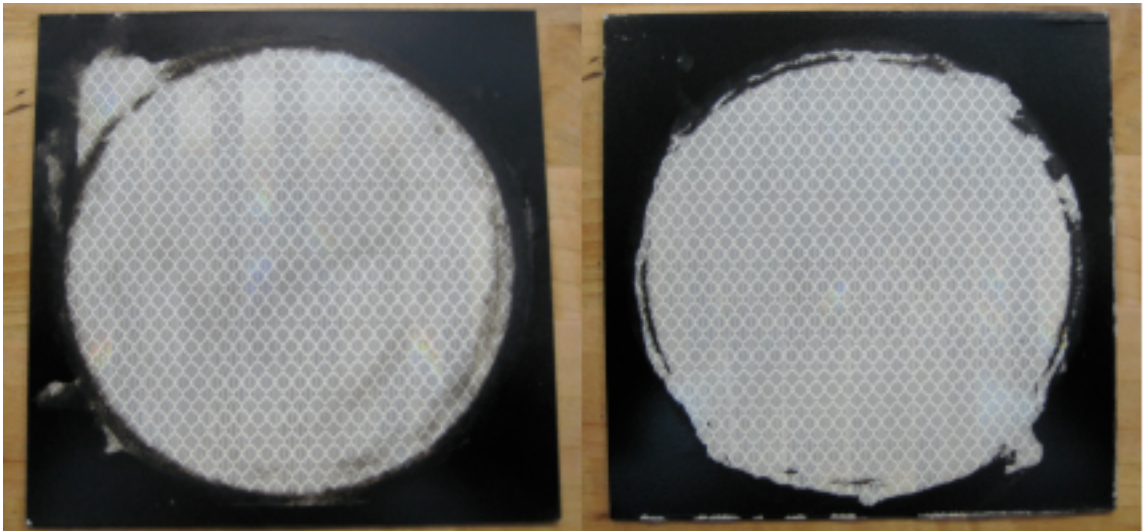
**Figure 3-20: Comparison of cleaned signs; Left with 1160, Right without.**

cleaning fluid, which could not be removed even with vigorous rubbing. This residue can be seen in Figure 3-20 as a mottled appearance in the cleaned area. Initially this was thought to be due to the paint adhering to signs with the 1160 film better than to those without, but further testing revealed that this was probably not the case. Instead, it was probably due to a lack of sufficient cleaner being used to remove the paint. Also, it appeared partway through the test that the paint seemed to be removed from the sign before the 40 cycles had passed, meaning that the runs could be of a much shorter duration. Thus, for future tests, the number of cycles was reduced from 40 to 20.

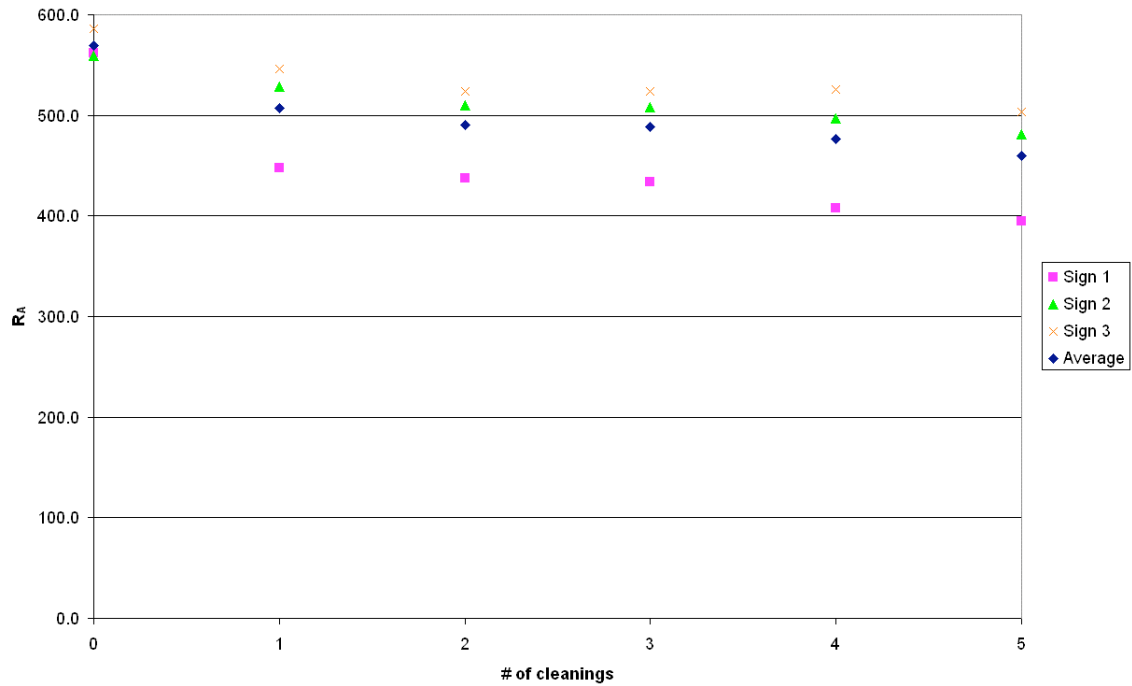
**Figure 3-21: Results from multiple runs w/o 1160 film**

rougher than a used one. Figure 3-21 shows the change in  $R_A$  for the signs without the 1160 film, and Figure 3-22 shows the change for those signs with the film.

These results were somewhat surprising. With the results from the factorial experiment, it was thought that the  $R_A$  would degrade steadily over several cleanings. Instead, what happened is the reduction in  $R_A$  leveled off, and in the case of the signs with the 1160 film actually began to improve dramatically. Visual inspection of the signs after the initial tests showed a fair amount of scratching on the surface from the new pad, but over time the samples began to regain a shiny surface again. It is thought that the reason for these results was probably a combination of pad wear and the characteristics of the cleaner. After the first few uses, the surface of the pad took on a noticeably softer feel which seemed to reduce its abrasive qualities. Additionally, once the SEI Graffiti Remover was applied and the solvent allowed to evaporate, the cleaner that was left behind had a waxy consistency which may have aided in "polishing" the sign. At any rate, it appeared that it was possible to clean the signs multiple times without significant damage, as the  $R_A$  levels never approached the minimum levels mandated by the FHWA.

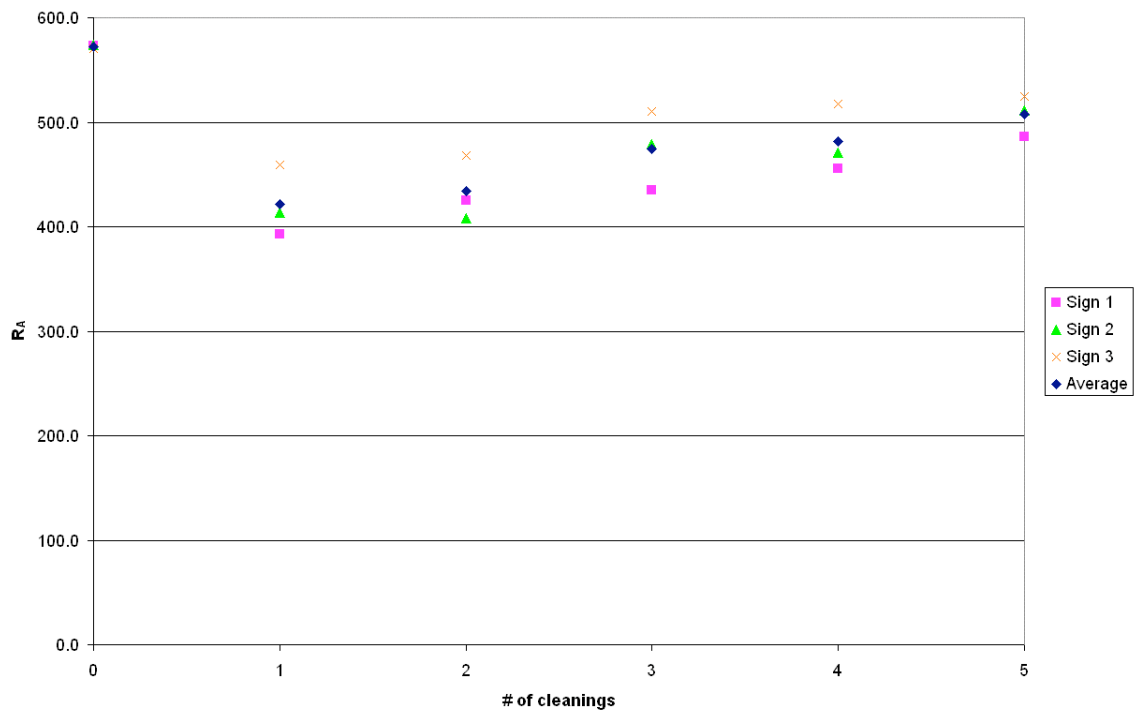
**Figure 3-22: Results from multiple runs with 1160 film**

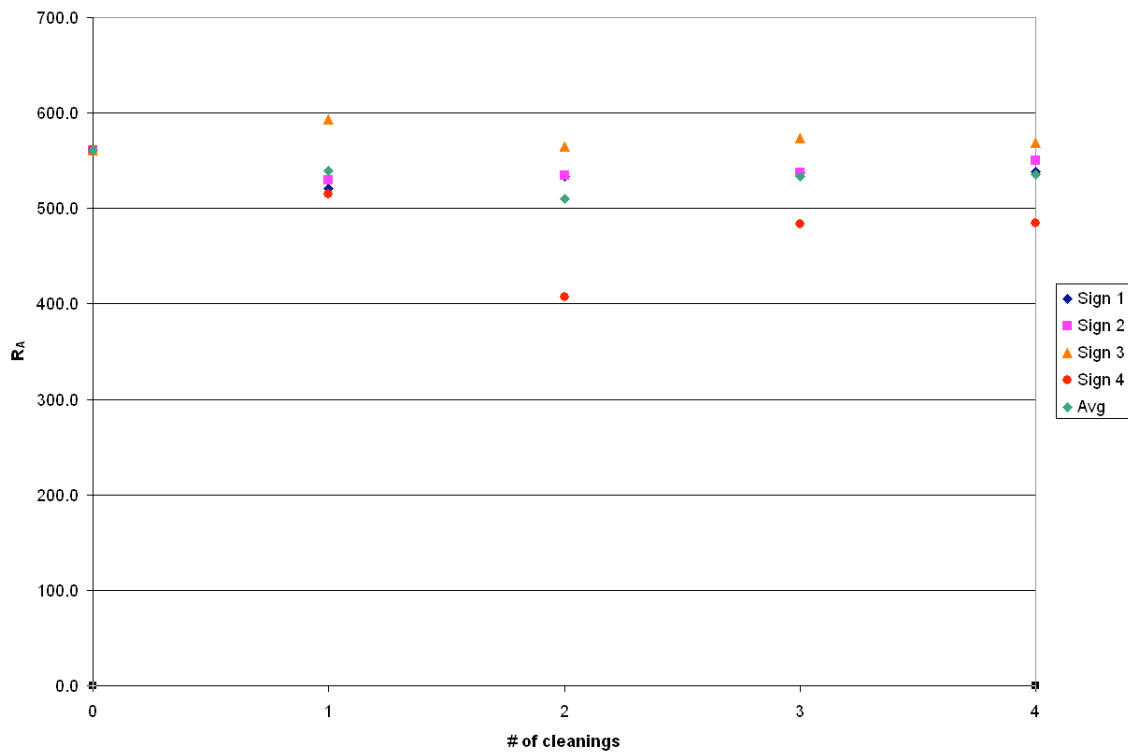
**Figure 3-23: Multiple cleanings on painted signs w/o 1160**

For the last test in the series, attempts were made to simulate a situation likely to be faced by maintenance workers: cleaning a sign that has been painted multiple times. The paint used was the same flat black spray paint used in the single-run test, was applied the same way and allowed to cure for at least 48 hours each time. Due to time constraints, only four cleanings were possible. Again, both signs with and without the 1160 film were tested, and the tests were run for 20 cycles. The pad used was the same one from the previous test, indicating that initial damage should not be a problem. Figure 3-23 shows the results from the signs without the 1160 film, and Figure 3-24 shows the results from those with the film.

While these results are not as dramatic as those from the previous test since none of the signs improved over several cleanings, it is notable that the  $R_A$  never really got close to the FHWA minimum levels. This indicates that it is probably possible to use the proposed design of a motorized pad and chemicals to clean a sign.

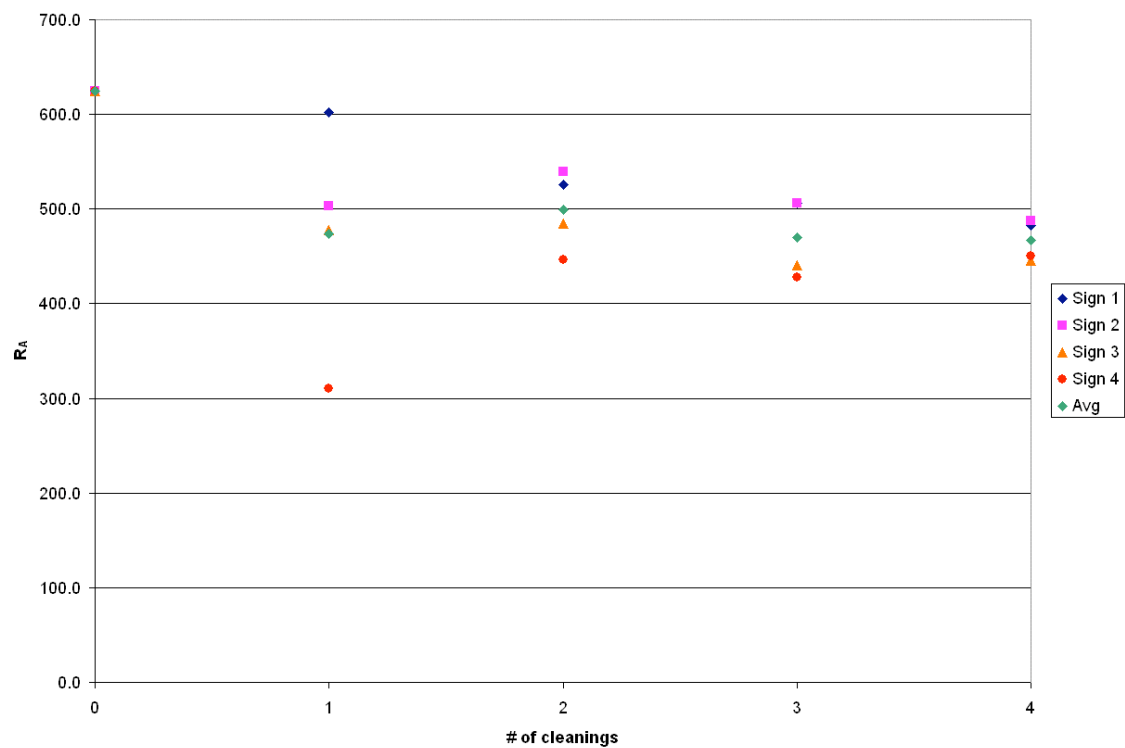
**Figure 3-24: Multiple cleanings on painted signs with 1160**

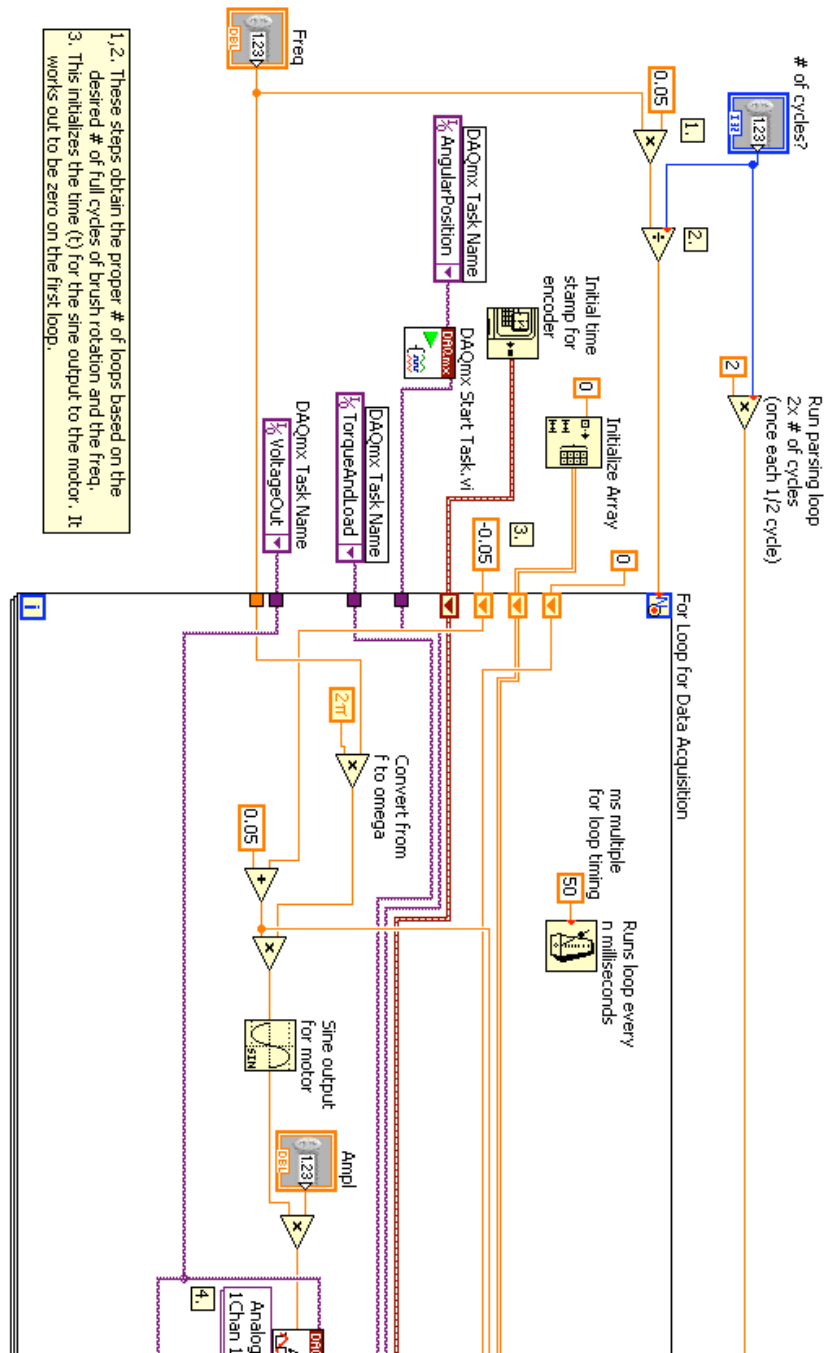
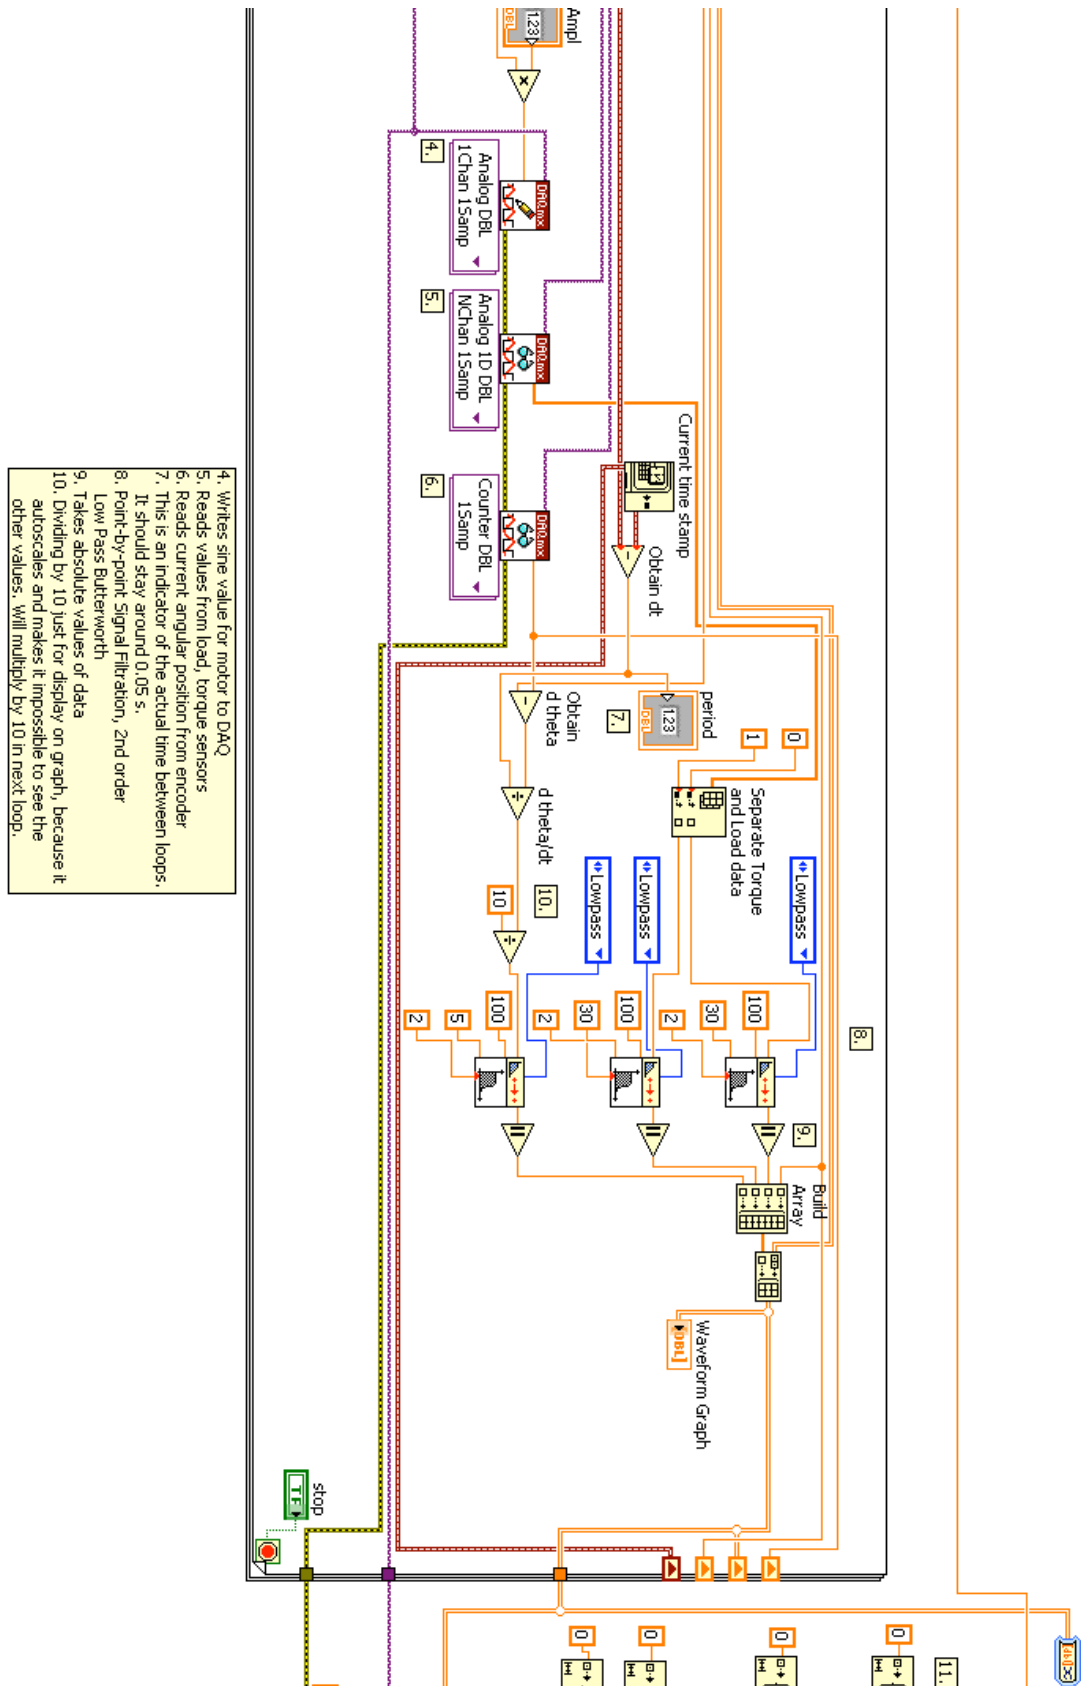
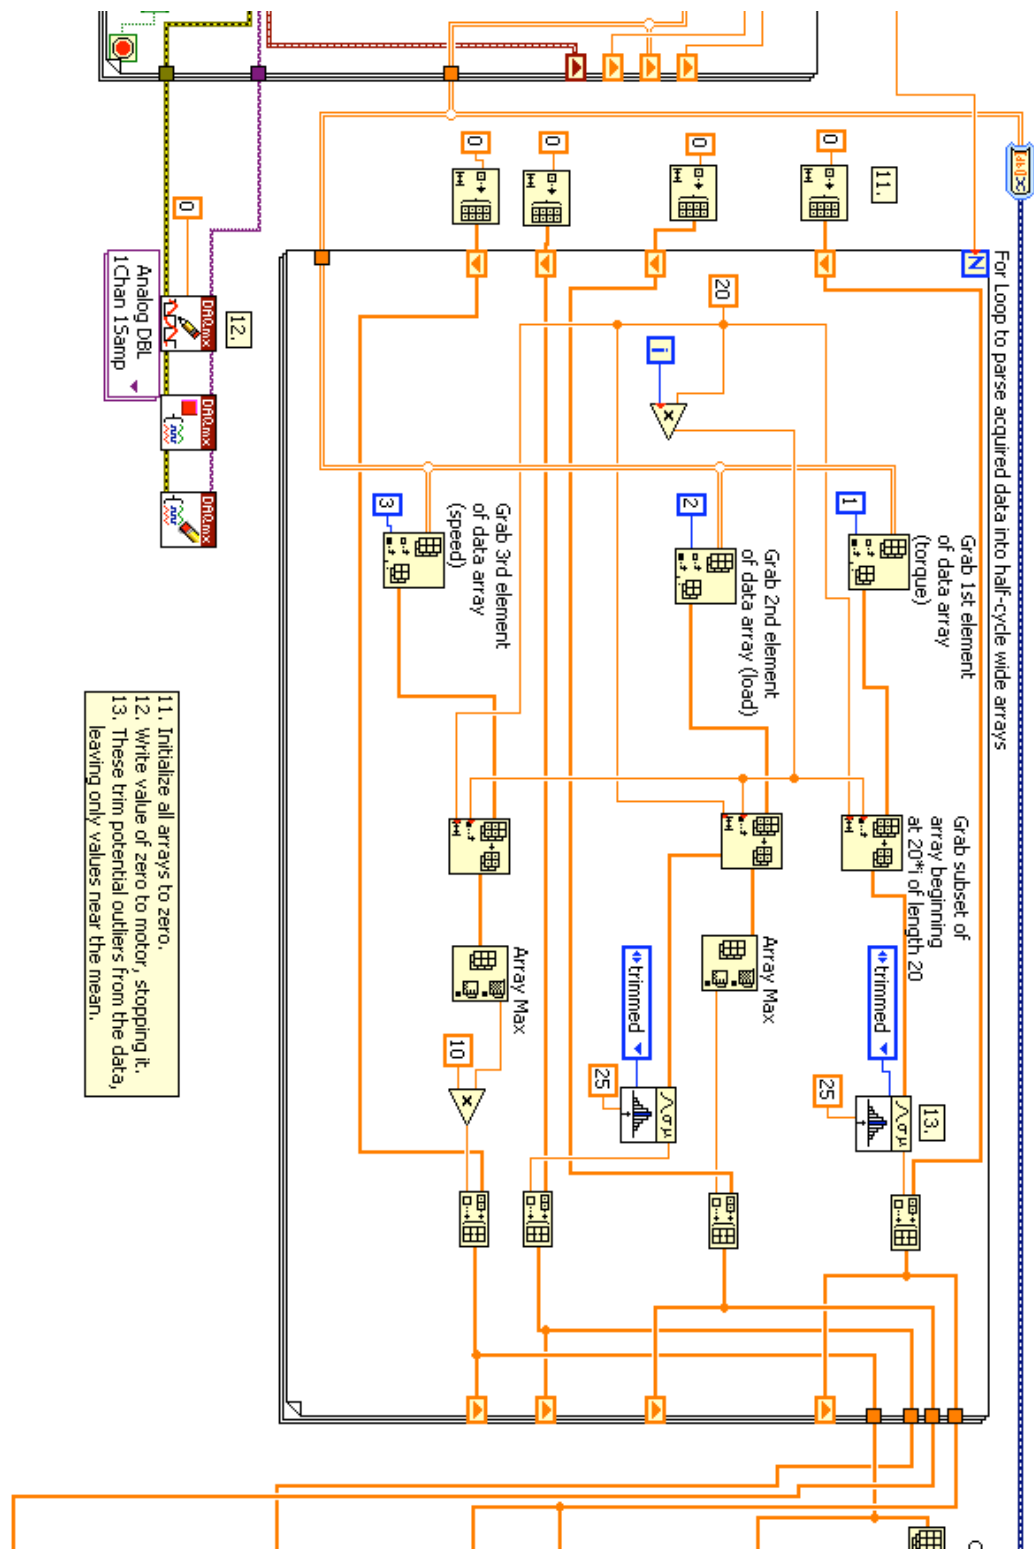
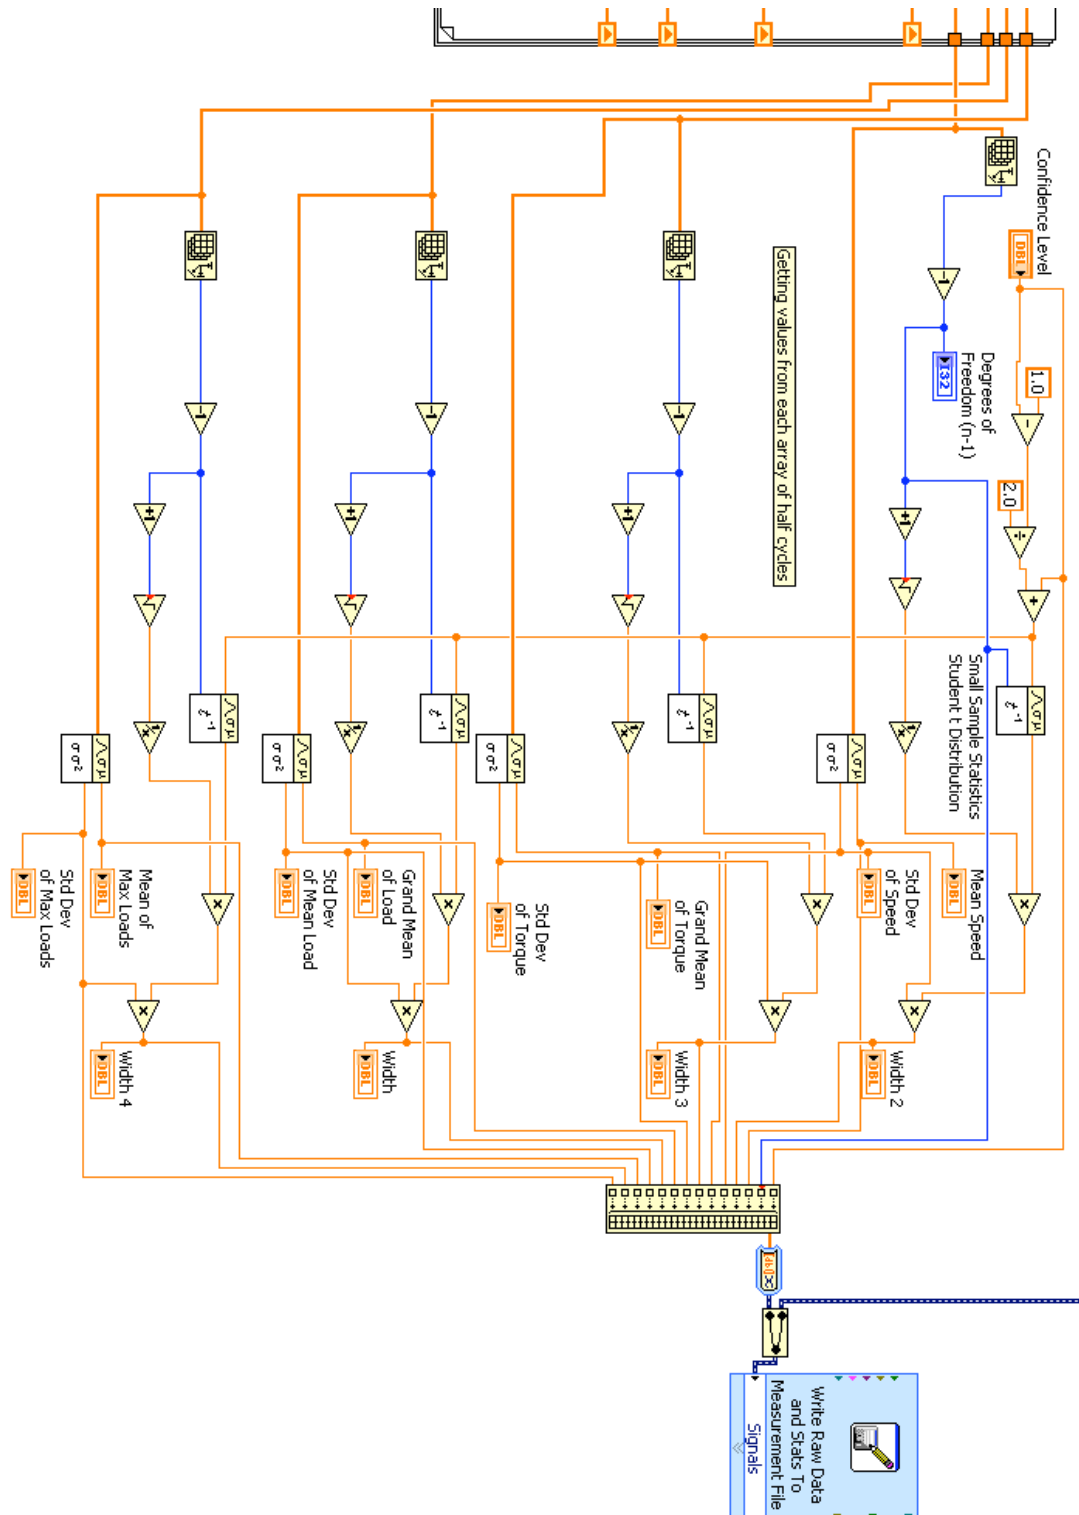
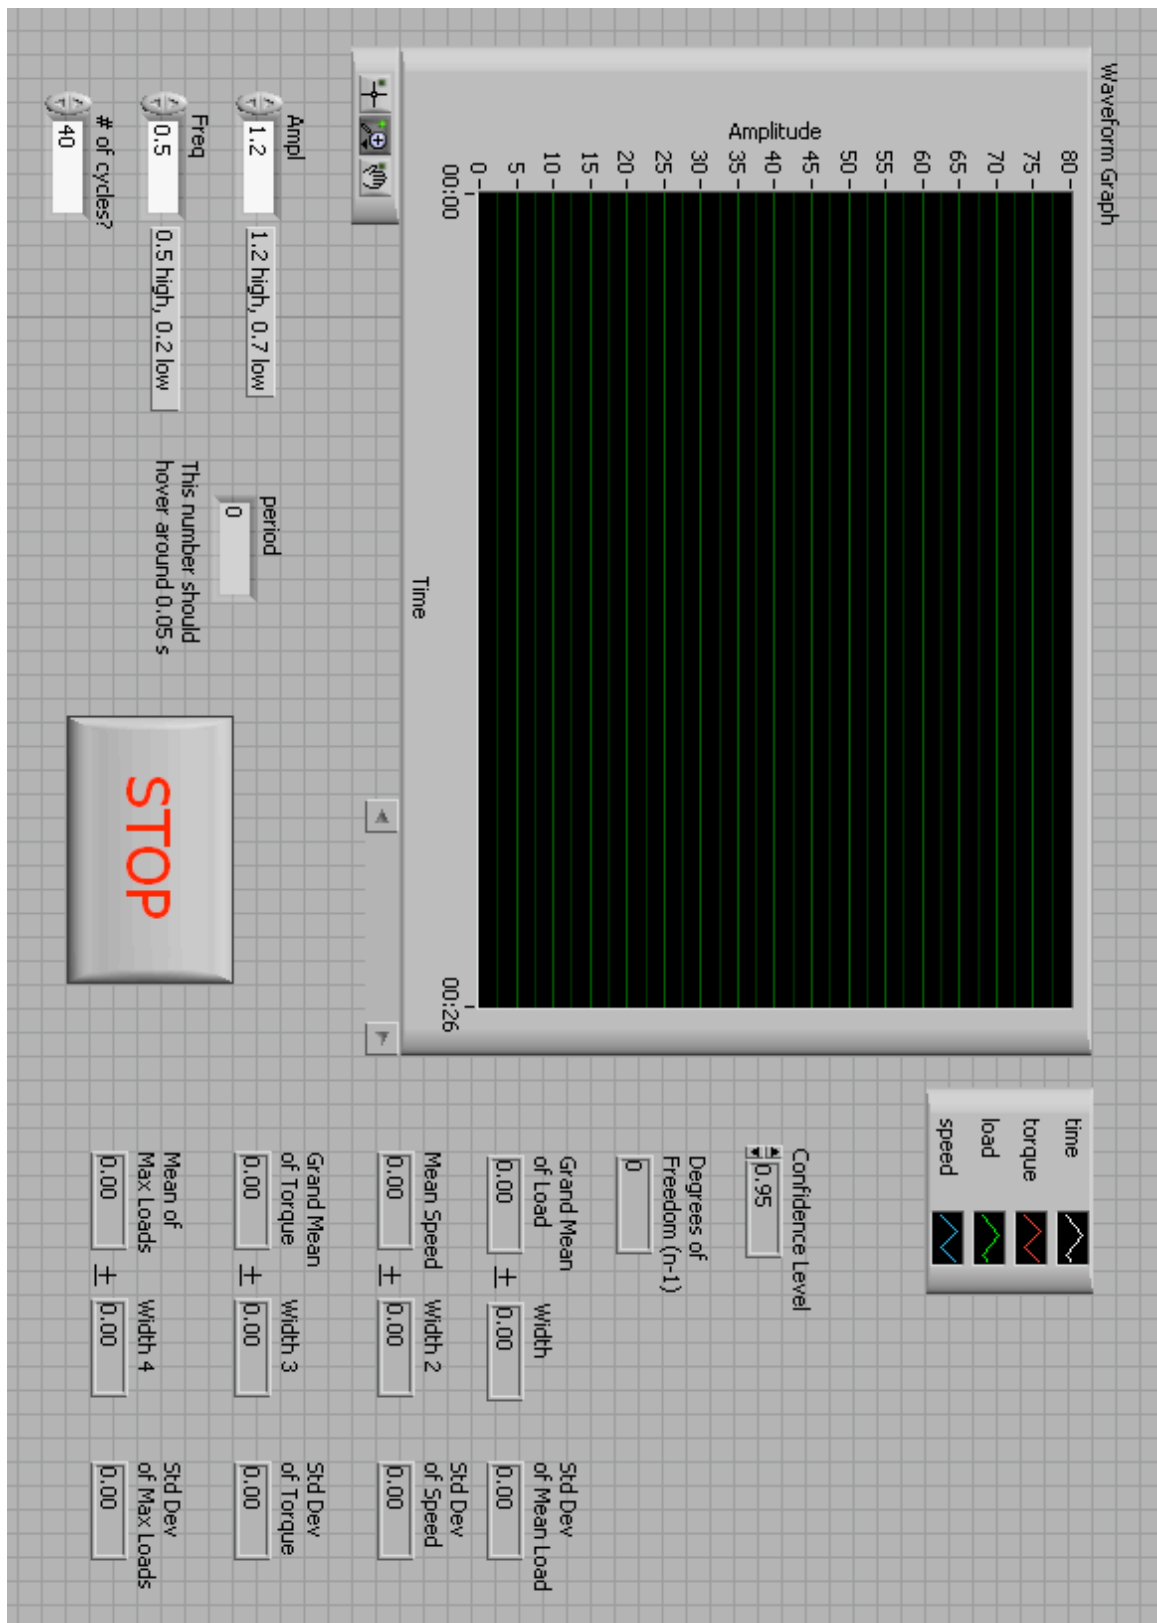
Figure 0-1

The following images show the LabVIEW Virtual Instrument that was written for the factorial experiment. The images should be tiled from left to right to obtain an image of the entire program. The final image shows the front panel of the VI.
