Evaluation of Pothole Patching Equipment and Processes

Report Number: CA12-1738 AHMCT Research Report: UCD-ARR-12-06-30-05 Final Report of: IA 65A0275, Task ID 1738

June 30, 2012

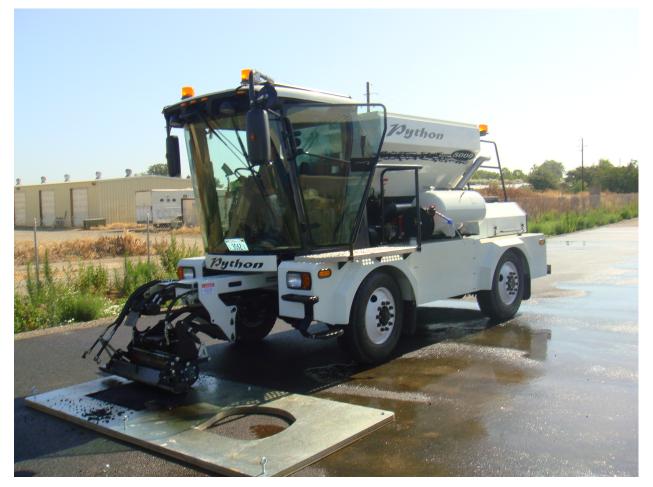
Figure 1. Python PHP 5000 Pothole Patcher During Testing at ATIRC

AHMCT staff was responsible for providing training, training materials, related training consumables, addressing maintenance issues and arranging heavy transport services to facilitate long distance moving of the Python Pothole Patcher (PHP) (see Figure 1) between Caltrans districts. AHMCT staff also acted as a liaison between Python Manufacturing, Caltrans and warranty service providers. The PHP spent a good portion of this research task deployed to Caltrans District 3 Rancho Cordova and District 4 Foster City, CA when operable.

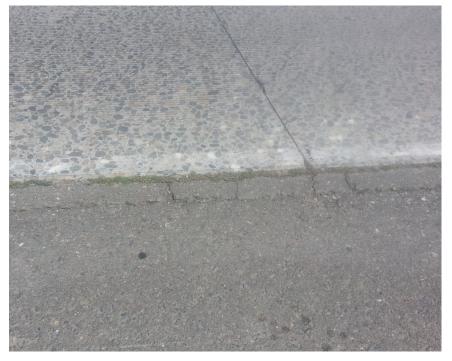
Figure 2. Example of an Edge Drain

Python Manufacturing was very receptive to suggestions that could potentially make the PHP more useful to Caltrans maintenance crews tasked with roadway surface repairs such as edge drain patching for example (see Figure 2). Python fabricated boom attachments that would control the dispensing and application of hot mix. Python also modified software options for the operator while in patch mode at AHMCT's request to facilitate slow rolling continuous patching consistent with linear edge drain repairs.

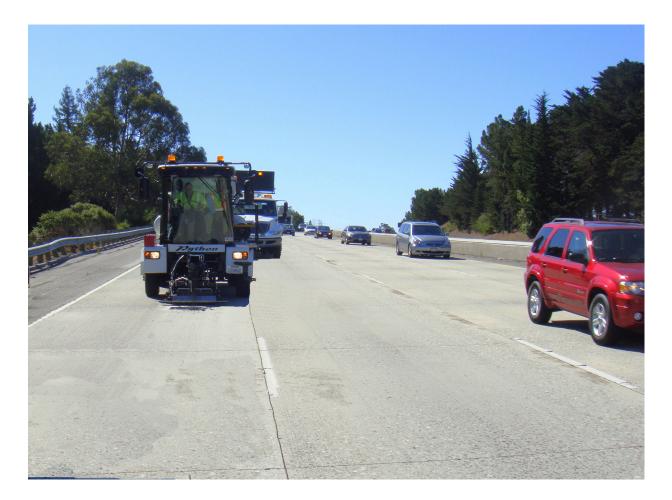
Figure 3. Python PHP Filling Potholes in Concrete Pavement N.B. I-280 Millbrae, CA

The PHP is currently deployed to Caltrans District 4 San Jose, CA and performing as designed. Figure 3 shows the PHP at work in Millbrae, CA. Maintenance crews and management have provided positive feedback regarding the PHP and its contribution to making roadway pothole patching safer, more effective and productive.
