Advanced Highway Maintenance and Construction Technology Research Center

Evaluation of Methods to Reduce Speeds in Work Zones

AHMCT Research Report: UCD-ARR-12-06-30-06
Final Report of Contract: 65A0275, Task ID: 2247

June 28, 2012

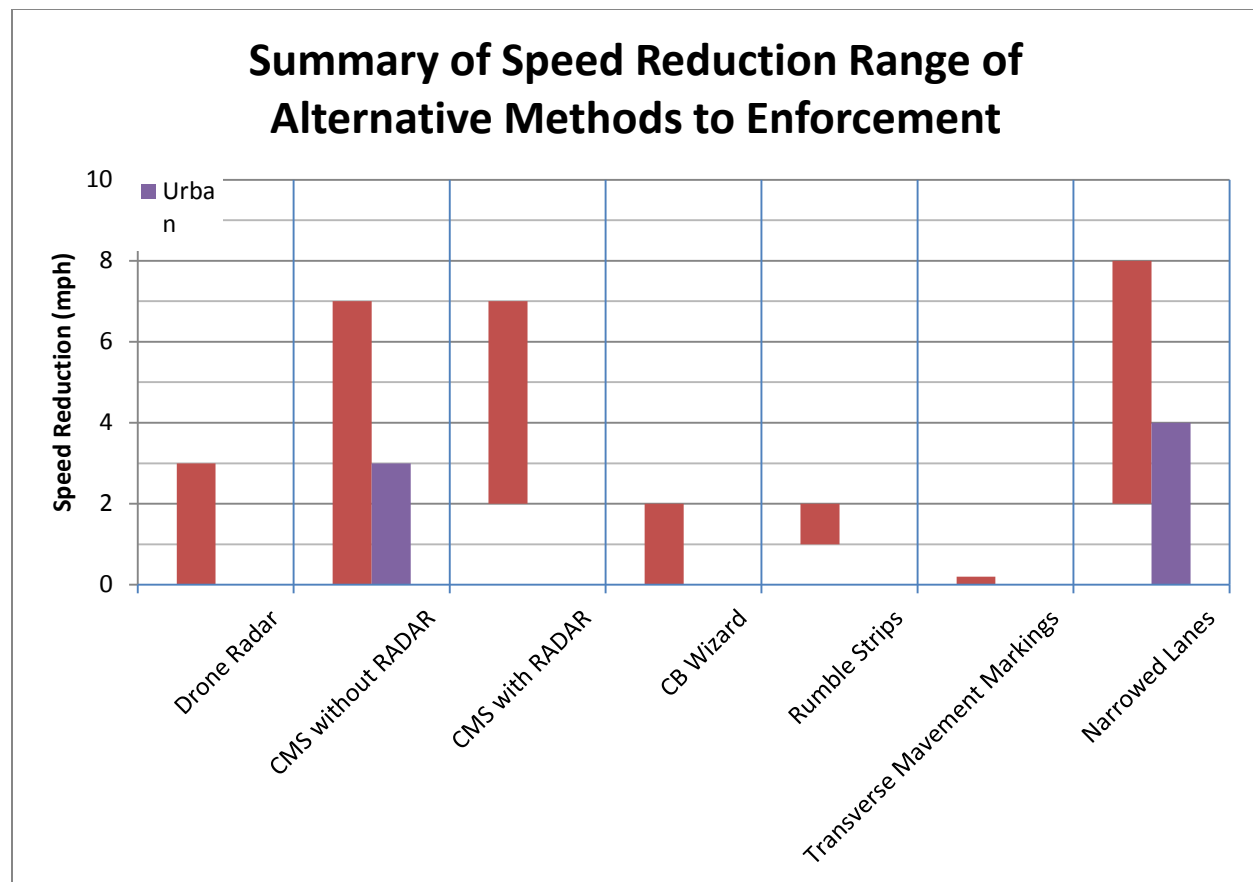
Figure 1: Summary of alternatives to the use of police enforcement (from data in [3], page 8)

It is clear from the data in this figure that use of CMS units with radar results in the largest speed reduction among the alternative enforcement methods considered. This suggests that the introduction of the CMS type device as a candidate to supplement COZEEP/MAZEPP operations in work zones can result in speed reduction without employing additional dedicated uniformed officer(s) and patrol vehicle(s) on site. Evaluating this and developing field experience in using a specific type of CMS unit that is presently used by CHP form the main part of this research.

Alternative methods of using police units on highways for speed reductions have been examined in the past. Many of the previous studies are discussed and summarized in a NCHRP report [2]. A plot of this summary in the form of a bar chart is depicted in Figure 1.

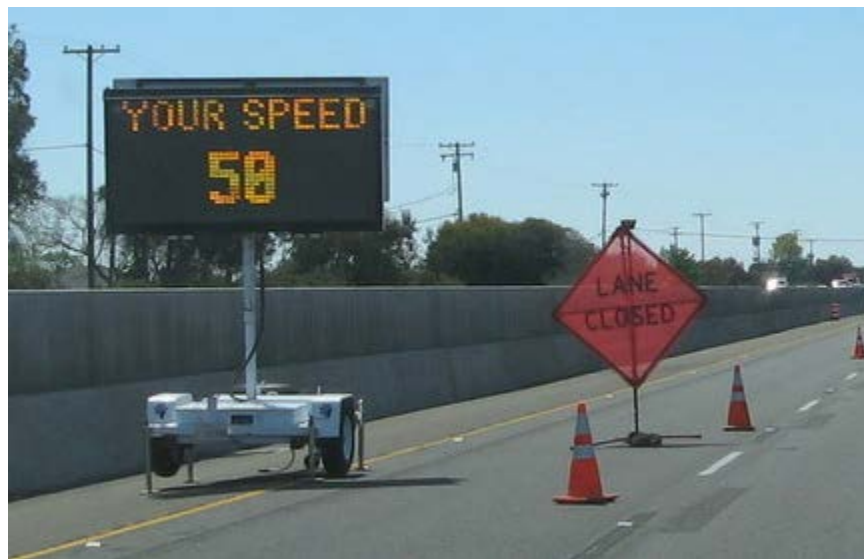
The particular CMS unit used in this study consisted of a display panel approximately eight feet wide and four feet high with an active LED matrix capable of displaying several lines of message. The entire unit was mounted on a trailer that would allow it to be towed to any location on the highway (Figure 2). The entire system is mounted on a self-contained, solar powered trailer which also houses the computer that manages the message displayed. The CMS with radar is an OEM (Original Equipment Manufactured) and all modifications are performed by CHP. The CHP-CMS trailer can be programmed to display messages such as lane closure advisories and reduced work zone speed limits. An onboard Doppler Effect radar unit is used to determine the speed of oncoming traffic and triggers a warning message display if the measured speed exceeds a certain preset threshold value. The programmed messages can be displayed intermittently with the measured speed to remind the oncoming vehicle of its speed.

Figure 2: The CHP-CMS Trailer

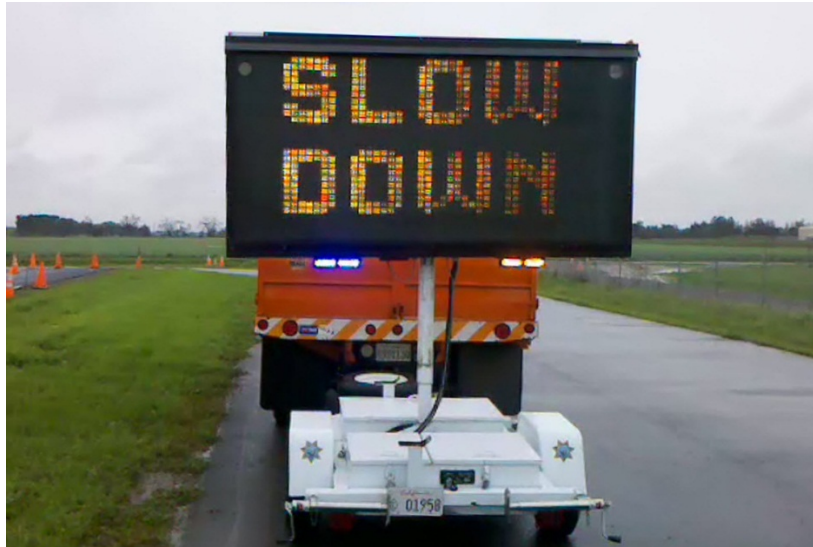
This CMS unit is owned and operated by the CHP and it is equipped with a blue and amber flashing light (standard color light used on CHP vehicles) mounted on the bottom of the display panel. At distance, the flashing light mimics the presence of a CHP patrol vehicle (hence the name CHP-CMS) thus strengthens the CMS's figure of authority. In case of driver being distracted from road condition, the flashing light is intended to capture driver's attention due to its strong visual cue and improves alertness (Figure 3).

Figure 3: CHP-CMS Trailer Showing Blue and Amber Lights

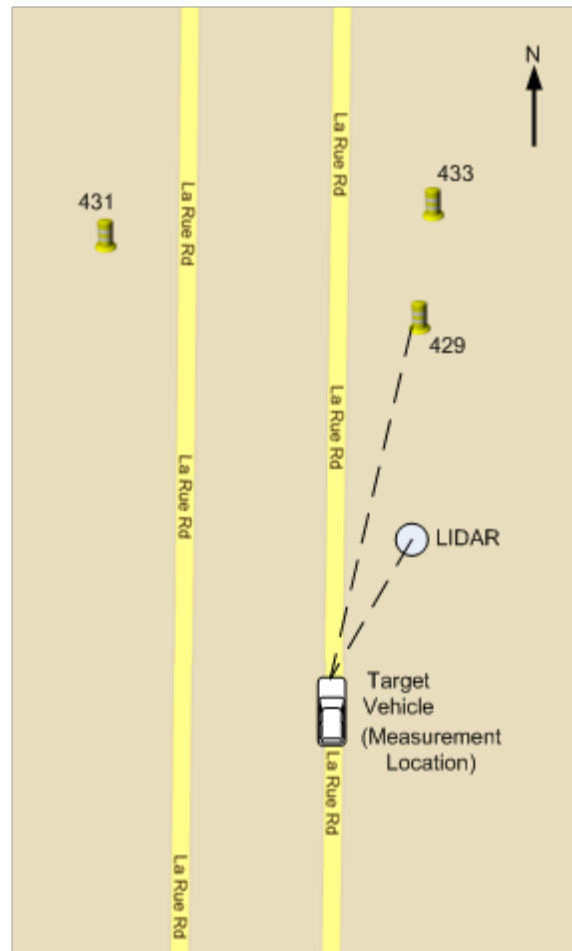
A set of tests were conducted on a north-south segment of La Rue Road near UC Davis on November 12, 2010. This road is a two-way, four-lane (two lanes in each direction) street with a median approximately the width of one lane and a speed limit of 30 MPH. Three iCones and one LIDAR unit (with an operator) were placed as shown in Figure 4.

Figure 4: iCone placements in speed accuracy test (not drawn to scale)
(Map data ©2013 Google)

iCone 429 was positioned downstream of the measurement location and aimed upstream at the northbound traffic. The iCone's specification indicates a detection range of approximately 150 to 200 feet from the iCone's location. Therefore, the LIDAR operator was positioned between the iCone and measurement location, approximately 130 feet upstream of iCone 429. At this location there was a tree that was used to help the operator stay out of sight of the driver's view for as long as possible. In this set up, the LIDAR operator tracked vehicles and obtained a speed reading for vehicles approximately between 20 to 70 feet upstream of his/her location, which would be the segment of roadway where the iCone is likely to obtain a speed reading. Only northbound traffic was recorded with the LIDAR gun. In order to determine whether iCone measurements are biased towards the lane adjacent to their placements, iCones 431 and 433 were placed approximately across from each other, both aiming north, covering approximately five

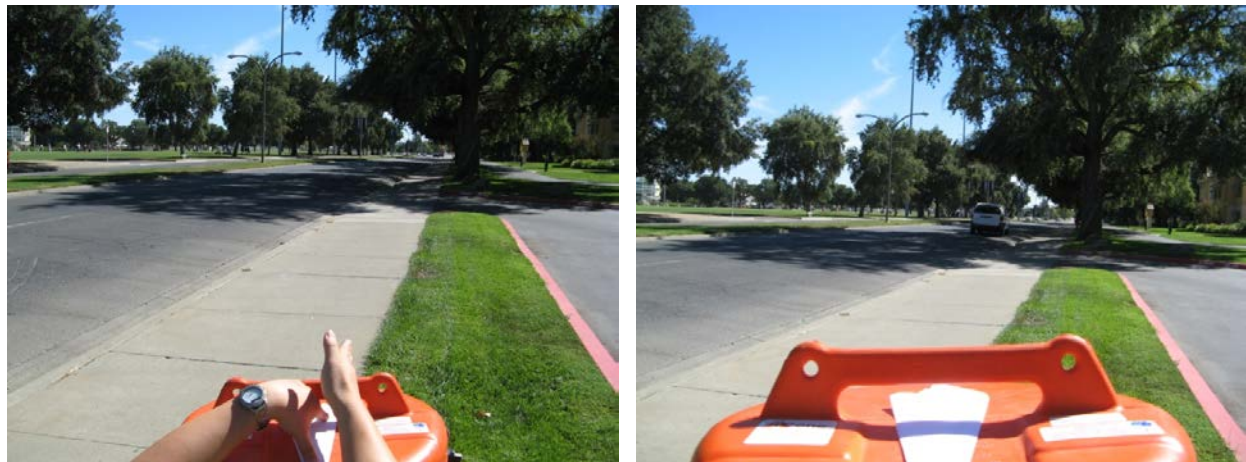
In aiming the iCones, each iCone arrow was initially placed parallel to the road and then the iCone was rotated slightly towards the roadway. Figure 5 shows the iCone aiming process from the operator's point of view.

Figure 5: Aiming iCones.

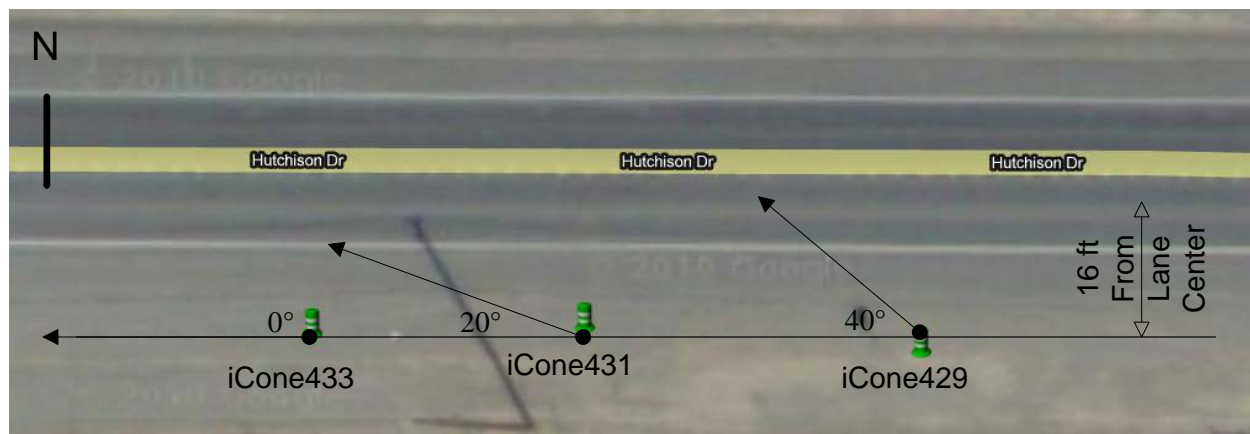
In the orientation test, three iCones were placed the same distance from the lane center, as shown in Figure 6. In this test, iCone 433 was placed with an orientation of 0° , parallel to the road. iCone 431 was oriented at 20° towards the road and iCone 429 at 40° towards the road. All iCones had the same offset of 16 feet from the center of the nearest lane. The offset of 16 feet was selected to represent placement of the iCones outside a 10 foot shoulder. The target of speed measurements was assumed to be at the center of the nearest lane (6 feet for half of the width of the target lane and 10 feet for the width of the shoulder).

Figure 6: iCone placement for orientation test
(Map data ©2013 Google)

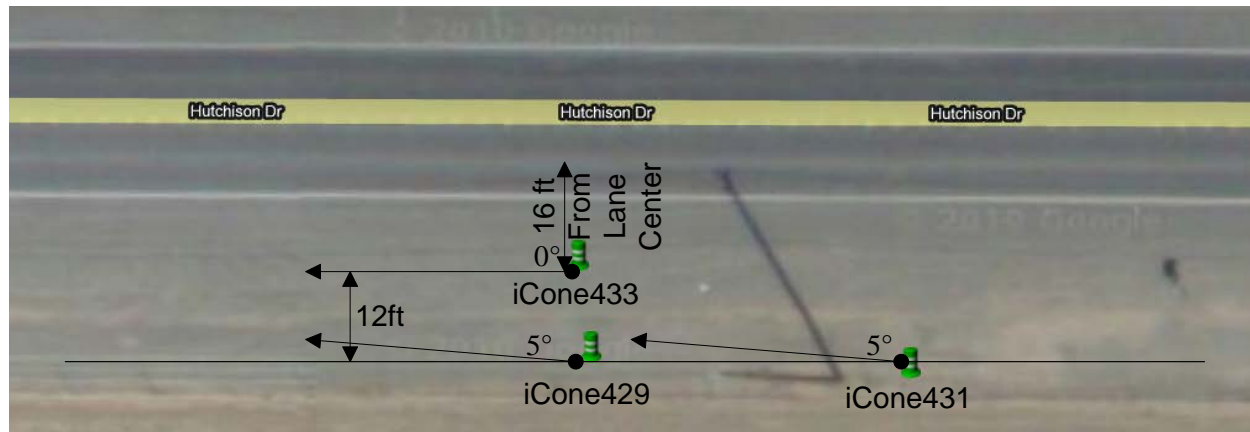
In the position test, the configuration of the iCones is shown in Figure 7. The iCones 433, 431 and 429 were placed, respectively, with offsets of 16 feet, 28 feet and 28 feet from the center of the target lane. The 28 feet distance was selected to represent one additional lane of offset.

Figure 7: iCone placement for position test
(Map data ©2013 Google)

Speed data was collected using all three iCones positioned as described. The test data results are summarized in Table 3. The data in this table does not show any significant differences in the speeds measured, which indicates that iCone speed measurements are not sensitive to their placement in terms of their offset position and orientation. This would make iCones ideal for field usage when rapid deployment of the speed sensing system is needed.

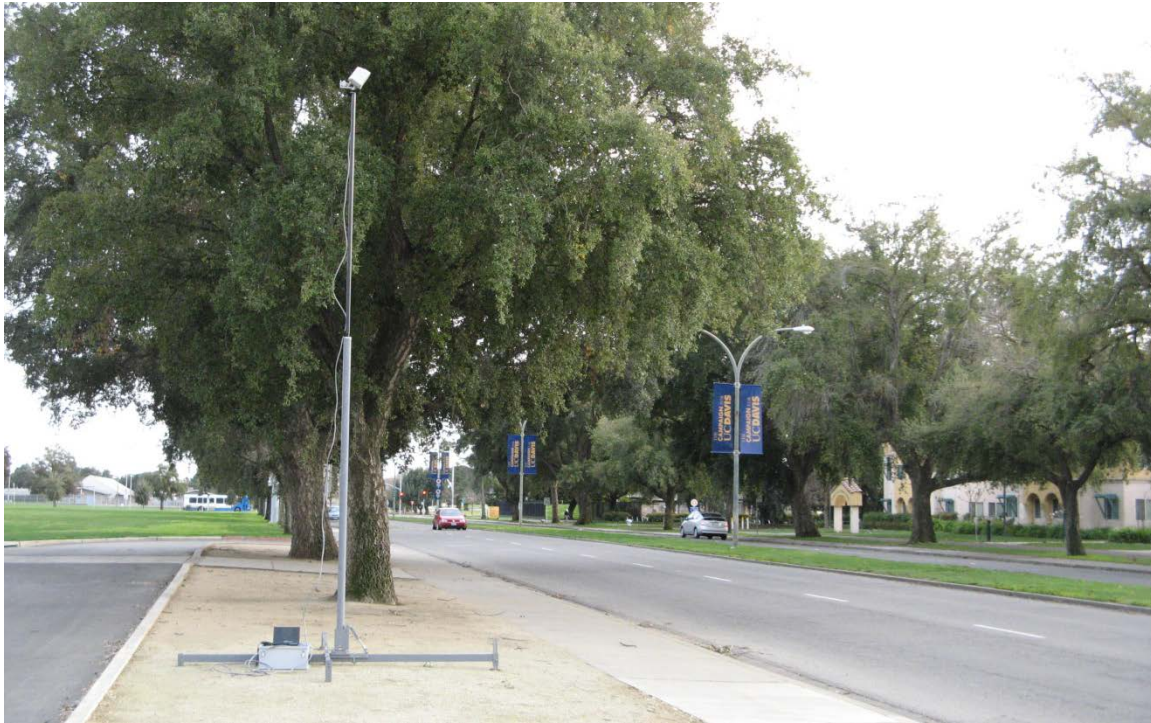
In this test, the number of vehicles detected by the RTMS for each lane was used to calculate traffic volume/count and was tested against manual counting of traffic volume/count. The test was performed on November 12th, 2010 at the same location as the iCone test of that date. In order to test the RTMS, an easily deployable mast was designed to mount the RTMS unit at a height. The mast is shown in Figure 8. The mounting height of the RTMS as shown in this figure was 19 feet and during the test on November 12th 2010, it was placed with an offset of 12 feet to the edge of the road.

Figure 8: RTMS Mast for Rapid Deployment (View Looking South, Nov 12, 2010)

The offset distance of 12 feet was chosen to emulate the scenario where the RTMS is set up beyond the shoulder of the freeway in a work zone evaluation. During the test, manual counting of vehicles passing in the area measured by the RTMS was performed for all lanes of traffic. As shown in Figure 8, there were two northbound lanes and two southbound lanes with a median which was one lane wide. The RTMS unit was placed next to the northbound lanes. The test data was collected for a period of 20 minutes and showed 123 northbound vehicles and 174 southbound vehicles in manual counting versus 120 northbound and 151 southbound vehicles in RTMS counting. This data indicates that the RTMS unit missed the number of vehicles by 2.4% in the near side lanes and by 13.2% in the far side lanes. This can be due to the shadowing effects (See Appendix B). Observation of the RTMS display unit during the testing showed that the system was, sometimes, registering “ghost” vehicles outside the boundaries of the far side lanes. This effect was mitigated by manually adjusting the lane range assignments on the RTMS. The final conclusion from this test is that RTMS units can provide relatively accurate measurement of traffic volume/count for near side lanes. It is therefore recommended that RTMS units be used in the manner described here for obtaining traffic volume/count in work zone testing for near side lanes. Near side lanes are defined as lanes adjacent to the location of the RTMS mast.

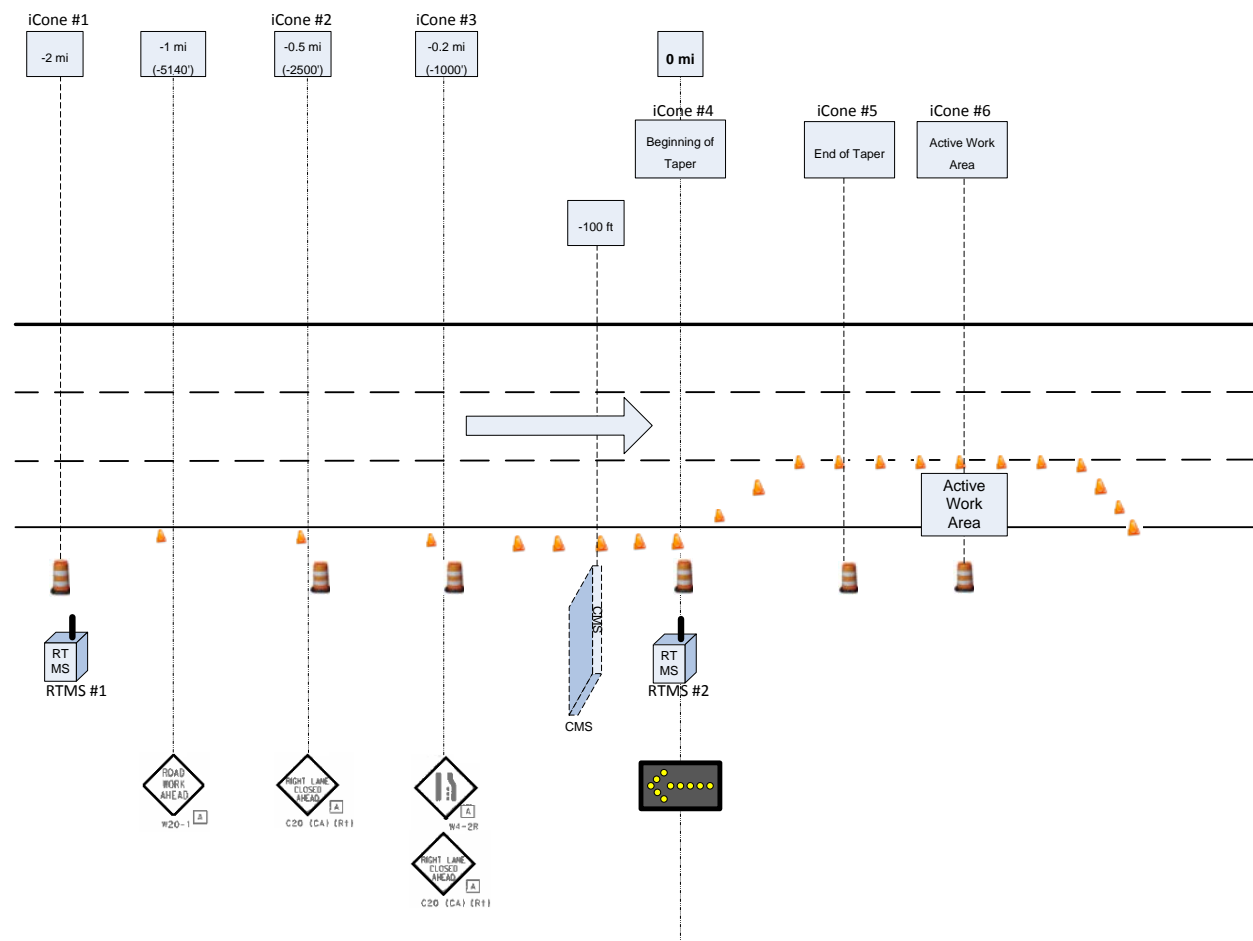
In evaluating the effectiveness of the CHP-CMS, it was important to measure average traffic speeds at several areas of the work zone. This was important to properly assess driver behavior and response to the presence of the CHP-CMS. There were a total of six iCones and two RTMS units available for this project. A test layout was developed distributing these sensor units as shown in Figure 9. In this figure, the zero reference point is at the beginning of taper. One set of sensing units consisting of one iCone and one RTMS system was placed upstream of any signage

to obtain base-line values for average traffic speed, volume and headway. Discussions with Caltrans field personnel indicated that an approximate distance of two miles upstream of the beginning of taper is the proper location for these first set of sensing units. The next two iCones were distributed in-between the first work zone sign (stating: “Road Work Ahead”) and the beginning of taper. Data from these two iCones can provide information on speed changes due to the advisory signage for the work zone. The next set of iCone/RTMS pair was positioned at the beginning of taper to measure the number of vehicles remaining in the closing lane. This was also near the location of the CMS sign as recommended by Caltrans field personnel for the first test on March 22nd, 2011. The fifth iCone was then positioned at the end of taper which was upstream of where highway workers would be present. This was also the area that the reduction in lane(s) was completed in the work zone. The sixth and last iCone was positioned somewhere in the active work area of the work zone preferably approximately in the middle of this area to provide data on the final average traffic speed in the area closest to the highway workers. In the test performed, the work zone was along the fast lane of the highway (left side). The mirror image of this layout as shown in Figure 10 is used.

Figure 9: Proposed Sensor Layout for Work Zone Testing.

The sensor layout discussed served as a baseline configuration for field testing. The layout was adjusted to its final configuration based on logistics at a specific work zone and the requirements set forth by the Caltrans personnel in charge of a work zone.

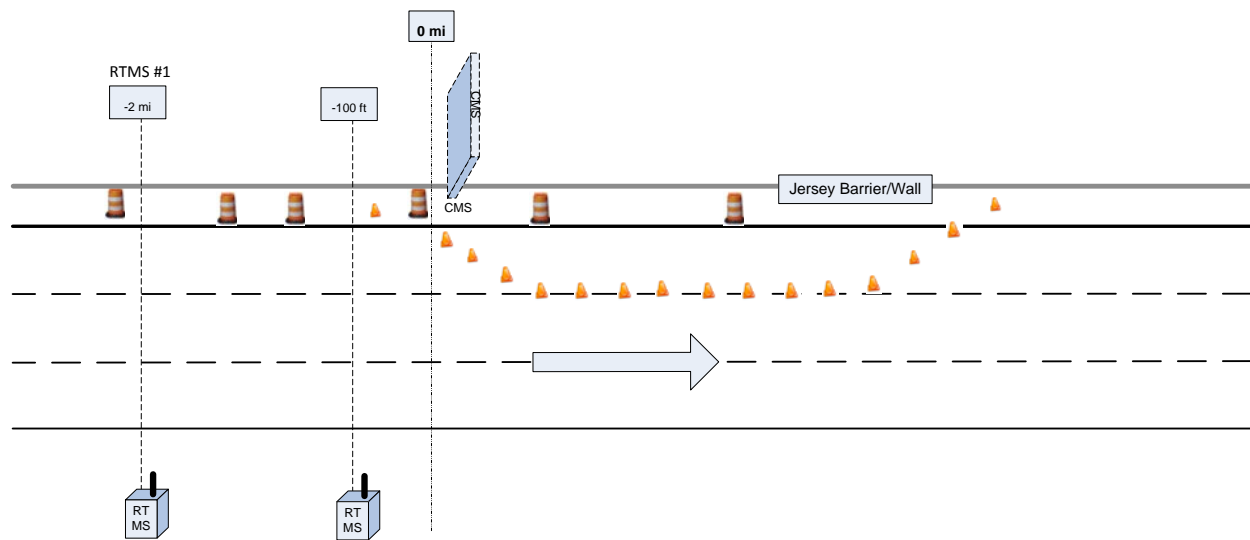
Figure 10: Proposed Sensor Layout for Work Zones on the Left Side of a Highway.

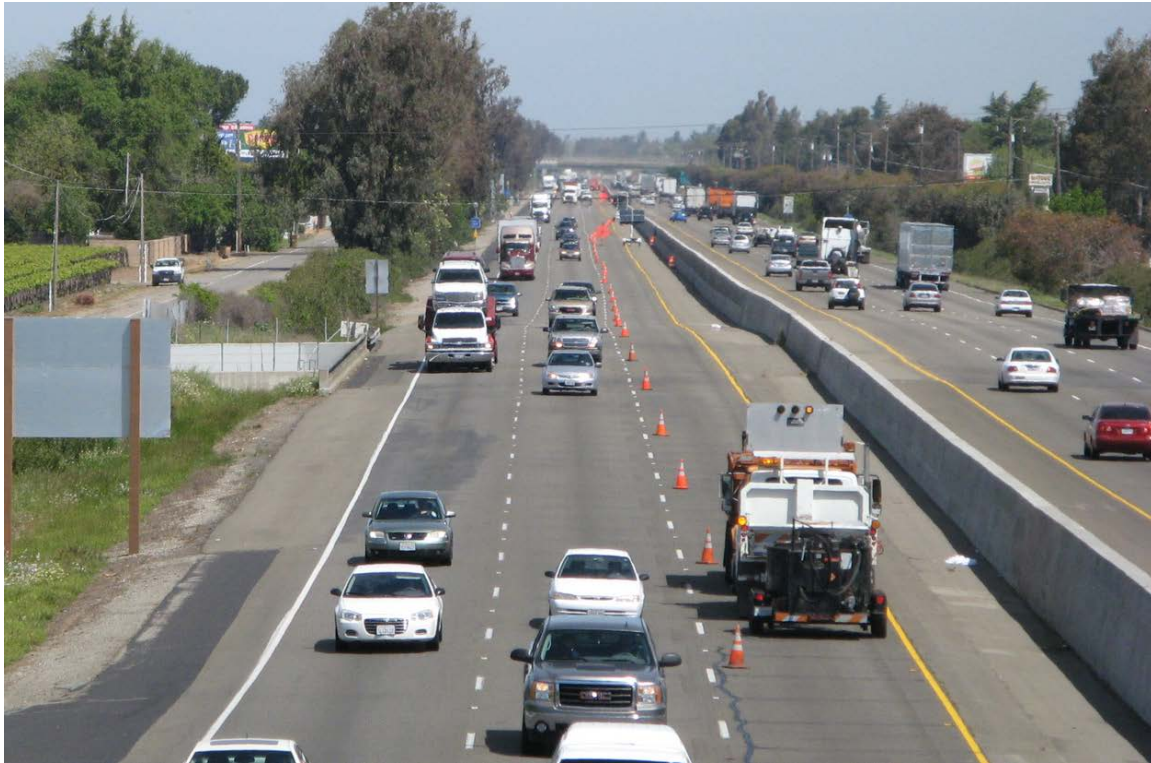
The work zone for the two April 15th, 2011 tests is shown in Figure 11. The test on March 22nd, 2011 was performed on the same highway upstream of the depicted location. A visual walk through of the April 15th work zone as seen from the view of the driver is depicted in Figure 12.

Figure 11: View Looking Down At the Test Work Zone of April 15, 2011.

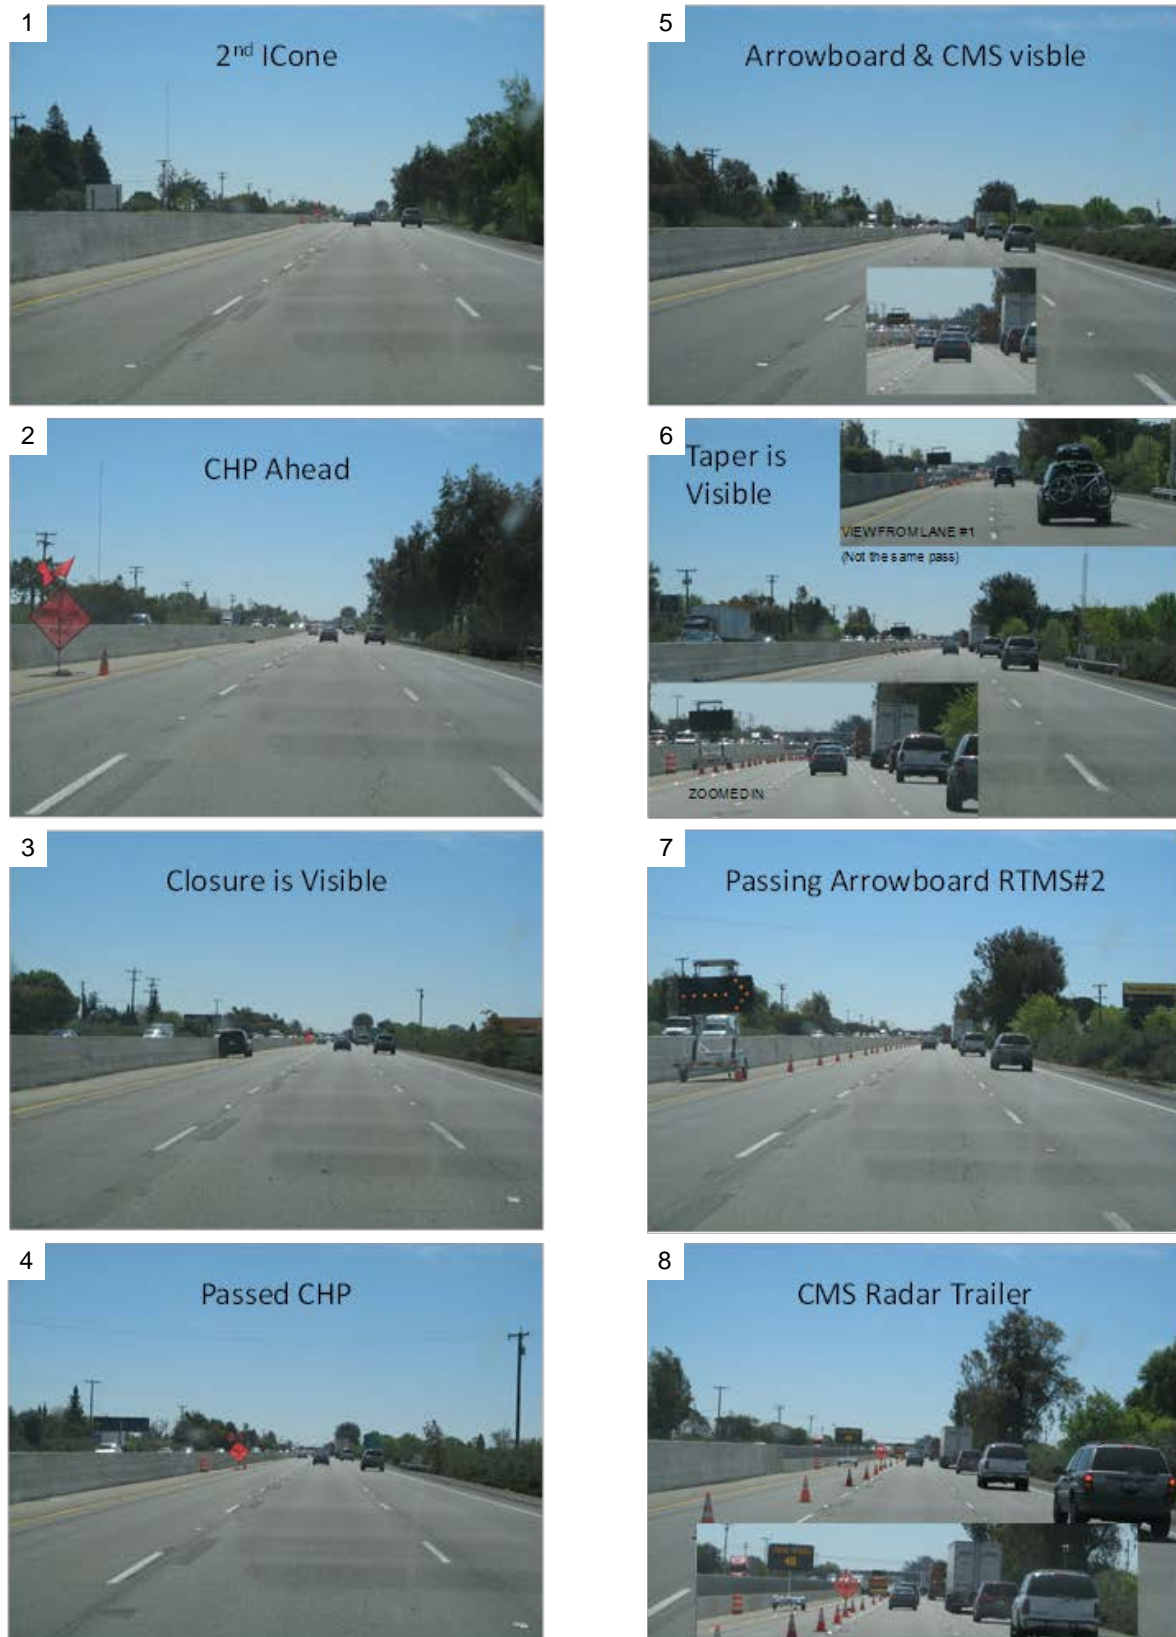
Figure 12: Pictorial Walk Through of the Test Work Zone on April 15, 2011

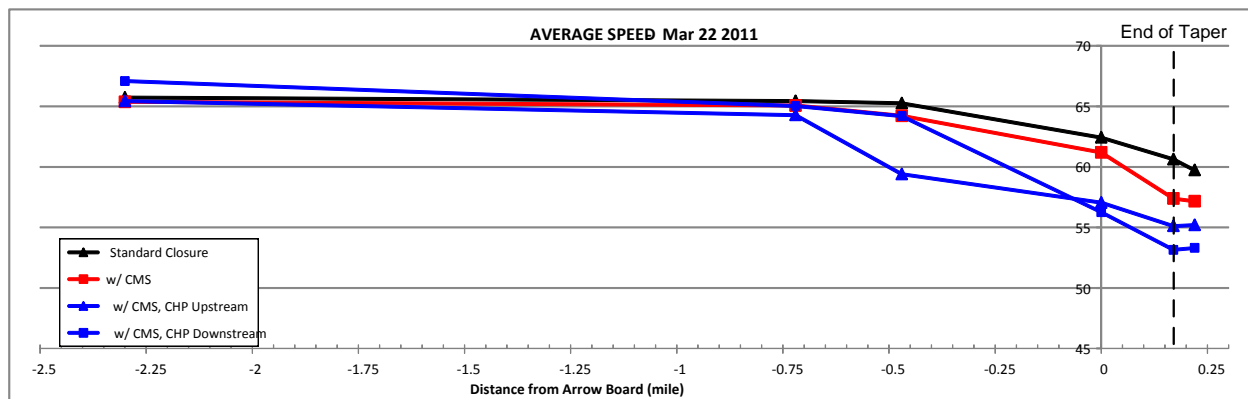
In this section, the test data from the six iCones from the three tests is discussed followed by the data obtained from the downstream RTMS. Figure 13 provides a summary plot of the six iCone speed measurements for testing of four different configurations on March 22nd, 2011. The horizontal axis plots the iCone location from the zero reference point in miles. The vertical axis is the average speed measured by the iCones in MPH. The four configurations consist each of speed measurements with no CHP-CMS and no CHP vehicle (indicated in black), CHP-CMS unit in place (indicated in red), CHP-CMS unit and CHP vehicle upstream (indicated in blue triangle), and CHP-CMS unit and CHP vehicle downstream (indicated in blue square).

Figure 13: iCone data from March 22, 2011 test.

The data in these plots clearly show that the CHP-CMS unit is effective (at least in the three tests) in positively influencing the driver behavior resulting in a reduction in average traffic speed from the upstream highway speed of approximately 8.0 to 12.6 MPH at the end of taper (fifth iCone or the second to last mark from the right in the plots). Furthermore, the same data indicates that the closure alone may be responsible for approximately 5.1 to 5.7 MPH of this reduction. The data also indicates that when there is a CHP vehicle upstream of CHP-CMS there is a local reduction of speed near the CHP vehicles but the speed at the end of taper is not significantly affected. The same local effect of the CHP vehicle in speed reduction was also observed in Test 2 of the April 15th test. This is illustrated in Figure 15. During this test, an unusual level of traffic congestion was developed, therefore it was not clear how much of the reduction in speed shown in Figure 15 is from the local effect of the CHP vehicle and how much is from the intrinsic traffic congestion. The main conclusion is that the data clearly indicates that the CHP-CMS trailer can be an effective deterrent for reduction of average traffic speed in a work zone.

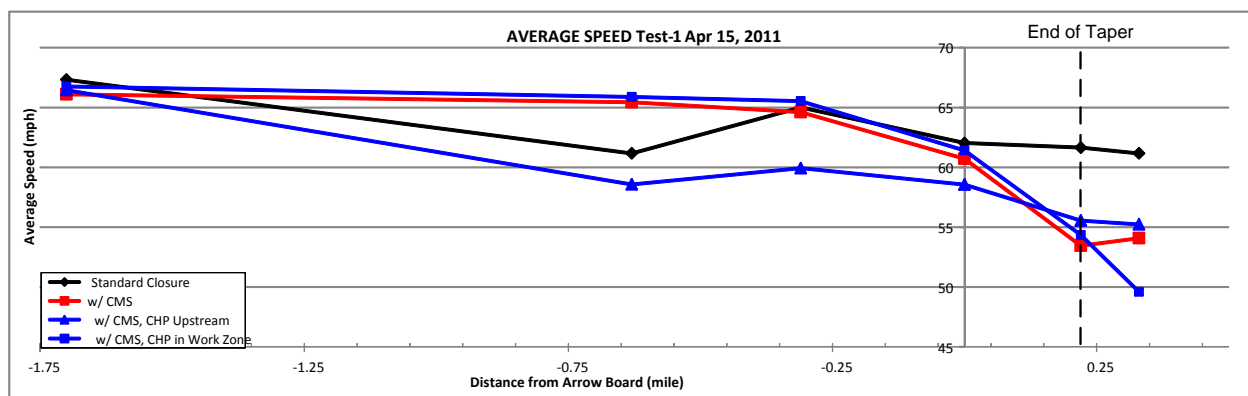
In the April 15th series of tests the CHP-CMS unit was positioned at the end of the taper rather than at the beginning due to lack of available shoulder space in the location of the taper. Plots in Figure 14 and Figure 15 represent average traffic speeds for the same configurations described for the March 22nd test. The plots in these three figures in combination with aerial views of the highway section where the iCones were placed are provided in Appendix C.

Figure 14: iCone Data from Test 1 (Morning Hours) on April 15, 2011.

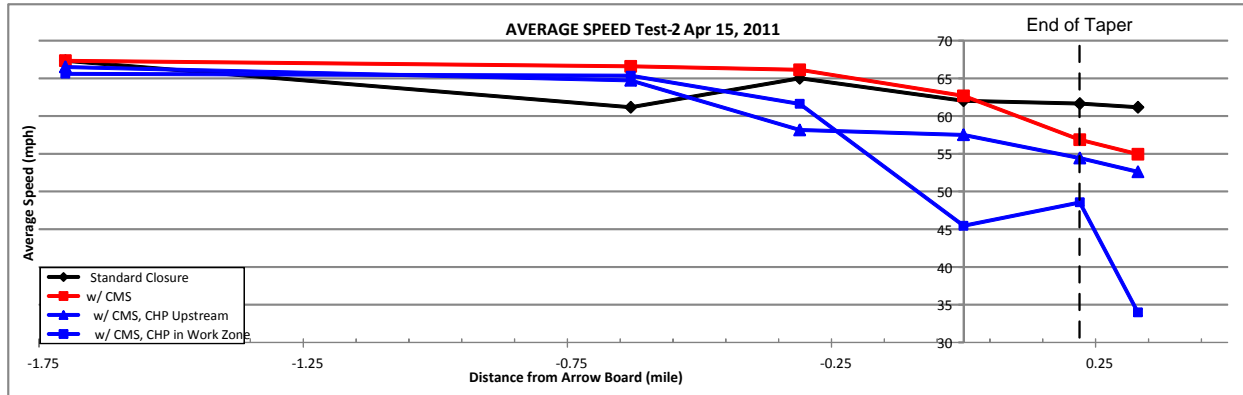
Figure 15: iCone Data from Test 2 (Afternoon Hours) on April 15, 2011.

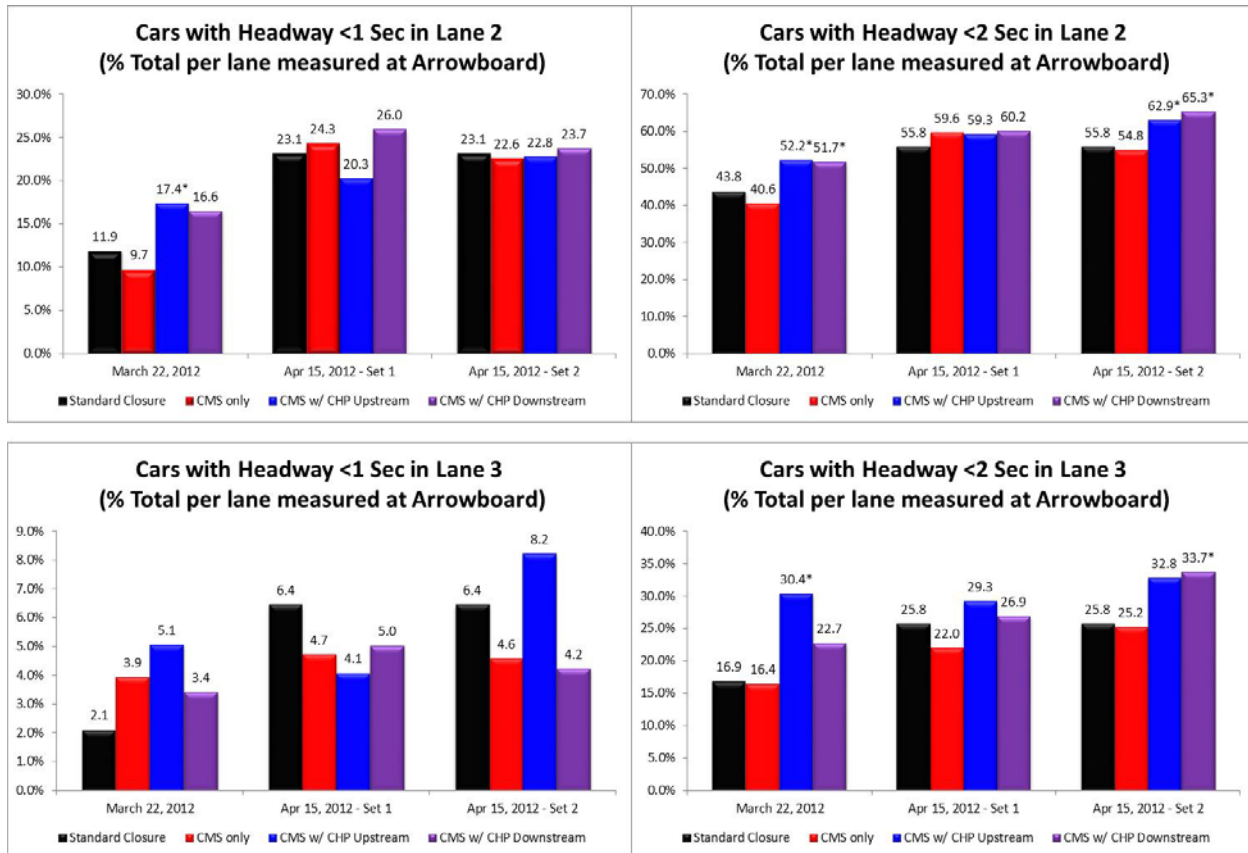
Finally the CHP-CMS unit with the CHP vehicle downstream of the CHP-CMS location is shown in purple. There are a total of four plots, two plots for the number two lane and two plots for the number three lane. Each of the two threshold values for headway is plotted per lane.

Figure 16: RTMS Data: Headway Data from All the Three Tests

A visual inspection of the data in the plots shows that the addition of the CHP-CMS unit to a standard lane closure produced no consistent effect on the percentage of vehicles with less than ideal and minimally ideal headways. A similar observation can be made for the addition of a CHP vehicle, both upstream and downstream of the CHP-CMS unit.

A chi-square (χ^2) test using a 2 x 2 contingency table was conducted to determine the statistical significance of the differences between the standard closure and other conditions. A difference is considered significant if $\chi^2 \geq 3.841$, indicating a probability level (p-value) of less than 0.05. The significant differences are denoted with “*” in Figure 16. The CHP-CMS unit’s effect on headway is inconclusive. The existence of significant increases in percentage points in some plots of the CHP-CMS with the CHP vehicle suggests that there may be a risk of causing drivers to follow each other too closely.

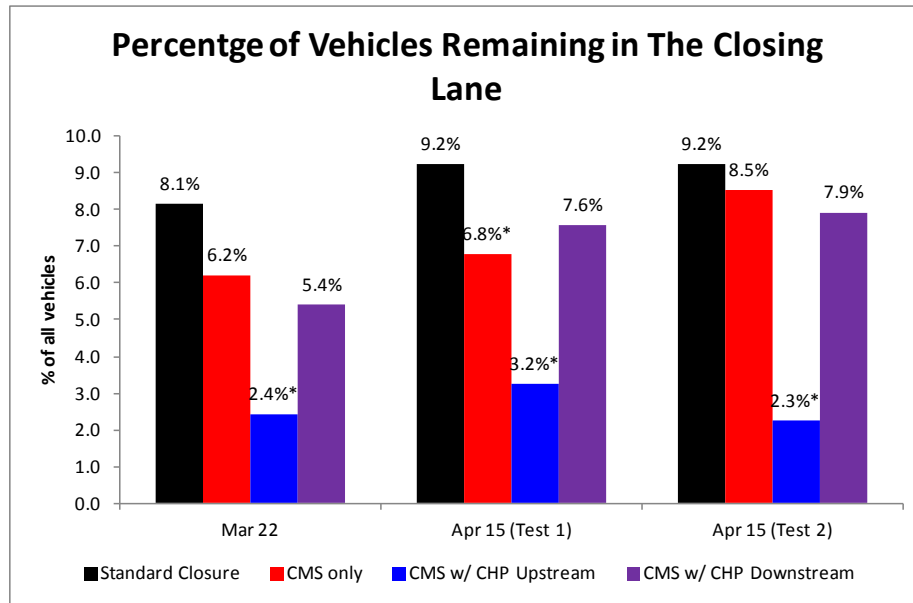
The other aspect of the RTMS data is the per-lane traffic volume/counts. This data is obtained by manually counting all vehicles in the video footage produced by the onboard camera of the RTMS. The percentage of vehicles remaining in the closing lane (No. 1 lane) is then used as an indicator of late merging behavior. The percentage data is plotted in Figure 17.

Figure 17: RTMS Data: Percentage of Vehicles Remaining in Closing Lane at the Beginning of Taper from All Three Tests

The data suggests there are reductions in the percentage of vehicles remaining in the closing lane at the beginning of taper. The Chi-square analysis was also performed for this set of data. The presence of the CHP-CMS unit only resulted in significant reduction for one of the three tests ($\chi^2 = 5.1872$ for Test 1 of April 15th). The presence of the CHP-CMS with the addition of the CHP vehicle upstream resulted in significant reduction in all three tests ($\chi^2 = 16.4471, 34.7272, 28.9308$, for March 22nd, Test 1 of April 15th and Test 2 of April 15th, respectively). The presence CHP-CMS unit with the CHP vehicle downstream resulted in no significant reduction of late-merging vehicles. The reductions associated with the CHP vehicle located upstream are consistently significant.

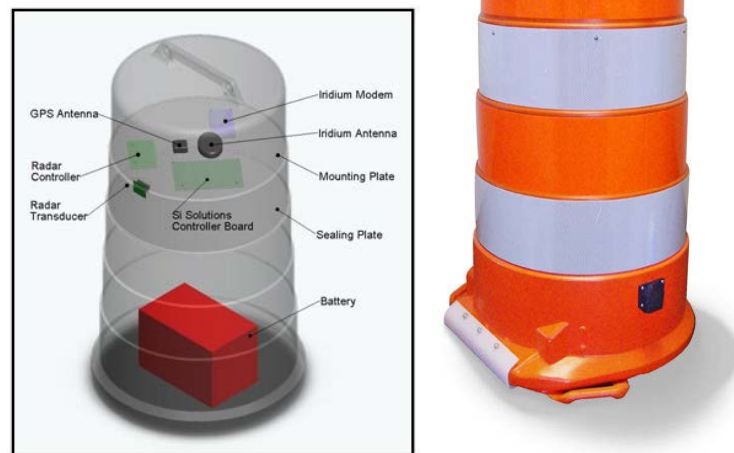
Figure A - 1: Inside/Outside of an iCone (Note the switch near the top and charging port on the base).

The electronics are located towards the top of the barrel, whereas the battery is fixed to the base of the barrel. The overall appearance of the iCone closely resembles that of a regular traffic control barrel, but there are a few subtle differences: there is a switch near the top of the barrel, a charging port on the base, and an arrow sticker on the top of the iCone to aid in aiming during deployment. This non-threatening appearance minimizes its influence on the motorists, making the iCone system an ideal candidate for recording traffic speed data inconspicuously. A device that catches a driver's attention may cause them to slow down, thus introducing bias in the data collected.

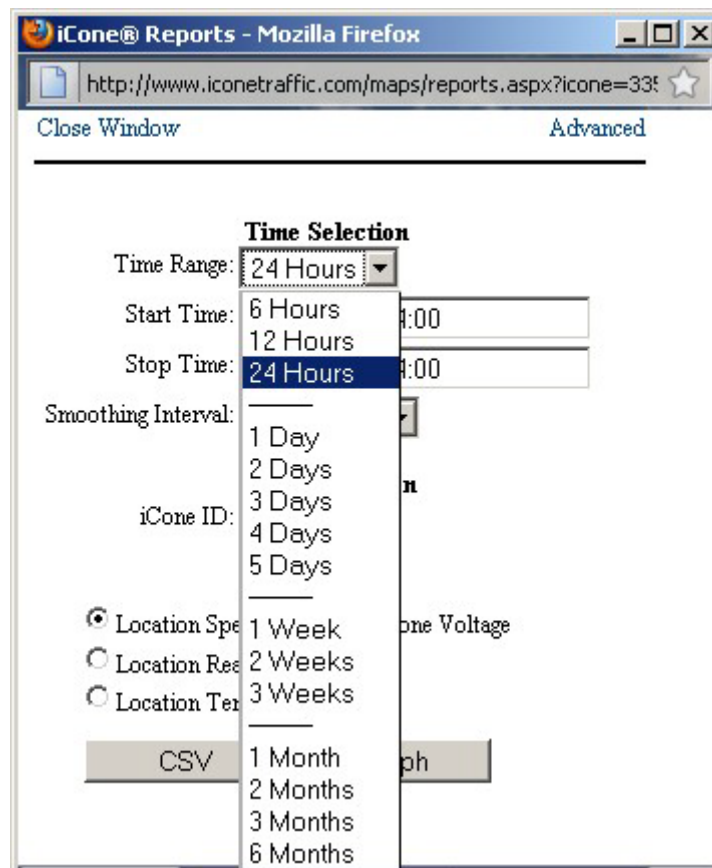
Figure A - 4: Pop up window with time range selections

The screenshot shows a web browser window titled "iCone® Reports - Mozilla Firefox" with the URL "http://www.iconetraffic.com/maps/reports.aspx?icone=33". The page has a "Close Window" button and an "Advanced" link. The main content area displays a "Time Selection" section with the following fields:

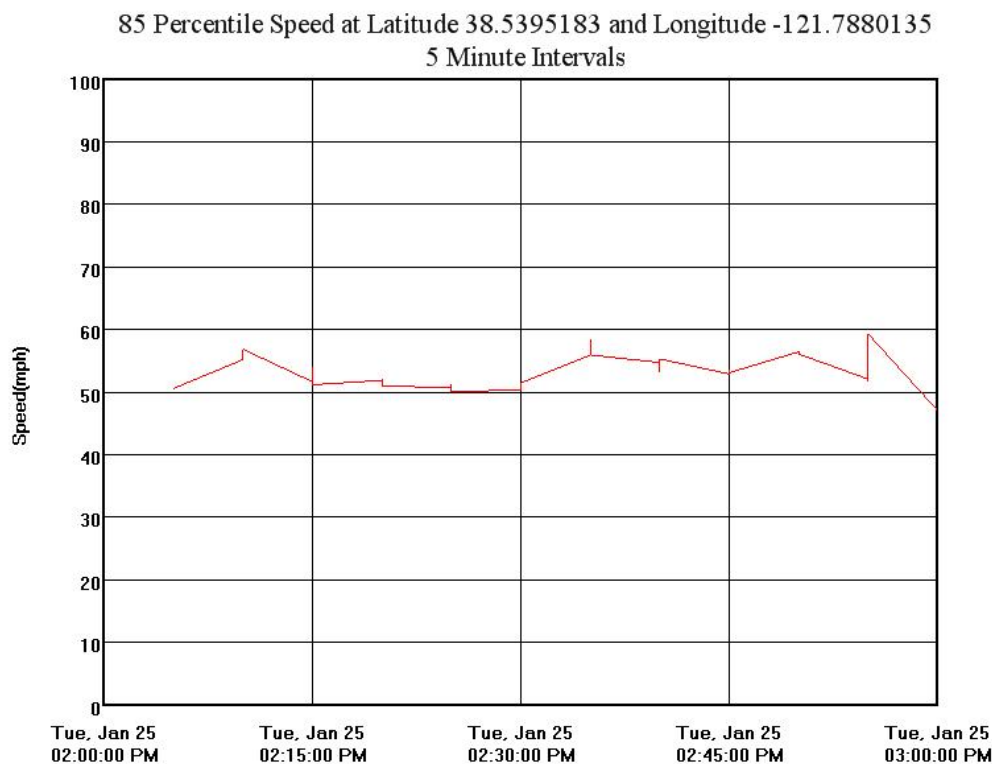
The data includes the iCone ID, the time, the average speed and the respective number of reads (vehicles), the standard deviation, the percent speed, and also provides data binning with 5 MPH bin-widths.

Figure A - 7: Sample *.jpg plot output

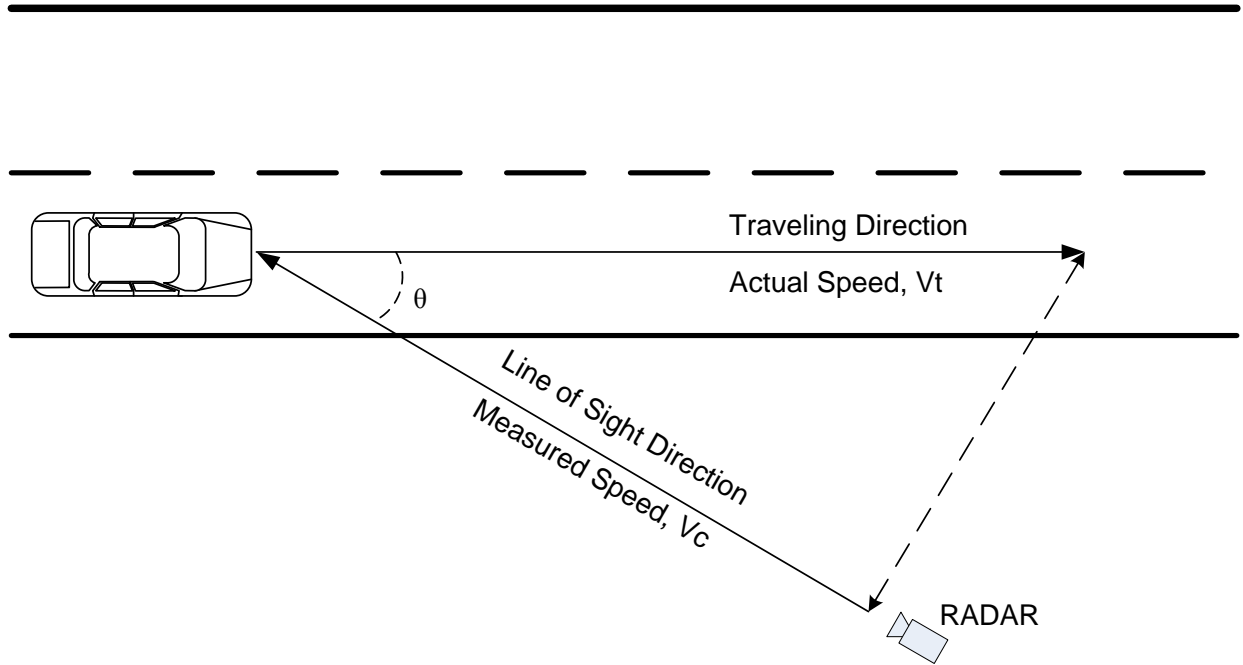
The radar unit inside the iCone detects the relative speed between the observers and the observed based on the Doppler Effect. In the case of traffic monitoring, the “line of sight” of the radar doesn’t always match the target vehicle’s direction of travel, as depicted in Figure A - 8. This mismatch causes the measured relative speed between the observer and the target vehicle being different from the actual traveling speed of the vehicle. This phenomenon is called the Cosine Effect. The speed measured by the radar is merely a component of the vehicle’s velocity parallel to radar’s line of sight and is therefore less than the actual traveling speed of the vehicle.

Figure A - 8: Radar device on the shoulder, not in line with the car's traveling direction. The relative velocity between the vehicle and the radar was less than the vehicle's actual traveling speed.

The relationship between the actual traveling speed and the measured speed can be determined from Figure A - 8 in the following equation:

In most cases the angle is small such that $v_t \approx v_c$ with $\theta \rightarrow 0$ is an adequate approximation of the traveling speed of the target vehicle. The opposite extreme case is when the radar's line of sight direction is perpendicular to the traveling direction, i.e. $\theta = 90^\circ$. In this case the measured speed will be zero regardless of the traveling speed of the target vehicle. However, this situation assumes the ideal condition where the angular beam width of the radar is infinitely narrow. For practical purposes, it can be assumed that the beam width of the iCone's radar is wide enough such that the Cosine Effect is negligible. The sensitivity of to the Cosine Effect is evaluated by placing multiple iCones at different angles and comparing the measured speeds on the same section of a road. The evaluation result can be found in the main body of this report.

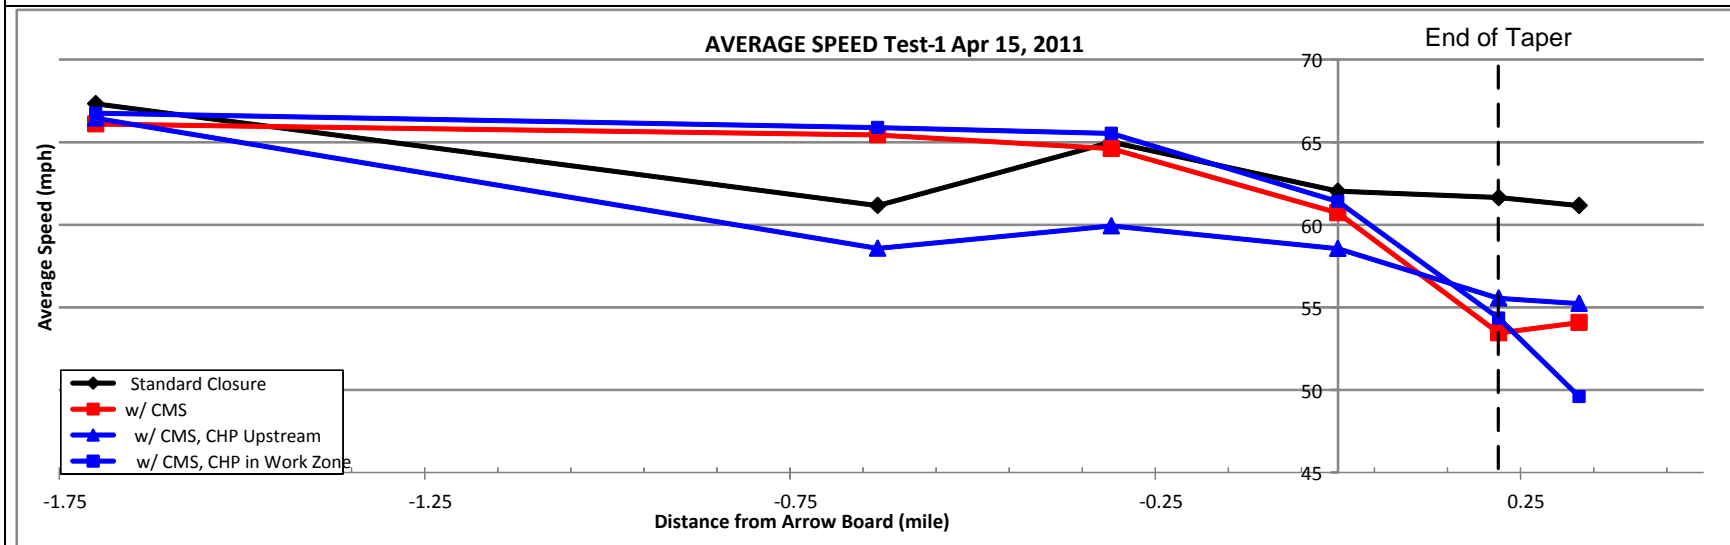
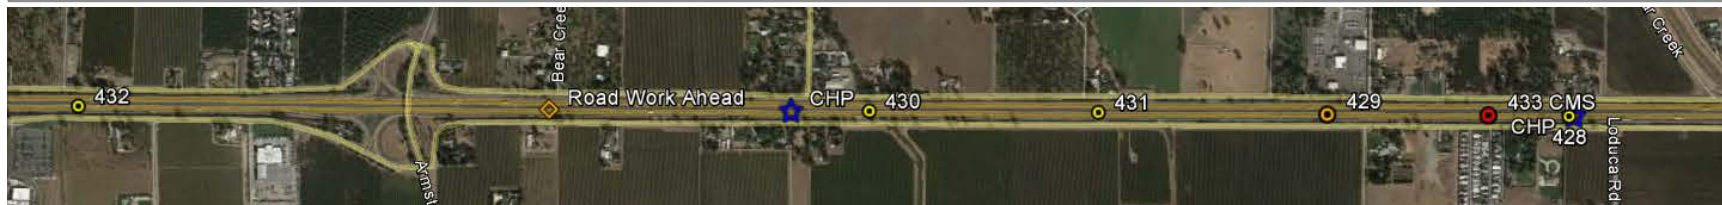
April 15, 2011 – Test 1
(Map data ©2013 Google)

APR 15, 2011 - 99 Southbound – E 8 Miles Rd, Test 1
