Advanced Highway Maintenance and Construction Technology Research Center

Evaluation of Methods to Reduce Speeds in Work Zones

AHMCT Research Report: UCD-ARR-12-06-30-06
Final Report of Contract: 65A0275, Task ID: 2247

June 28, 2012

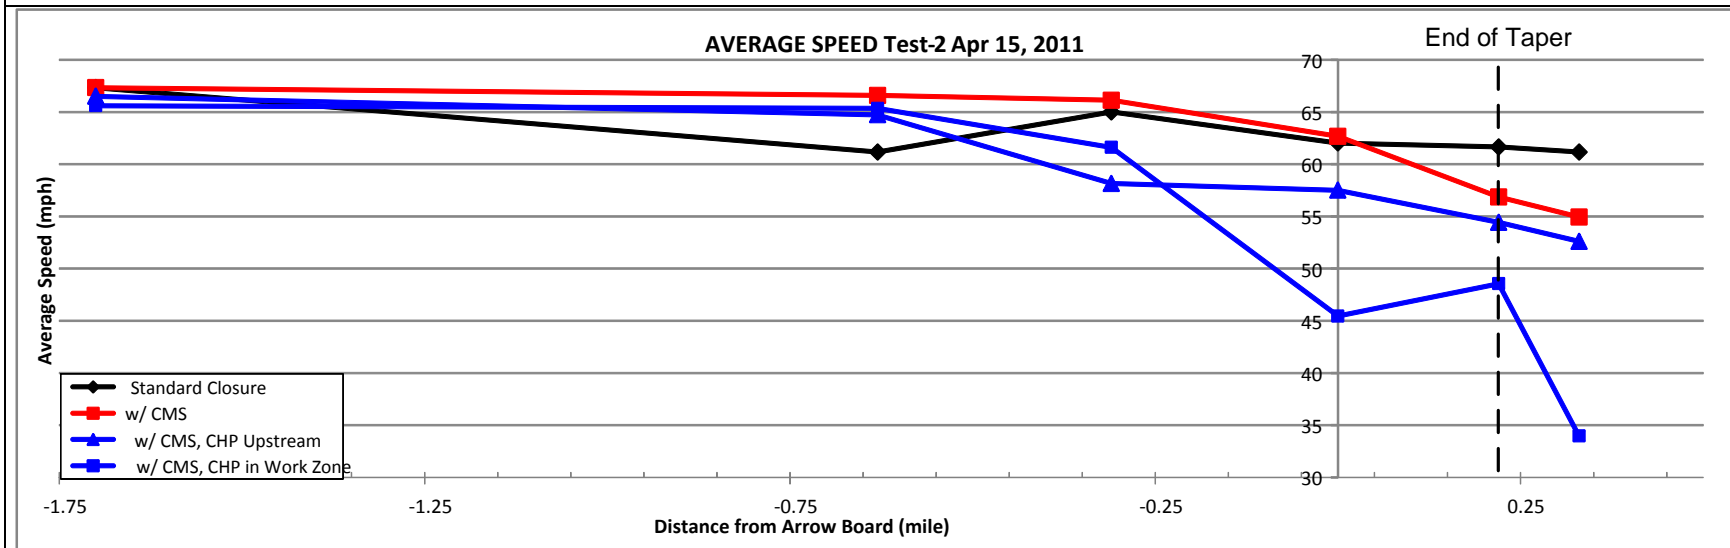
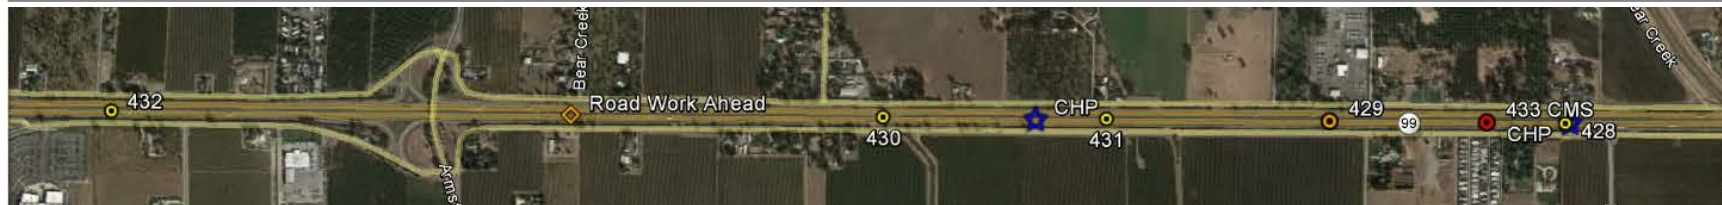
April 15, 2011 – Test 2
(Map data ©2013 Google)

APR 15, 2011 - 99 Southbound – E 8 Miles Rd, Test 2

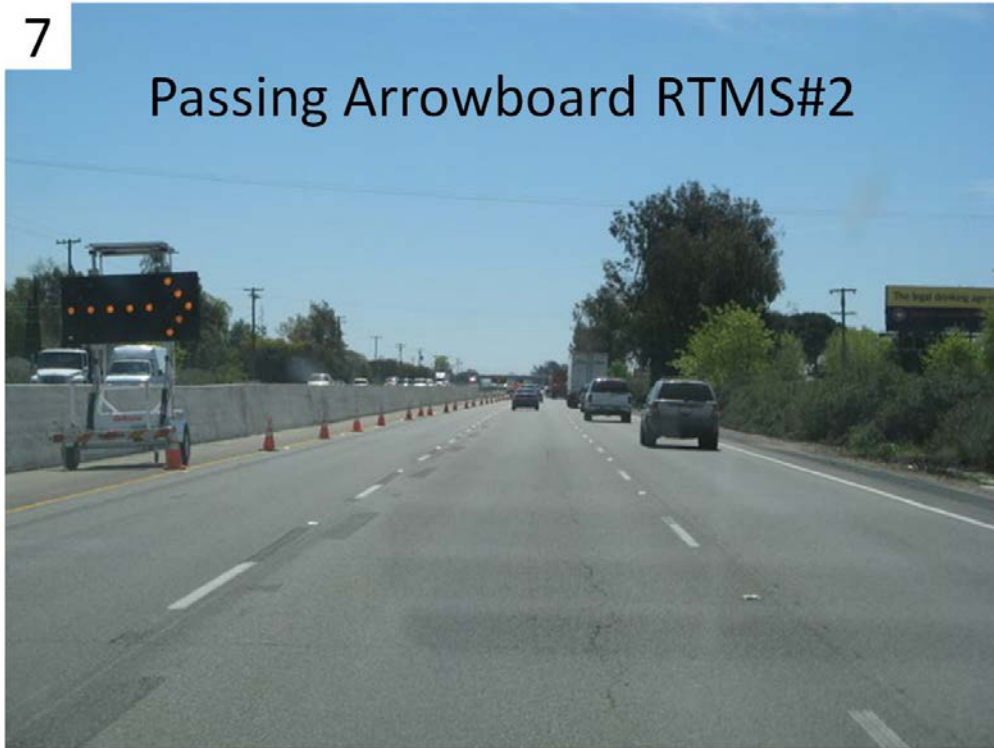
7

Passing Arrowboard RTMS#2

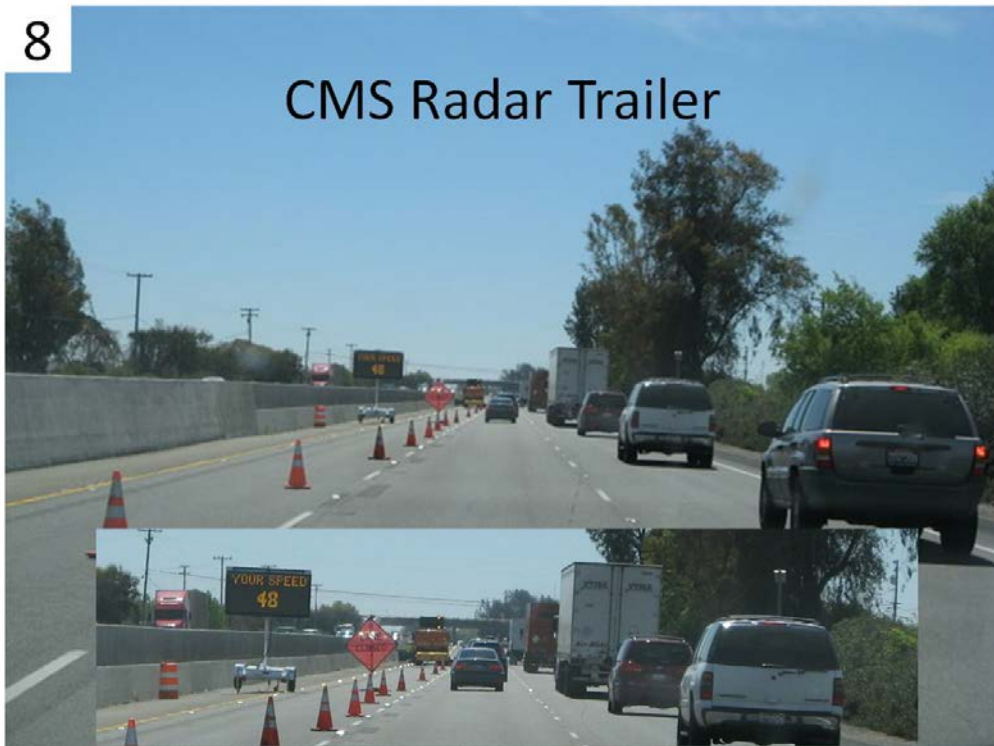
8

CMS Radar Trailer
