1. Report No. CA 13 2249A	2. Government Accession No.	3. Recipient's Catalog No.	
4. Title and Subtitle: Scientific Evaluations of Operational Performance, Procedures, Impacts, and Benefits of Highway Construction Zone Enhanced Enforcement Program (COZEEP) and the Highway Maintenance Zone Enhanced Enforcement Program (MAZEEP).		5. Report Date October 28, 2013

6. Performing Organization Code AHMCT	
7. Author(s): Bahram Ravani, Chao Wang, Wilderich A. White, and Patricia Fyhrie		8. Performing Organization Report No. UCD-ARR-13-10-28-01

Final Report

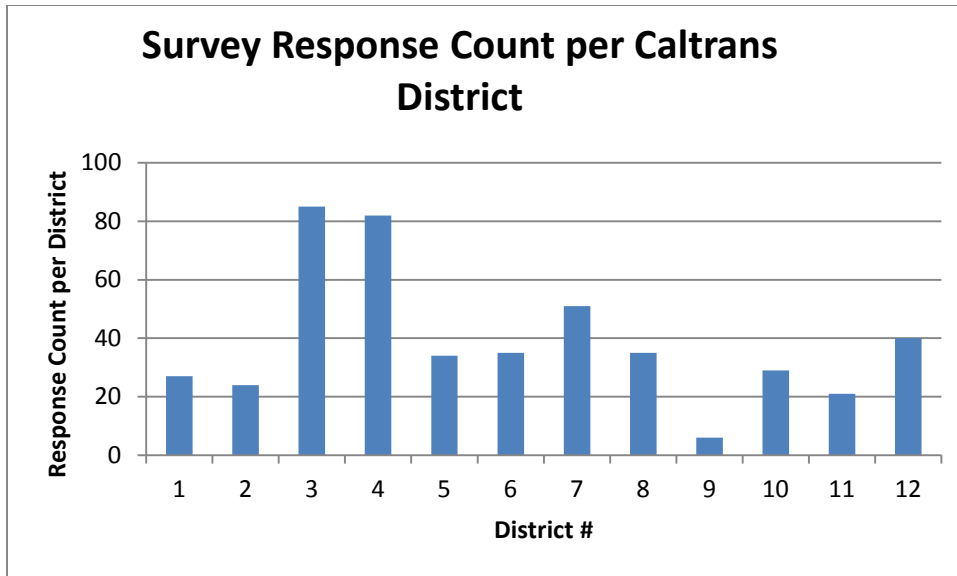
Figure 1. Survey Response Count by Caltrans Districts.

In order to supplement information gathered in the testing a detailed survey questionnaire was prepared by the research team. The survey was conducted by Caltrans and data was collected from those who work or are involved with highway work sites. The survey was provided through an external web site, in a blind fashion, and it could be filled out by workers using a smart phone or other mobile devices with internet access. The survey could also be printed and filled out manually and submitted. A total of 529 responses were collected in a six week period with 60% to 65% of responses being from highway workers. The responses fairly represented all area with highways within California. A plot of responses from different Caltrans districts is depicted in Figure 1.

The chart in Figure 1 indicates that the survey was effective in soliciting responses well across California. The data in the survey responses provided valuable information on highway workers views on safety benefits of COZEEP/MAZEEP and some of the best operational configurations for COZEEP/MAZEEP implementation.

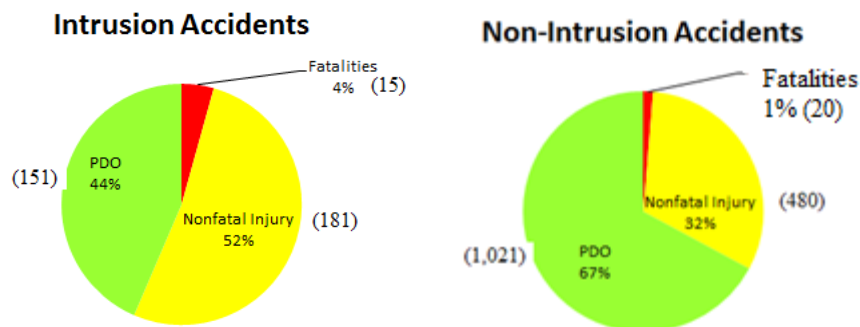
Figure 2. Work Zone Accident Distribution by Type for Intrusion and Non-intrusion Accidents.

A proper assessment of the cost benefits of COZEEP/MAZEEP operations that would be quantitative and would provide an assessment of the level of the benefits achieved is very difficult and requires much detailed data. In order to provide estimates of such cost benefits, CHP traffic accident reports for a period of three years from 2008 to 2010 was collected for all accidents in California that the accident occurred in or near a highway work zone. A total of 13,125 CHP reports were identified and reviewed. These reports were studied with redacted identification data to ensure confidentiality of personal information. A total of 1,868 of these accidents were identified that had direct interactions with the work zone active area. These accidents consisted of 347 accidents that involved intrusions into the work zone and 1,521 non-intrusion work zone accidents. The distribution of these accidents in terms of fatalities, non-fatal injury accidents, and Property Damage Only (PDO) accidents for each set is shown in the pie charts depicted in Figure 2 (167 involved injuries and 136 only had property damage). From the remaining 1,403 non-intrusion accidents, a total of 469 resulted in injuries and the rest only involved property damage to the traveling public. The distribution of work zone accidents for each type is depicted in Figure 2.

The cost of these accidents were then calculated considering the cost of property damage as well as injury and fatality costs using standard cost data for Caltrans. The cost data used for such calculations is summarized in Table 1. The actual costs of these collisions are discussed in the next section.

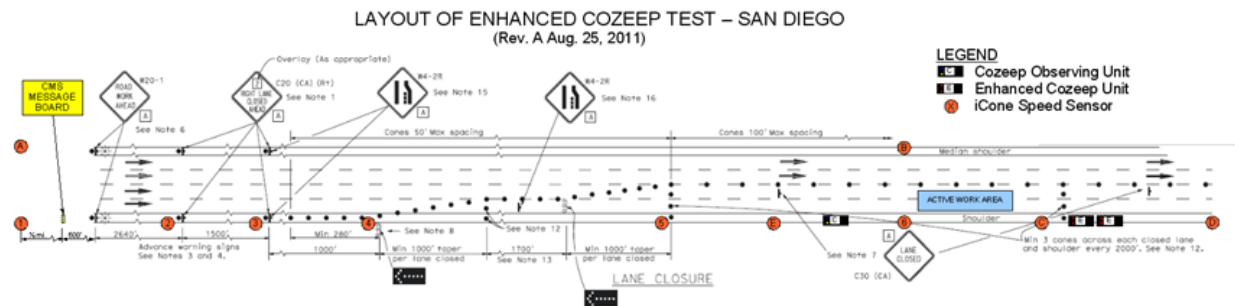
Figure 3. The Test Layout for Testing in Urban Areas.

For the urban environment tests, the researchers had a total of eleven iCones available for deployment. Nine were placed along the closure side of the freeway and the remaining two were placed on the opposite side to provide a duplication of speed readings as a check on accuracy. One of the two iCones on the opposite side was placed across the first of the nine and the other one was placed across from the one closest to the active work area. This layout was used for a typical lane closure for all of the testing done in the urban area. An illustration of the lane closure including its signage and the iCones used in the testing is shown in Figure 3 below.

The nine iCones along the closure side of the highway were located to capture speed readings as traffic passed through the closure. The first five iCones were intended to capture the speeds through the advance warning area and the taper up to the point at which the lanes are fully closed. iCone number 6 is assigned to a position immediately upstream of the active work area which is the point at which drivers will ideally have responded to all the indications that workers are present and will be traveling at the speed limit. The remaining three iCones are then located in the closed lanes to capture the transitions in speed throughout the work zone.

- iCones number 2 and 3 are located next to the two ‘Right (or Left) Lanes Closed Ahead’ signs that will potentially cause drivers to begin to reduce speed and move out of the lanes being closed. These are the first signs that indicate to the driver that a specific action is required in addition to monitoring speed.

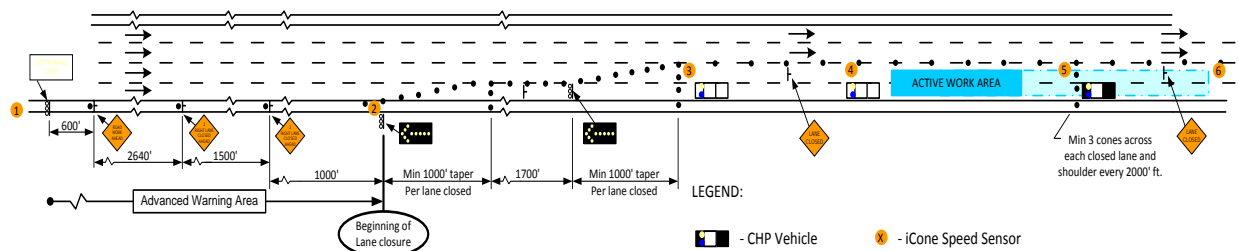
Figure 4. The Test Layout for Testing in Rural Areas.

For the testing in rural areas, the researchers had a total of six iCones available for deployment, and all of them were placed along the closure side of the freeway. The layout used for a typical lane closure and its signage used in the testing is shown in Figure 4.

All six iCones along the closure were located to capture speed readings as traffic passed through the closure. The first three iCones are intended to capture the speeds through the advance warning area and the taper up to the point at which the lanes are fully closed. iCone number 4 is assigned to a position immediately upstream of the active work area which is the point at which drivers will ideally have responded to all the indications that workers are present and will be traveling at the speed limit. Together with iCone number 5 and 6, the last three iCones were evenly distributed throughout the active work area until the end of the lane closure. The intended function of each iCone is described below:

- iCone number 1 is intended to define the baseline traffic speed where drivers are not aware of the upcoming closure. It is placed at approximately 0.5 mile upstream from the first indication of the lane closure. If the condition upstream does not reasonably

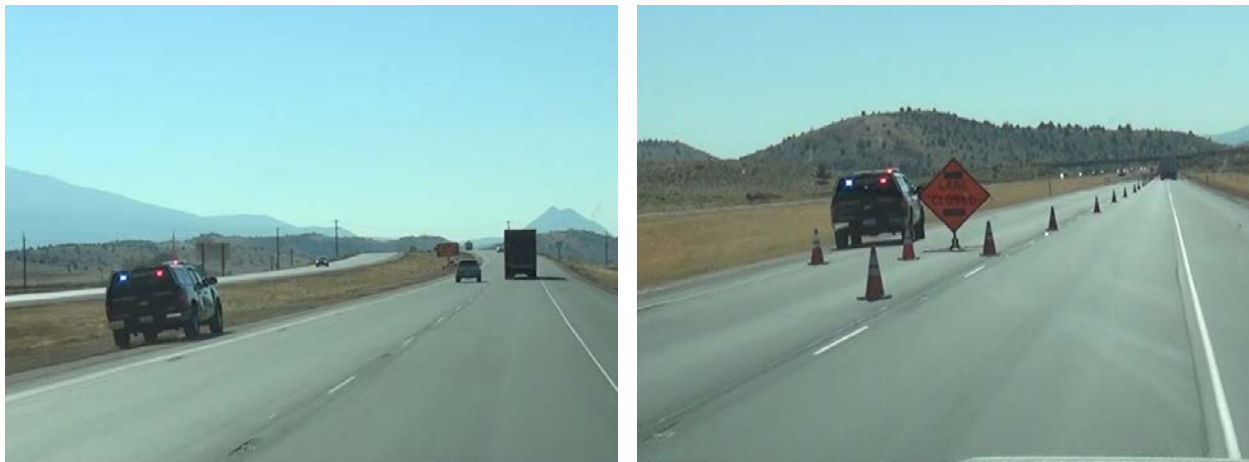
Figure 5. Locations of CHP vehicles: at the Beginning of Taper (left) and at the End of Taper (right).

Similar to the urban area tests, the researchers again made observations and recorded videos along with verbal notes as they as they drove past the work zone on the highway. The video footage helped confirming the CHP location recorded on the CHP Log Sheet, and helped reconstructing the events during the test. A summary of the notes can be found in the speed profile plates.

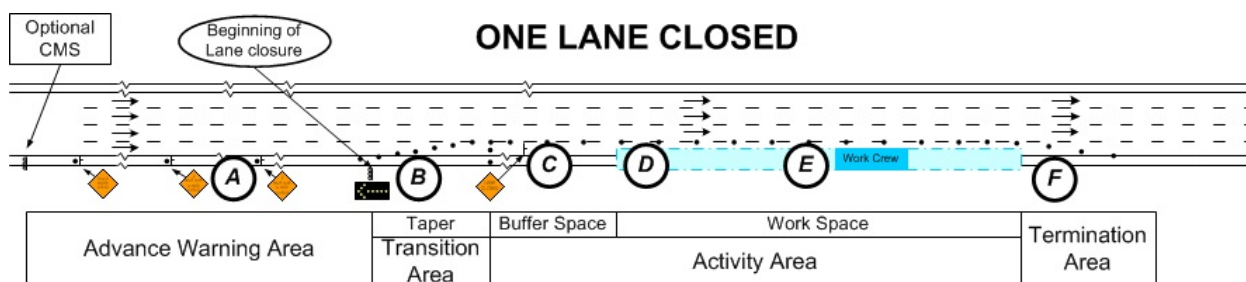
Figure 7. A Sample Work Zone Layout with one lane Closure.

The next piece of information that was sought was on the positioning of the CHP units at a work site. Caltrans nomenclature on the various positions within a work site was used [11]. Figure 7 depicts a sample layout of a work zone with a one-lane closure. Question 9 is the survey's first question on positioning of CHP units. It is assumed for this question that there is only one lane closed on the roadway.

10. Refer to the above figure where one lane of traffic is closed. Based on your experience and judgement, where would you recommend CHP vehicles be placed to maximize safety for all? Please choose A, B, C, D, E and/or F. Please provide any details you see fit.

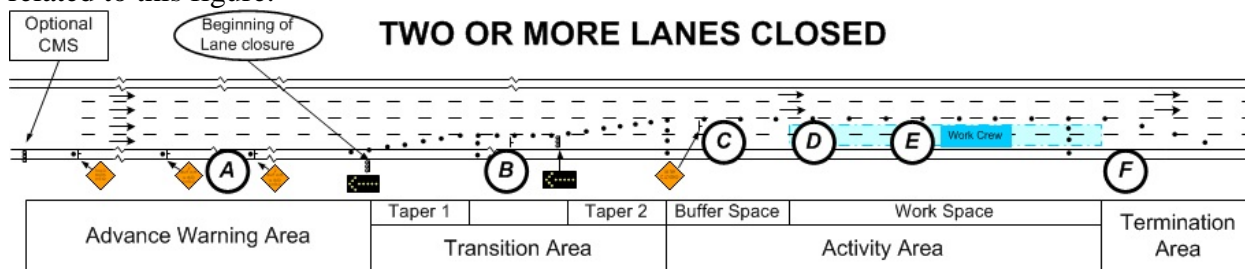
Figure 8. A Sample Work Zone Layout with two-lane Closure

Figure 8 depicts a sample highway work zone with 2 (or more) lanes closed. This and the next question are related to this figure.

12. Refer to the above figure where two or more lanes of traffic are closed. Based on your experience and judgement, where would you recommend CHP vehicles be placed to provide most benefit to workers on the road. Please choose among A, B, C, D, E and/or F. Please provide any details you see fit.

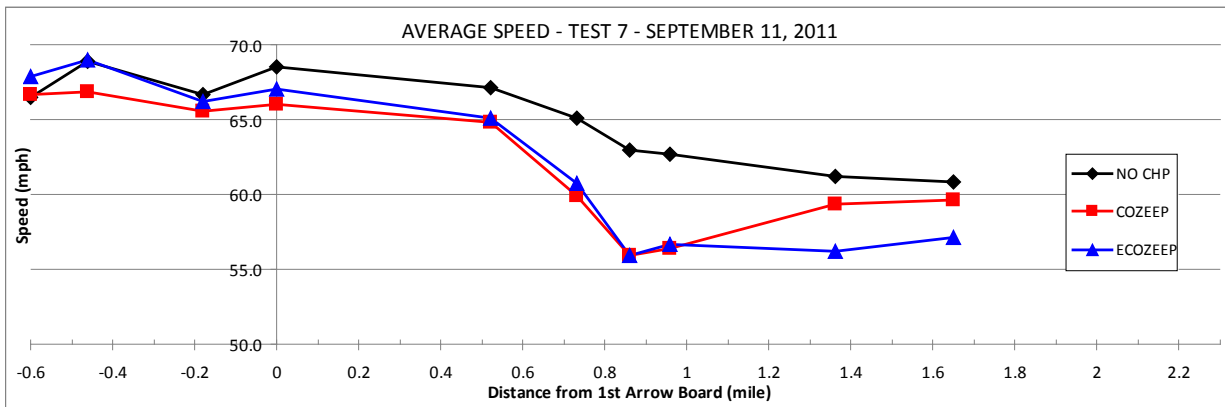
Figure 9. A Sample speed Data for a Test.

The detailed data for each test indicating the location and the date of each test as well as the nature of the lane closure together with plots of average traffic speeds at different iCone locations together with a Google Earth™ image of the site are given in Appendix B. A typical speed data for one of the tests is depicted in Figure 9. As it can be seen from this figure, although there is clear speed reduction due to use of COZEEP and ECOZEEP, the difference in speed reduction between the two is only significant in that vehicles maintained their reduced speeds over a longer distance in ECOZEEP as compared to COZEEP. This suggests that ECOZEEP is more effective for longer length work zones.

As it can be seen in the plots in Figure 9, the speed of traffic at different locations within the highway work zone varies. Therefore, in order to properly discuss speed reduction due to use of COZEEP/MAZEEP, one has to choose an appropriate reference location within the work zone. In this study, two reference locations are selected for discussing speed comparisons. In addition, the maximum speed reduction observed at any locations within the work zone is also discussed. The two reference locations are the end of taper and the end of buffer area as shown in the diagram in Figure 11. This figure depicts a typical highway work zone in California. The location of maximum speed reduction varied in different tests conducted and consisted of locations varying from the beginning of taper to some point in the active work area.

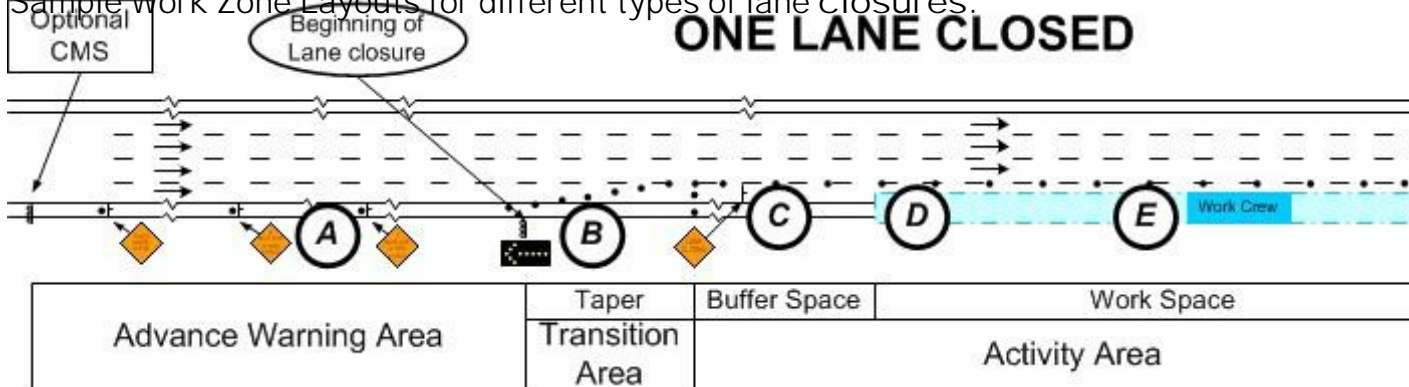
- (A) Upstream of Taper
- (B) Transition Area
- (C) Buffer Space
- (D) End of Buffer Space
- (E) Adjacent to work crew
- (F) Termination

Sample Work Zone Layouts for different types of lane closures.

9. Please refer to the figure above where one lane of traffic is closed. In your experience, where are CHP vehicles typically placed when COZEEP/MAZEEP is used? Please choose among A, B, C, D, E and/or F. Please provide any details you see fit.

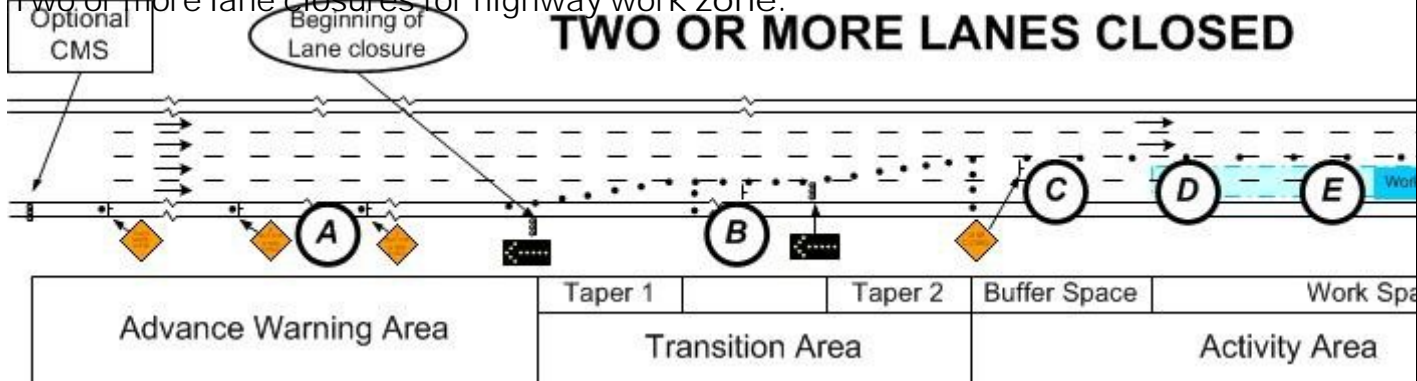
- (A) Upstream of Taper
- (B) Transition Area
- (C) Buffer Space
- (D) End of Buffer Space
- (E) Adjacent to work crew
- (F) Termination

Two or more lane closures for highway work zone.

11. Please refer to the figure above where two lanes of traffic are closed. Based on your experience and judgement, where are CHP vehicles typically placed when COZEED/MAZEED is used? Please choose among A, B, C, D, E and/or F. Please provide any details you see fit.

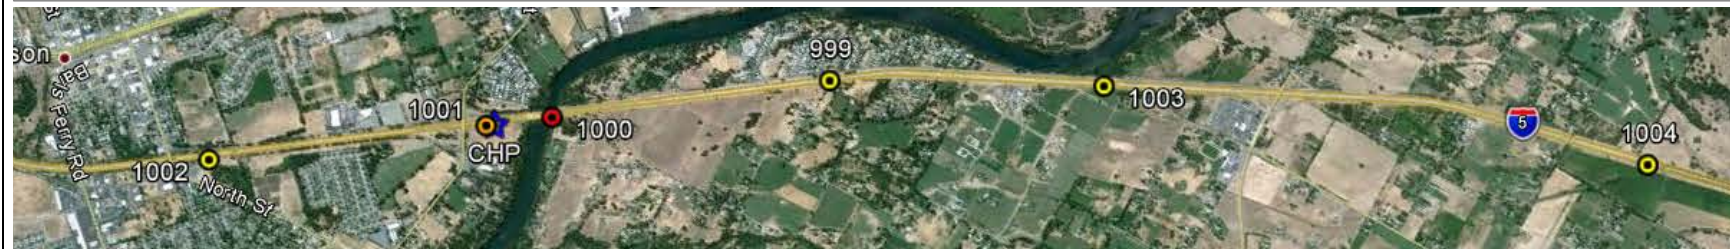
AUG 22, 2012 – I-5 Northbound – Redding, CA**Description:**

Tuesday 7 PM to 1 AM.

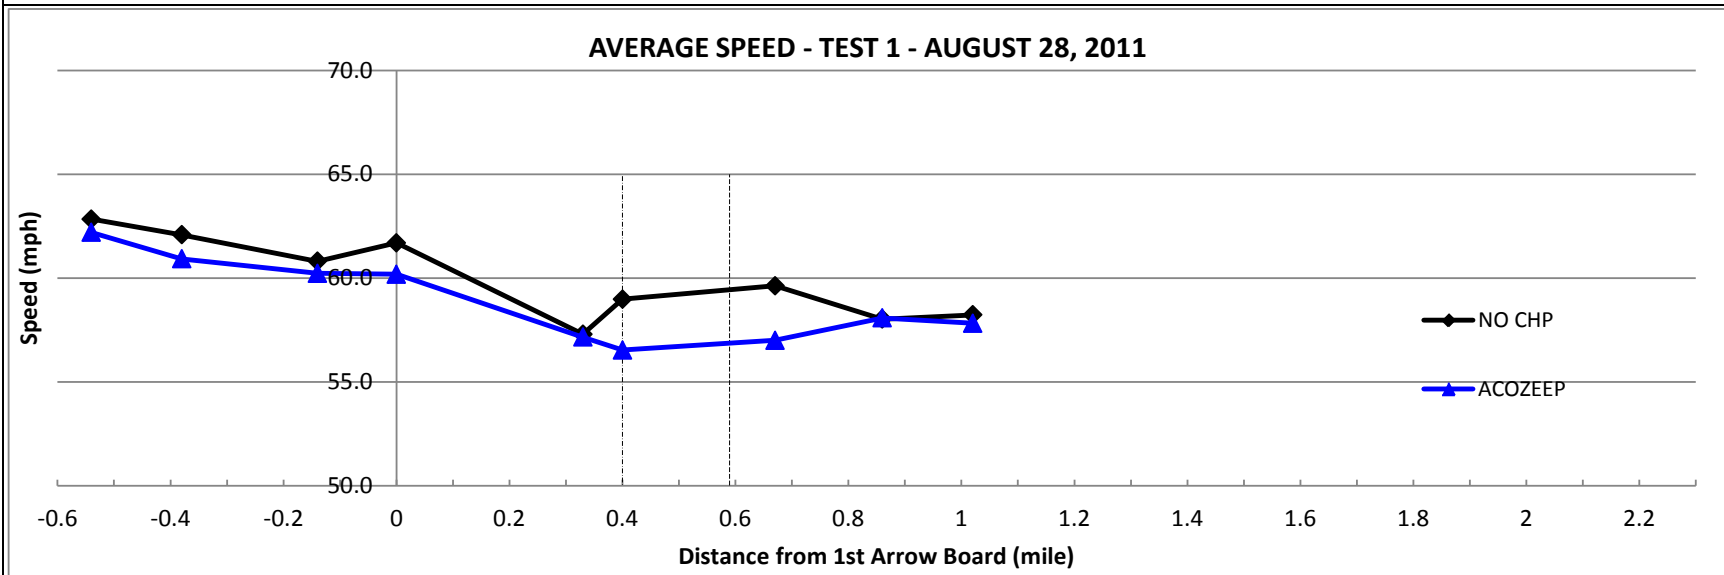
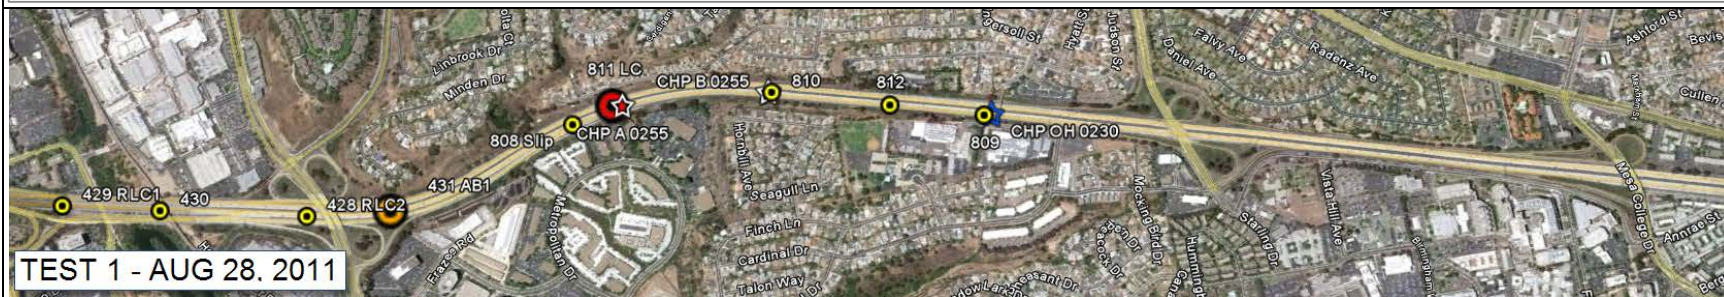
TEST 1 AUG. 28, 2011 - SR 163 Northbound - Friar Ave to Genesee Ave

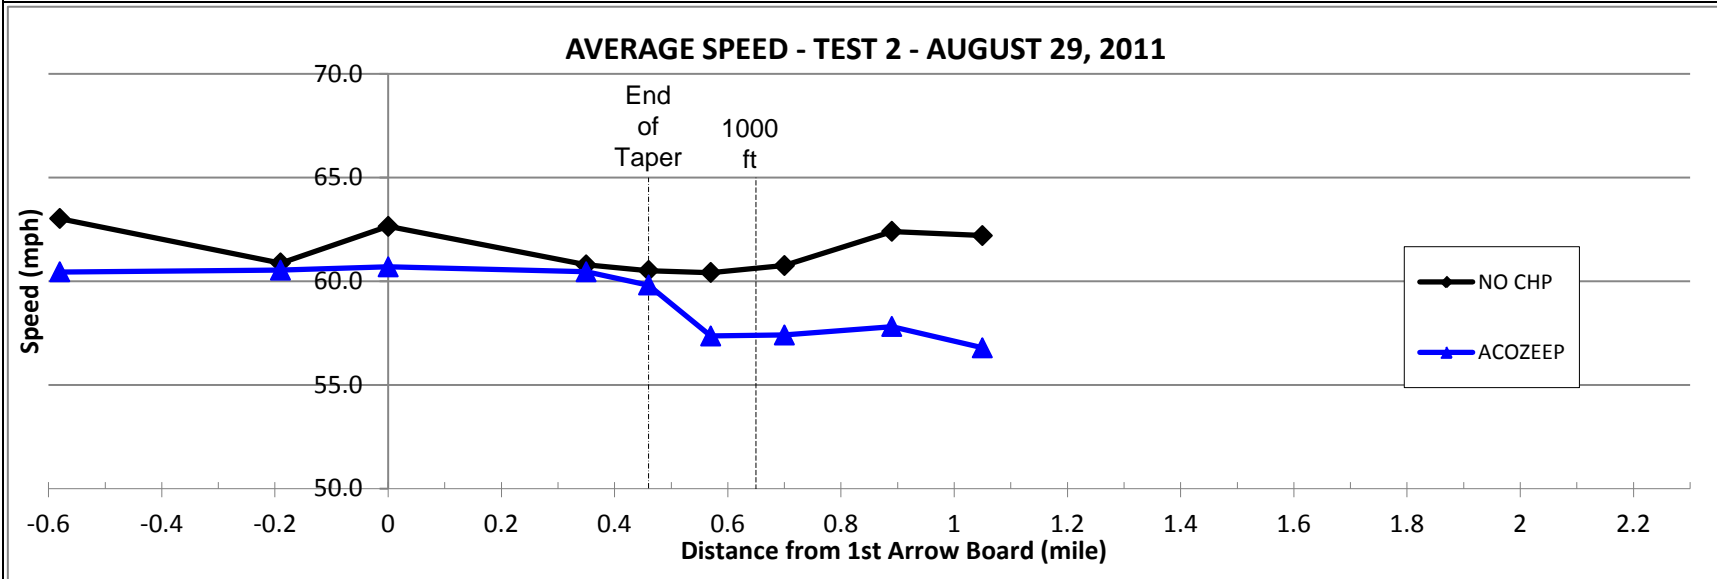
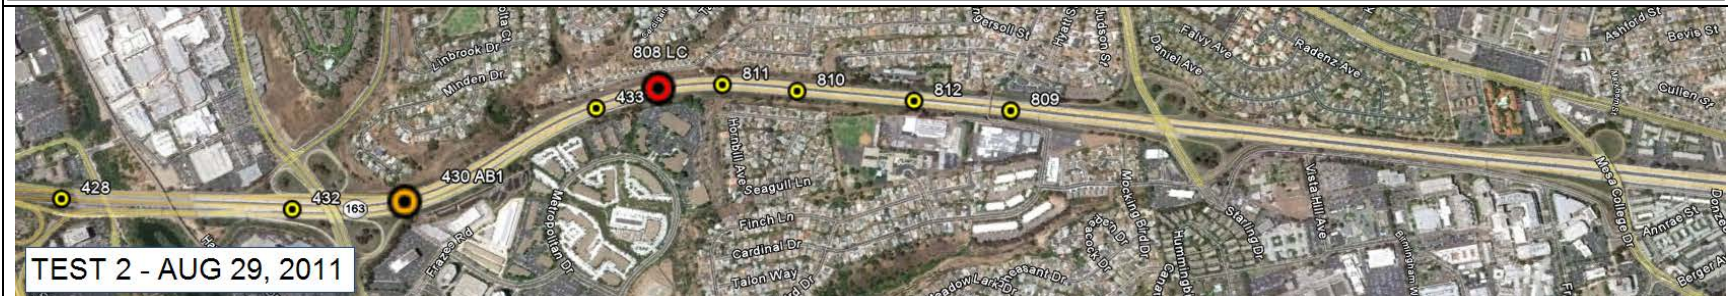
TEST 2 AUG. 29, 2011 - SR 163 Northbound - Friar Ave to Genesee Ave**Description:**

Monday Night. 2 right lanes closed. Work along shoulder back filling dike. Work moved from Friar to Genesee. Trucks unloading fill into machine with hopper.

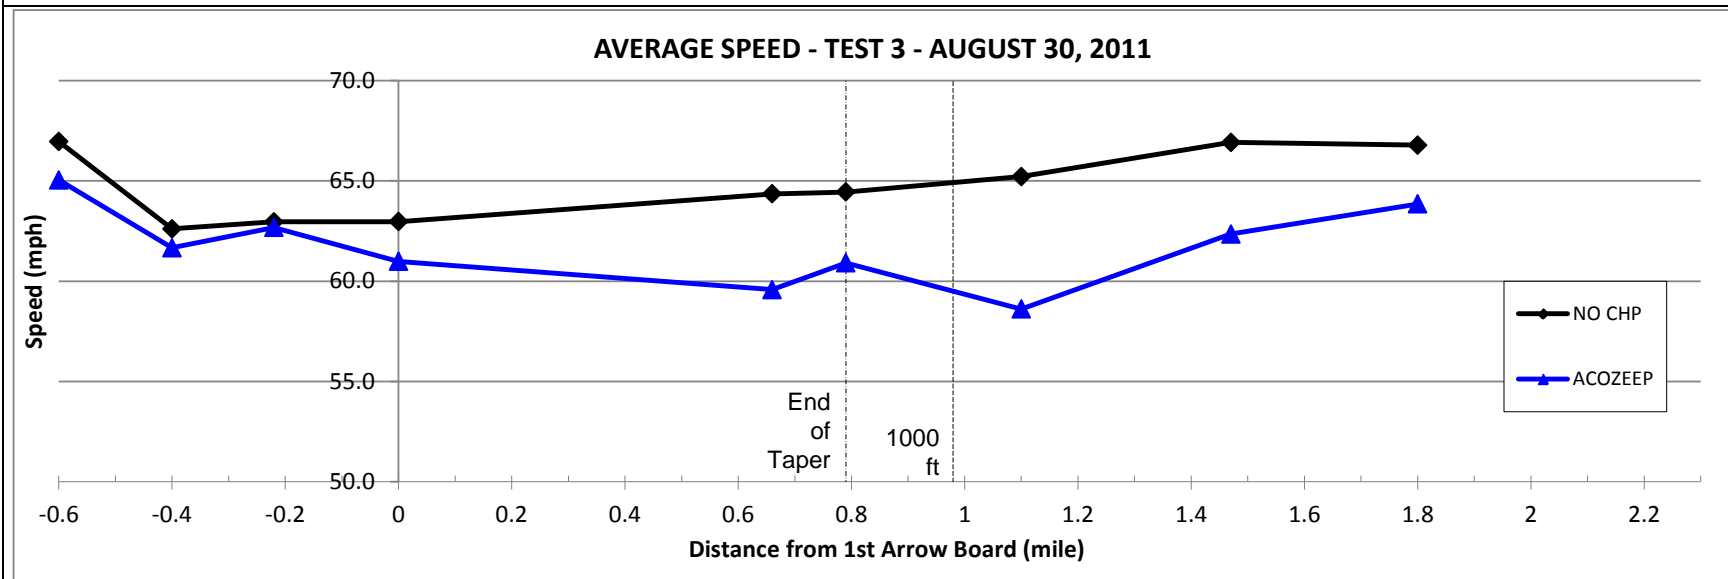
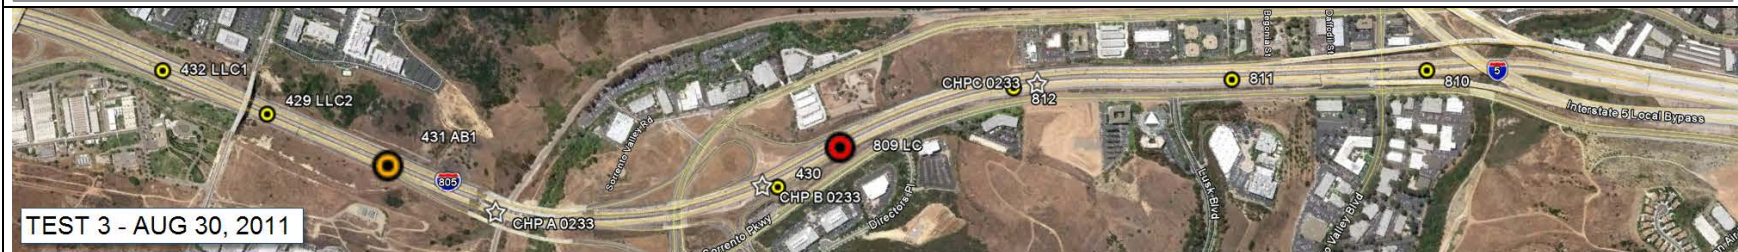
TEST 3 AUG. 30, 2011 - I 805 Northbound - South of Mira Mesa Ave to I5**Description:**

Tuesday Night. 2 left lanes closed. Excavator in median loading dump truck loading at Lane #1. Trucks entering and exiting. SD-805/Carroll Canyon Road Project No.: 11-2T0404

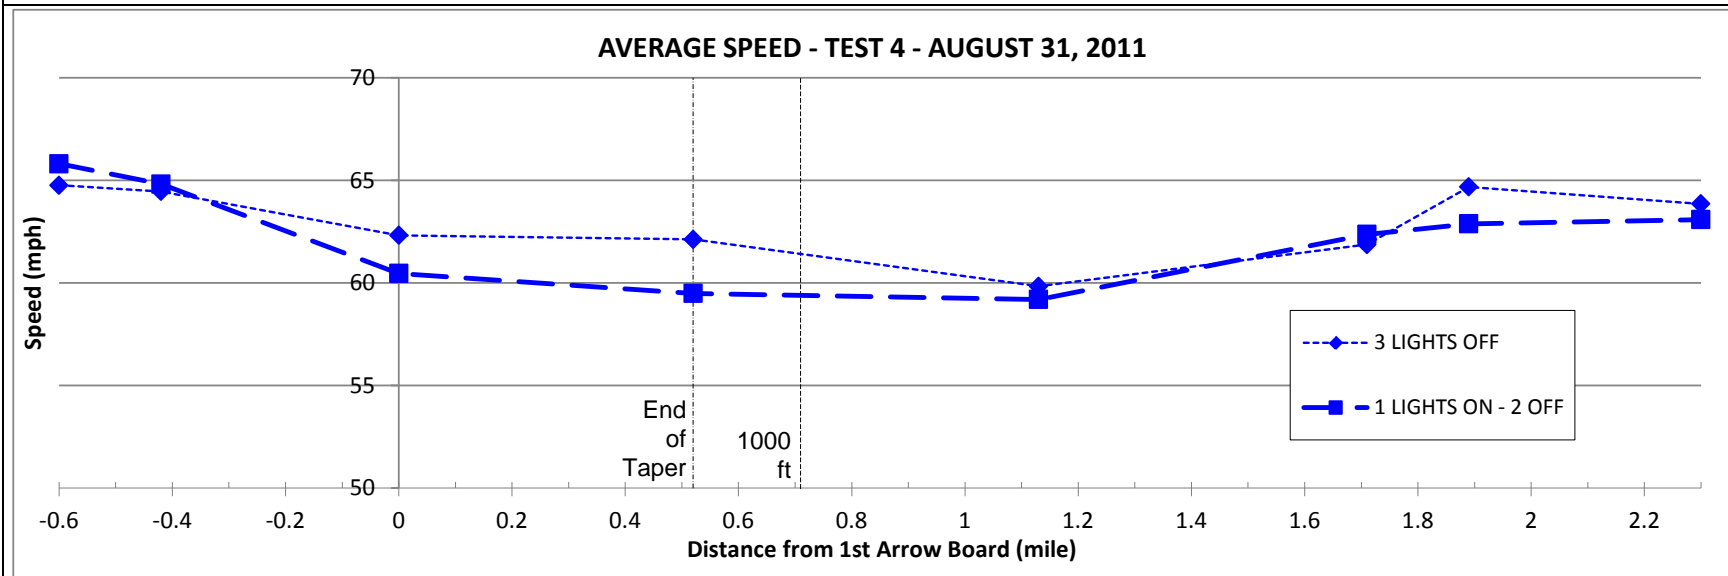
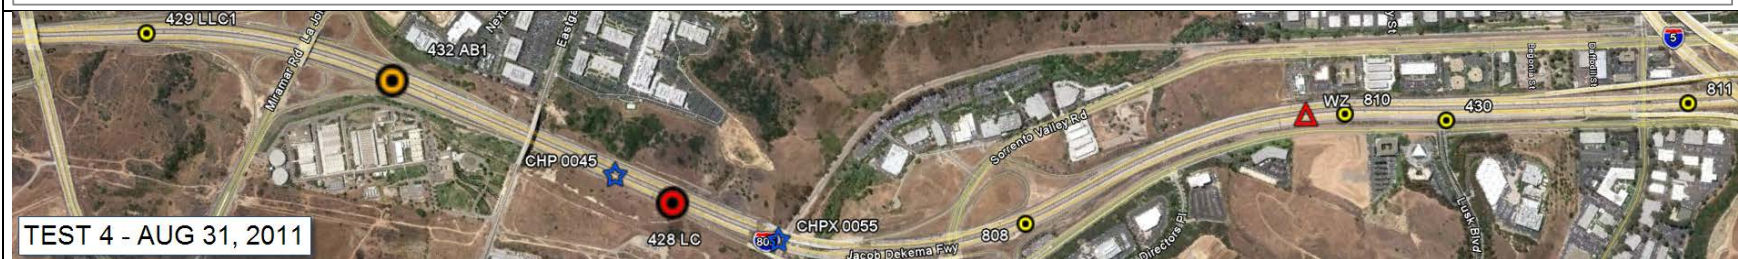
TEST 4 AUG. 31, 2011 - I 805 Northbound - La Jolla Village Dr to I5**Description:**

Wednesday Night. 2 left lanes closed. Excavator in median loading dump truck loading at Lane #1. Trucks entering and exiting.
SD-805/Carroll Canyon Road Project No.: 11-2T0404

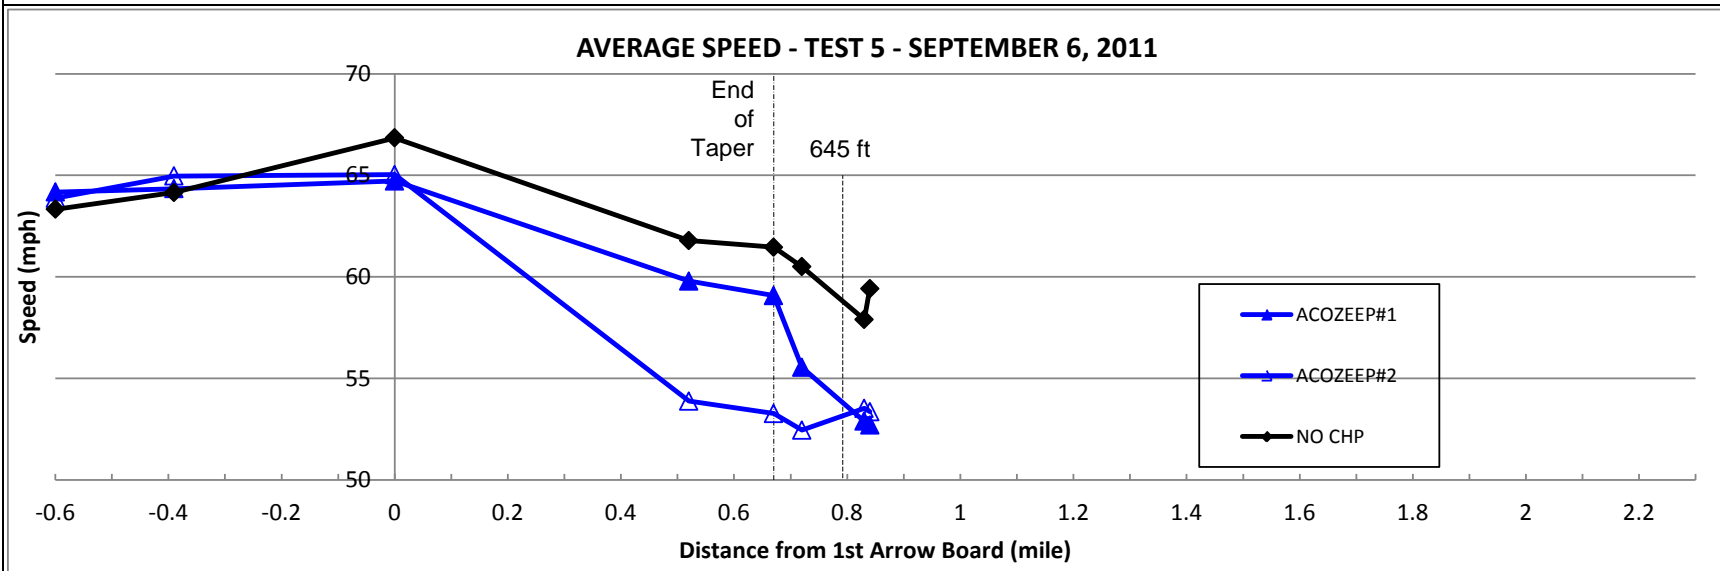
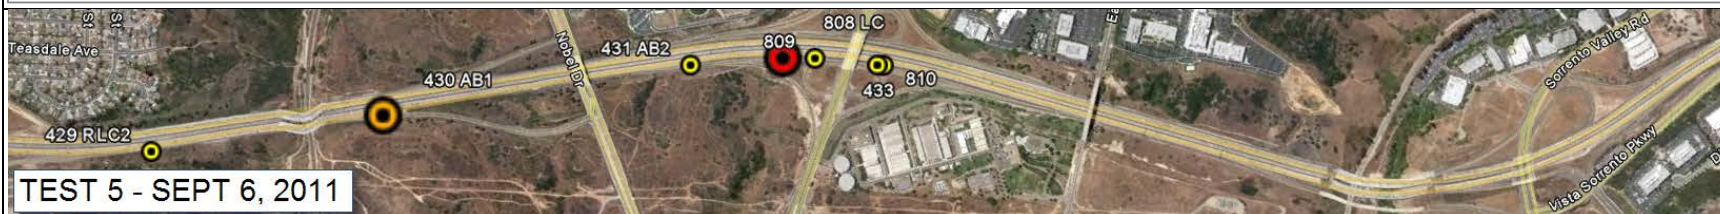
TEST 5 SEPT 6, 2011 - I 805 North - Nobel Dr Exit to La Jolla Village Dr**Description:**

Tuesday Night after Labor Day.

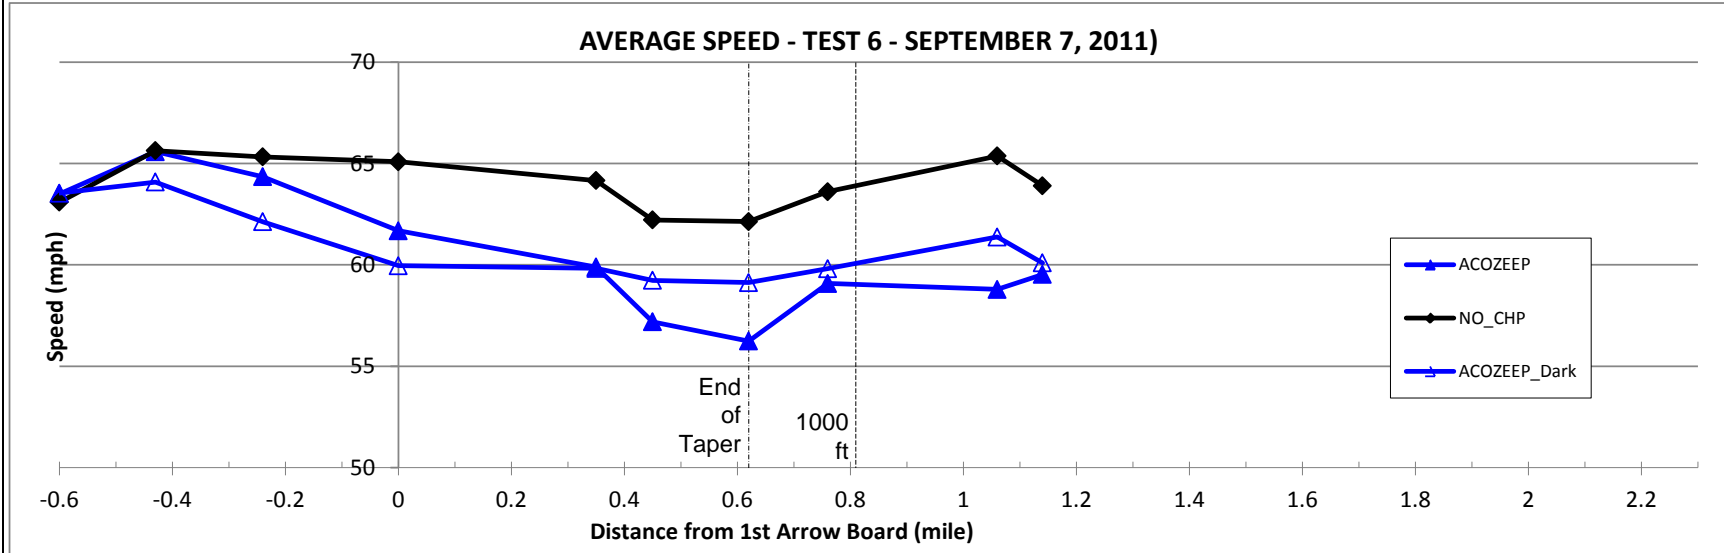
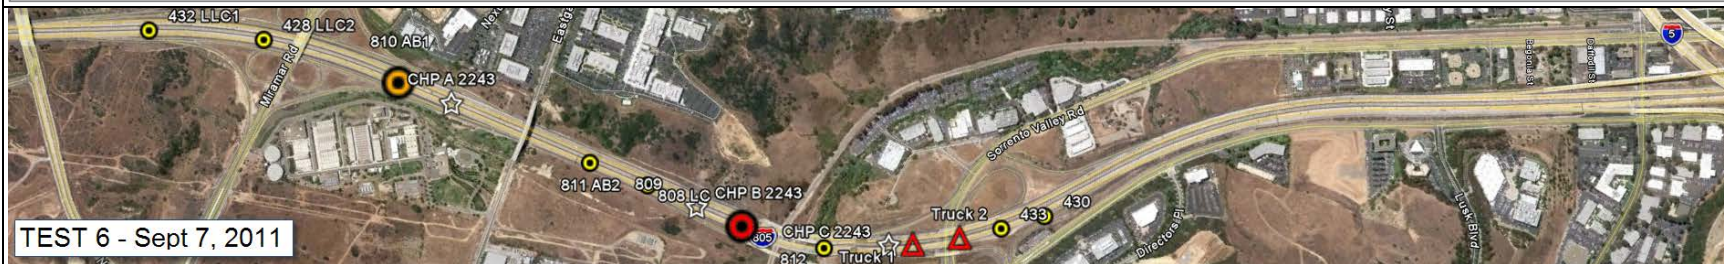
TEST 6 SEPT 7, 2011 - I 805 Northbound - Nobel Dr Exit to La Jolla Village Dr**Description:**

Wednesday Night. 2 left lanes closed. Excavator in median loading dump truck loading at Lane #1. Trucks entering and exiting.
SD-805/La Jolla Village Drive Project Project No. 11-089754

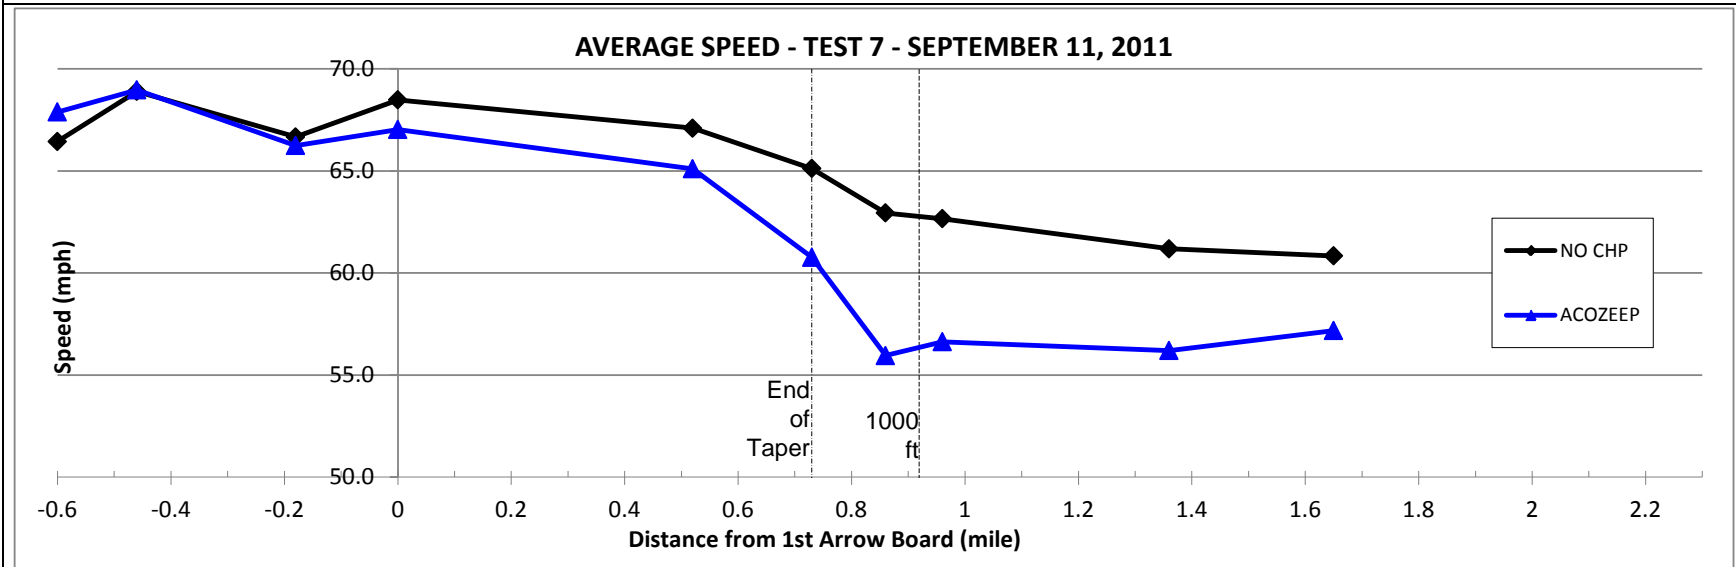
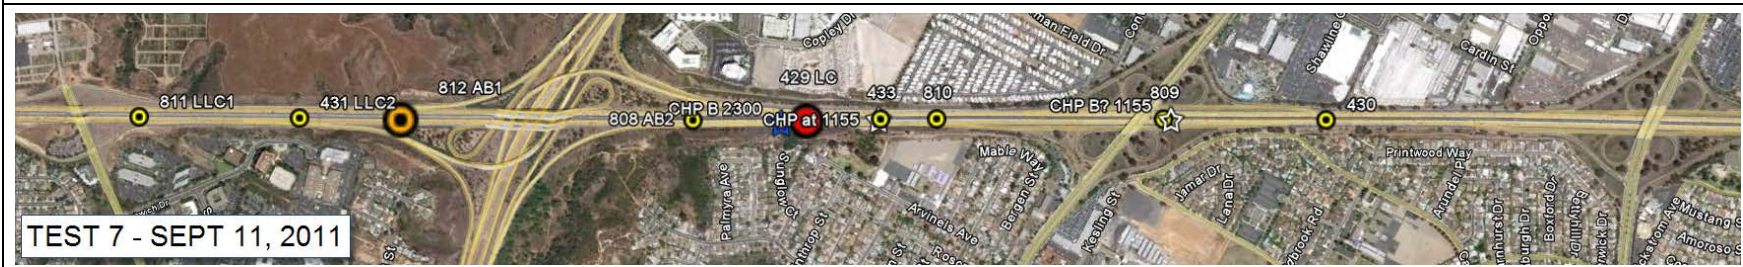
TEST 7 SEPT 11, 2011 – I 805 Southbound - Before SR52 to Balboa Ave**Description:**

Sunday Night. 2 left lanes closed. Work on lanes 1 and 2 repairing concrete.
SD-805 Grinding and Shoulder Rehab Project Project No. 11-2M01704

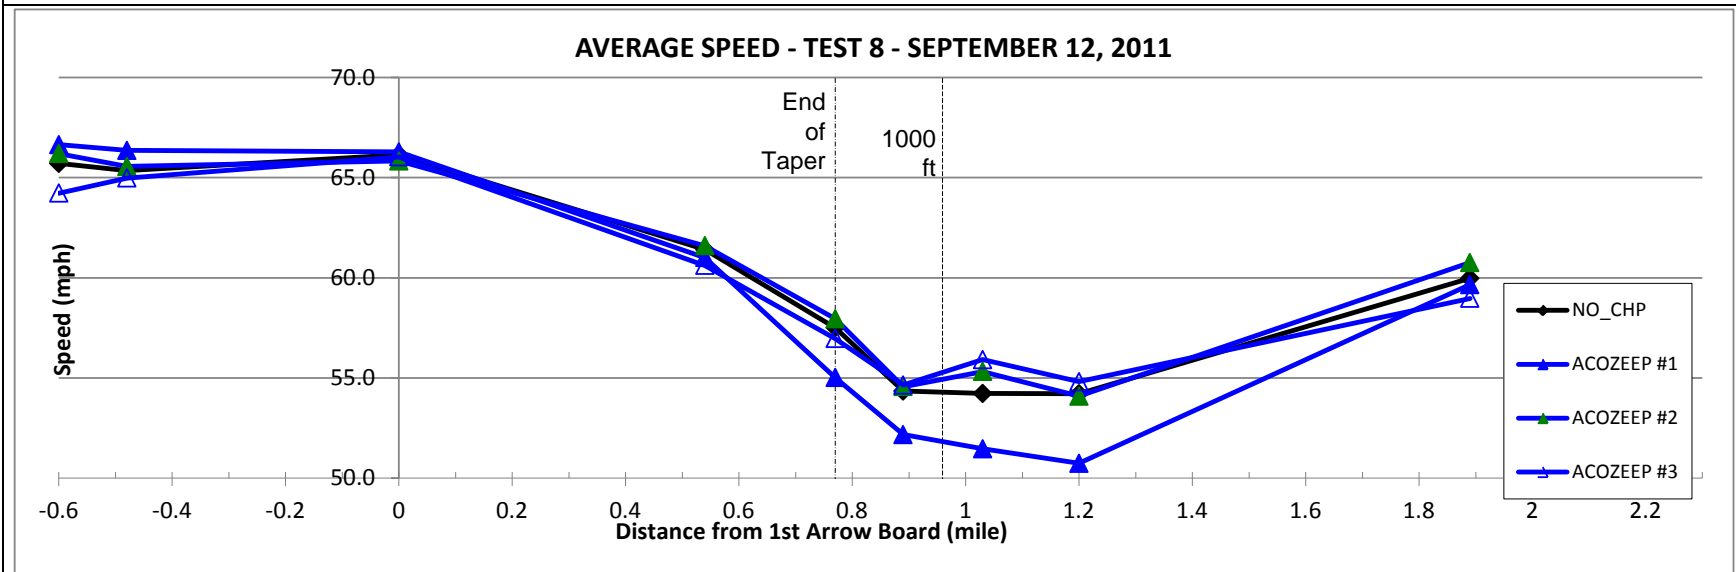
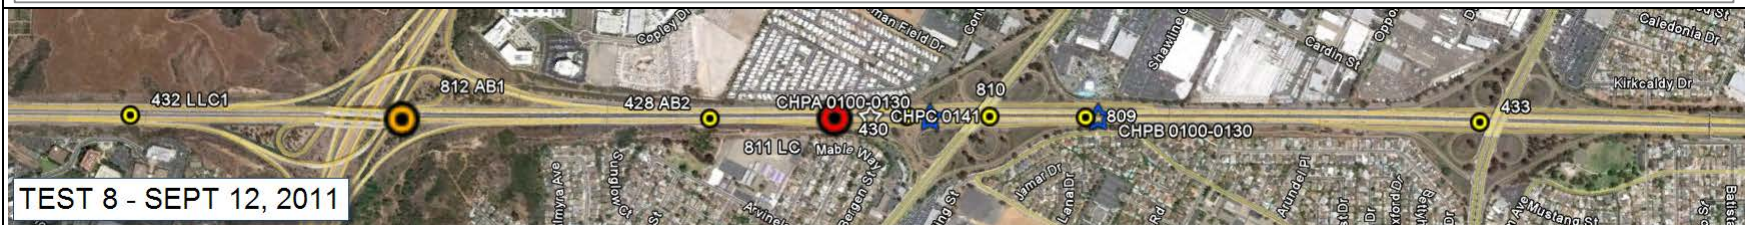
TEST 8 SEPT 12, 2011 - I 805 Southbound - SR52 to SR 163**Description:**

Monday Night. 2 left lanes closed. Work on lanes 1 and 2 repairing concrete. Monitored up to Balboa. Limited work beyond that point.
SD-805 Grinding and Shoulder Rehab Project Project No. 11-2M01704
